No. 1-64
I-0618-268-1640

THE TROUBLESHOOTER

Published by the Naval Mine Engineering Facility, Yorktown, Virginia.

1 JANUARY 1964

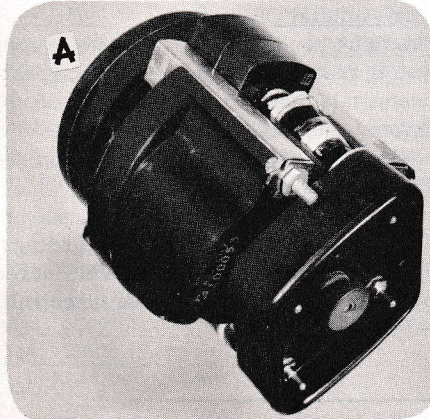
"HERE WE HAVE MATERIAL DAMAGE... WOULD YOU ACCEPT THIS COMPONENT AS 'CODE A'?"

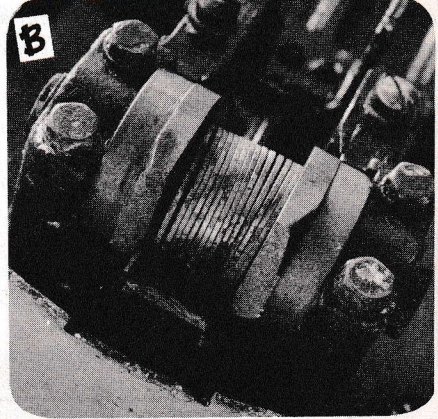
"SOMETHING HAPPENED TO THIS CASE ACCESSORY. AN EXAMPLE OF ROUGH HANDLING AND I MEAN ROUGH!"

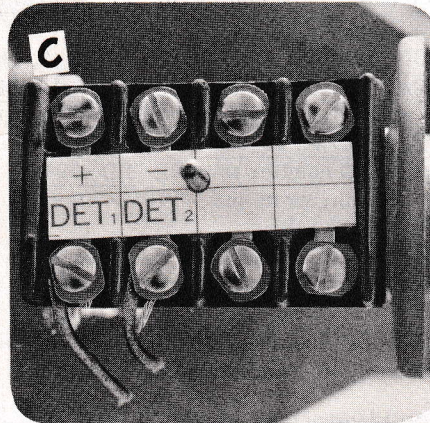
"NOTHING WRONG WITH THE TB - JUST WITH THE MINEMAN WHO ISN'T IN THE PICTURE!"

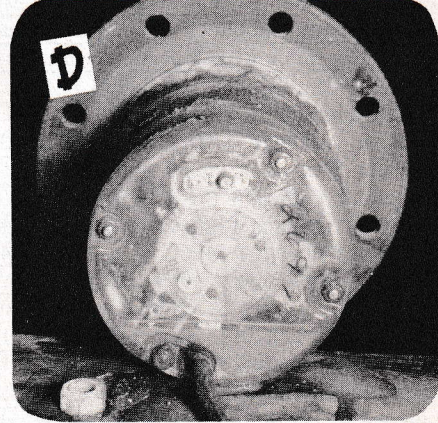
"IT WAS ALL RIGHT WHEN ASSEMBLED .. BUT THERE CERTAINLY IS SOMETHING WRONG NOW!"

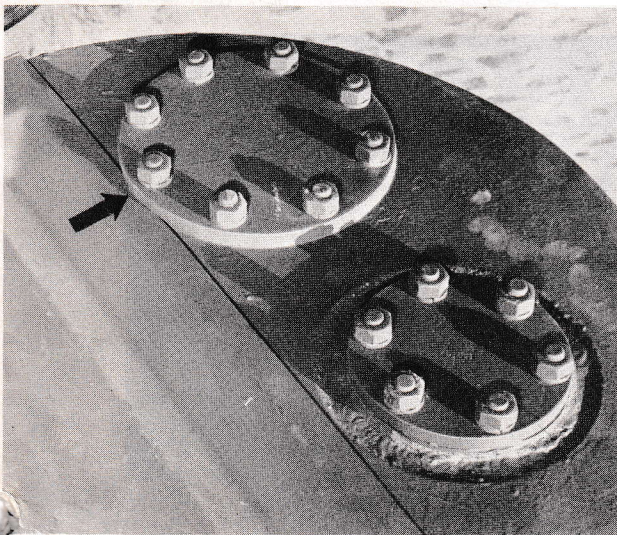
The edge of the fairing Mk 10 Mod 0 cuts into the filling hole gasket when the fairing is tightened down in the assembly of Mine Mk 25 (OA22). Found the misfit during preparation for FSMT but, upon inspection, found the same trouble in service mines.

You're not the only one to note this trouble spot and R. F. Stancik, MN2 of Navy No. 555, sent us a photo to prove it. For the time being our answer, when you find one, is to cut away the part of the fairing that interferes.

Also report via Rudminde so we can determine whether something more drastic is needed.
