# THE TROUBLESHOOTER

**AN OFFICIAL NAVORD PUBLICATION**

Published by the Naval Mine Engineering Facility, Yorktown, Virginia

1 APRIL 1967

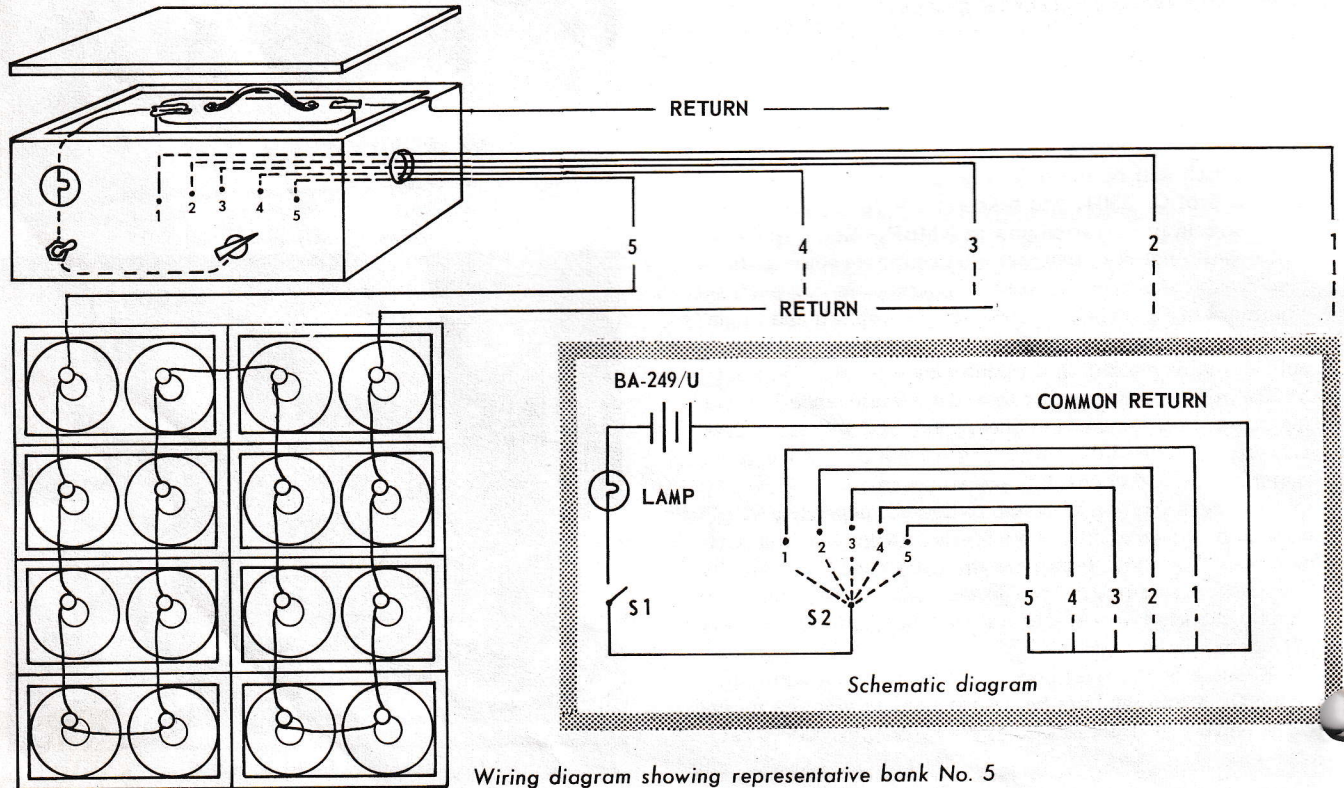
Wiring diagram showing representative bank No. 5

Battery, light, and switches are wired according to the wiring diagram. The leads from the selector switch are identified with the stacks to which they connect. Jumper wires between containers are made from pieces of hook-up wire about 15 inches long with an amphenol pin soldered on each end. A troubleshooting jumper wire, length equal to the height and breadth of the stacks, is made in the same way.

To use, turn the SPST switch to ON and rotate the selector switch through its five positions observing that the bulb lights at each position. When the bulb does not light at one of the positions it indicates a container with an open pressure switch in the stack being tested . . . to identify which, leave the selector on the "no-light" position and jumper rows of containers in the stack, one at a time. When the indicator lamp then lights the low pressure container will be in the jumpered row . . . simply jumper the containers in that row one at a time to reveal the bad container.

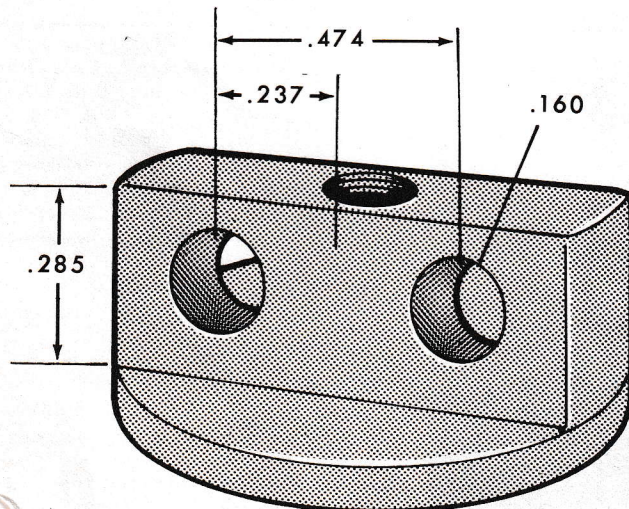
Terminal Block Hydrophone Mk 6 Mod 1

Hate to bring up those Hubbel connectors again but now we've found that they can be damaged by misorientation of the terminal blocks on the Hydrophone Mark 6 Mod 1. The holes in the blocks are off center and if, by accident of angle, they are too close together the 800/1800 series instrument cable has to bend back on itself. This distortion makes it necessary to force the connector in at an angle with resulting damage. Even if the damage doesn't occur going in, it sure will when coming out.

Our solution would be to drill a duplicate hole at the opposite edge of each block to give a choice of "Hubbel holes" to accommodate the cable in Mk 52/55 mines that use the hydrophone. It works for MOMAT 0321.

At the risk of having our name changed to The Hubbel-shooter I'm printing your suggestion and saying you can consider your fix official. Drawings have been revised so that in future procurements there will be two terminal holes on all of these gadgets. Others who are faced with the one-hole problem may do likewise per the illustrations here.

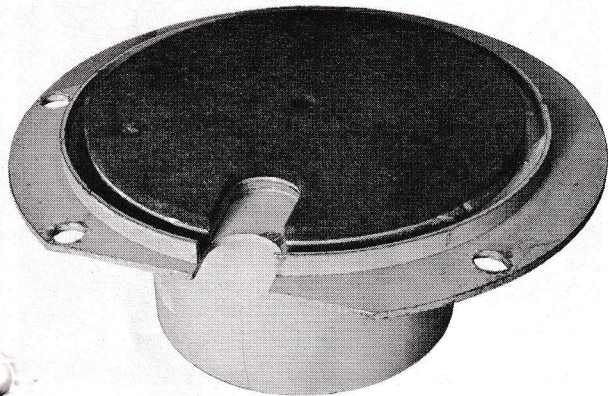
RETAINER ASSEMBLY COMPLETE WITH SPACER-DISC

Some retainers DWG 451863 for Firing Mechanism A-5 Mod 3 in Mine Mk 25 Mod 1 have found their way into depot stocks minus a spacer-disc, as evidenced by a Rudminde from NAVMAG Subic reporting their entire stock of retainers in this condition. These retainers should not be used without the discs because the retainer also serves as a cover for the battery compartment (BA-241/U) and it is the function of the spacer-disc, a circle of plywood with a felt pad cemented to it, to protect the top of the battery and hold it solidly.

All of these retainers should look like the one we show here, with the spacer disc as part of the assembly.

Any which do not should be placed in Code G and repair parts ordered with which to make them complete:

- ▶ Spacer-disc assembly (DWG 443660) 1350-038-5878
- ▶ Screw, round-head, 1/4-20 x 1/2, MS-35206-279, 5305-988-1723(1)
- ▶ Washer, flat, steel, 1/4-inch, MS-27183-10, 5310-809-4058(1)

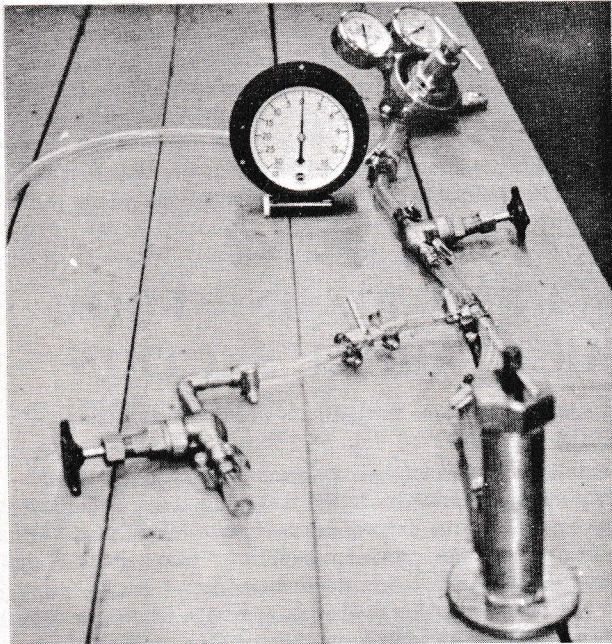
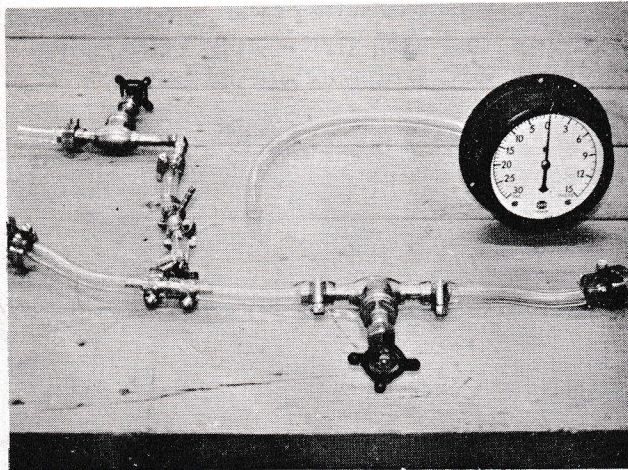
supplied with the filling kit," says Lt. Toby Horne, are so small that adequate closure cannot be obtained unless pliers are used, or cross pieces are brazed onto the clamps' screws." So 0321 has substituted 1/4-inch gate valves for these clamps (200 psi capacity, 4820-554-8711), each requiring two 1/4-inch nipples.

A close look at how the gate valves with nipples, two to each valve, are connected to the Tygon plastic tubing and made secure by hose clamps. The gage and nitrogen gas cylinder have not been connected. The evacuation and filling fixture assembly is shown in the top picture.

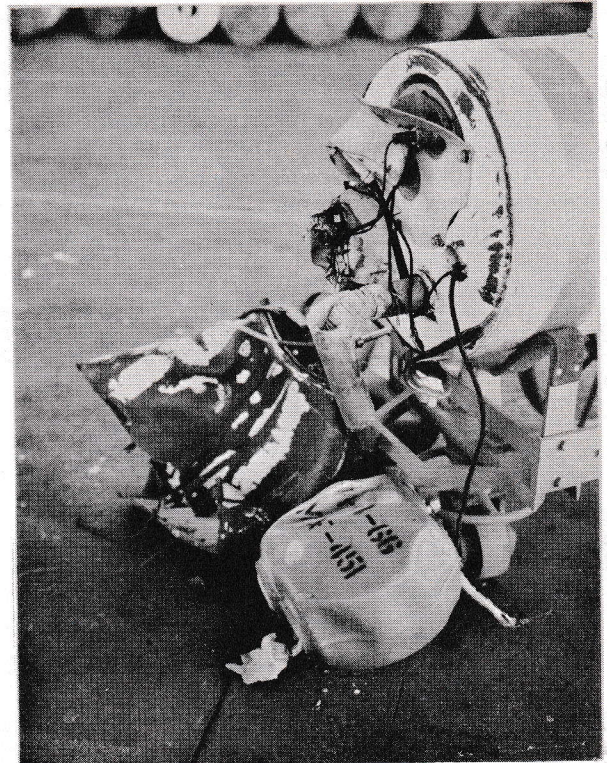
Would you believe what could happen to a mine that dropped without a parachute? They fall hard, as this photo by MN1 Jim McDonough from DRILLMINPREPFAC, Long Beach, shows. The mine, in case you can't recognize the remains, is (was) a Drill Mk 25.

Jim writes: "It appears as if the mine tumbled, and between the velocity and angle of impact the tail was completely sheared off, not to mention what damage was done to the components. Some mess!"

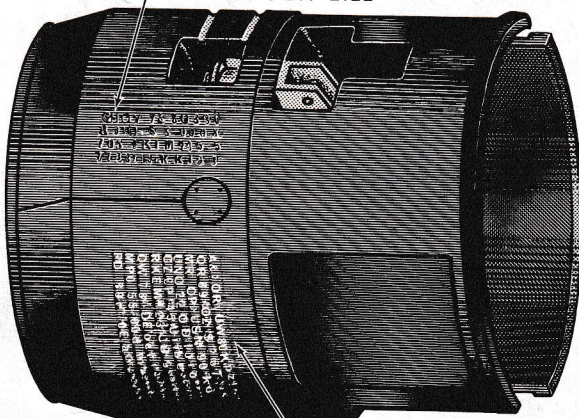
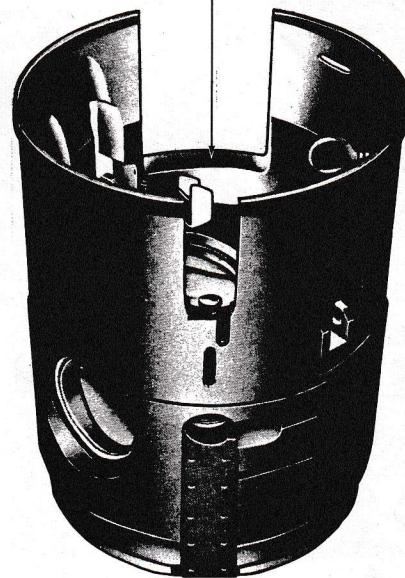
**A**CTIVITIES ASSEMBLING Mark 57 mines have had difficulty with the serial identification of the Mk 57-0 anchors. Rudmines on the subject fall into three categories: 1) serial number, manufacturer etc. stenciled on the anchor but not die-stamped; 2) serial etc. die-stamped but not stenciled; 3) two numbers die-stamped on the anchor without indication as to which is the serial number.

What leads to the confusion is that Drawing 1438502 requires die-stamping the outside of the anchor in 1/4-inch characters, information including serial number and manufacturer, and calls for this info to be repeated in stenciling. Then the drawing for the housing, 1467530 requires die-stamping in 3/8-inch characters, of the foundry heat number. This explains the two numbers and the confusion. The key is the fact that the numbers die-stamped in the mooring-arm-hinge cut-outs in the anchors (see illustration) is the foundry heat number. The number on the outside of the anchor is the serial number.

After stamping repair damaged areas with paint TT-E-516, black 8010-297-2122

Use white TT-P-98, Type I 8010-285-493

Activities discovering incomplete identification should die-stamp the following information on the sides of the anchors where shown in the illustrations.
