mine and depth - charge

THE TROUBLESHOOTER

AN OFFICIAL BUWEPS PUBLICATION

1 APRIL 1963

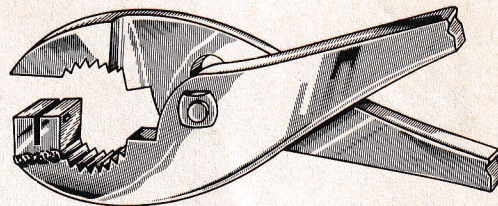
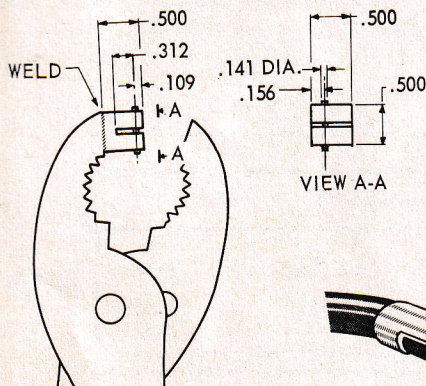
How to make . . . A HANDY LUG-ALTERING TOOL

THERE WAS SOME TALK about including these modified pliers in the Basic Tool Set for Mines, but the latest word is that they won't be. This means you make your own—if you haven't already done so. They are for flag-type lugs that're too big to fit between the TB barriers.

TO MAKE: Use standard Pliers, 10-inch, Federal Specification GGG-P-00471 (NAVY SHIPS) Type II, Class 2, Style A. Weld a half-inch cube of steel to one jaw as shown, then cut a 0.035-inch slot (use hacksaw) approximately 0.400-inch deep, centered in the face of the cube. Next drill a 9/64-inch hole (#28 drill) as shown. Insert a pin (#7 AWG steel wire) in the drilled hole and secure by peening the pin's outer ends.

TO USE: Place flag-type lug's prongs in the tool's slot so that the pin takes the normal position of a terminal screw in the lug, then squeeze the pliers' jaws closed thus reducing the width between the lug's bent side and the bottom of the "U" formed by its prongs (lower right). Most oversize lugs will fit terminal blocks without damage when so bent, but occasionally the ends of a lug's prongs will also have to be trimmed a few thousandths (file or snip) after using this tool.

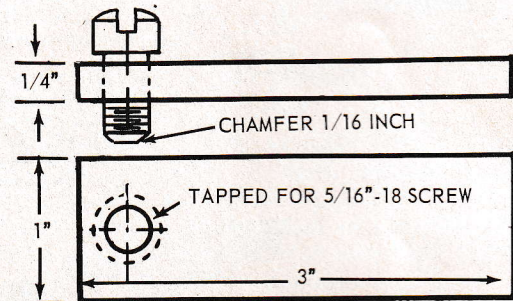
A good idea but, until that Screw, Fillister Head, 5/16" x 7/8"—18 DWG 1420208 Signal Assembly Anchor Drill Mine Float Mark 15 Mod 0/1 shows up with a tapered end, here's what you can do to any blunt-enders that seem to need guidance:

Get yourself a piece of 1/4-inch steel or brass about 1 by 3 inches. In one end (see sketch) drill and tap a hole to take that 5/16" screw. Clamp the other end in a vise and turn the end of the screw through enough so that you can chamfer it with a file about 1/16 inch at a 45° angle. When you back the screw out, you'll chase the end threads clean.

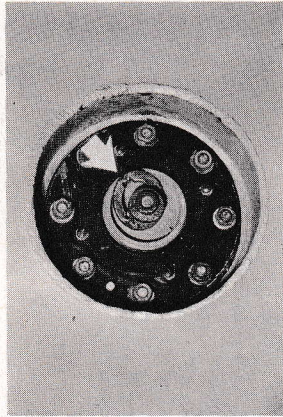
In T-Shooter 2-62, the "Job Right" article said that, when the arming wire safety lock's tabs become weakened so they won't hold the retainer during the water-impact shock of planting, the retainer tends to drift enough to get in the way of the piston nut and prevent full piston travel.

This has brought the comment: "It may be so for all I know, but to me it sounds like confusion. How about a picture?" Here 'tis! The arrow points to the retainer and you can see how that piston nut is hung up on it. Just goes to show how carelessness with a two-bit item can make a dud out of a dillion-dollar mine. This issue's "Job Right" article has the latest word on these arming wire safety locks.

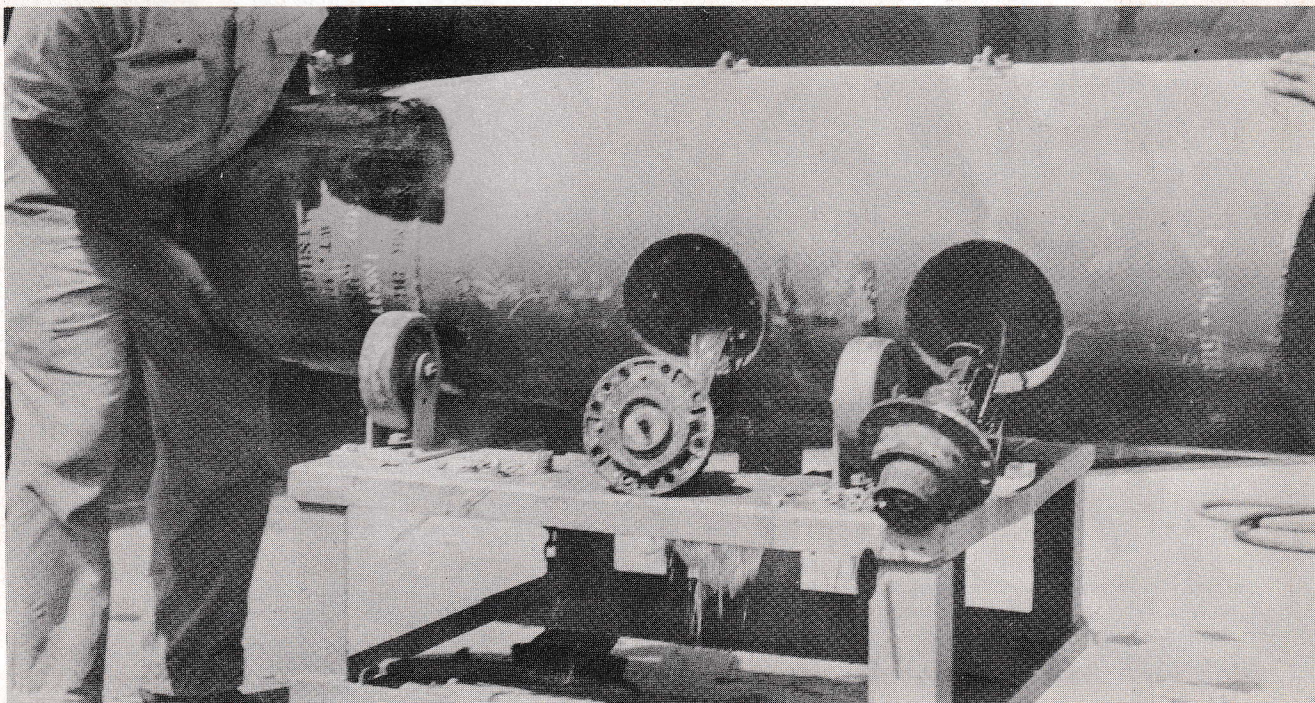
Water leaked into this mine because prescribed diaphragm replacement and test procedures were not followed.

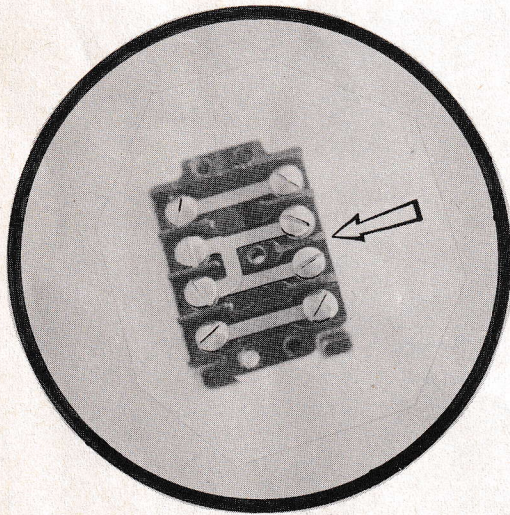
Bakelite terminal separators on terminal blocks broken.	Rough handling and/or inadequate packaging. Visual inspection not properly made.	Chances of short circuits between terminal connections increased.
Sterilizer Device SD 4-1 resistor carriage loose.	Carelessness and lack of attention to assembly details.	Possible loss of mine sterilization feature which increases the risk of casualties during subsequent check sweeping or mine clearance operations.

Forcing oversized lugs onto terminal blocks can also cause this barrier (separator) breakage. (See "TB patience" in HOT STUFF, in this issue.

Following proper procedures could have prevented this.

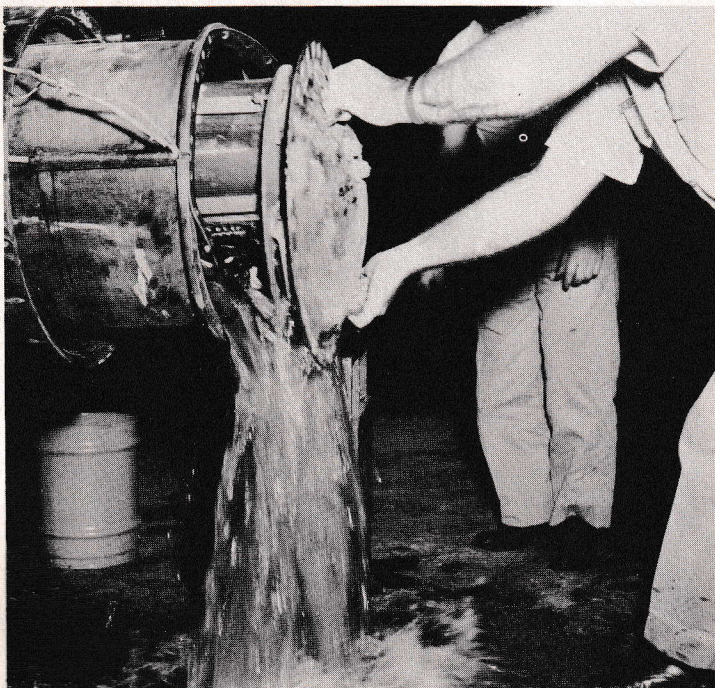
Pressure seals in Mine Mark 27 extension cover not tightened.	Instructions for checking torque on pressure seals not included in OP 2363 Volume 2.	Mine mechanism compartment flooded flooded with sea water.
Terminal connection improperly made at arming circuit stud on Mine Mark 27 Mod 4 extension cover.	Terminal screw was too long and bottomed in arming circuit stud before a tight connection was obtained.	Possible mine arming failure; dud mine.

A picture of personnel error. Pressure seals in extension cover weren't tightened.

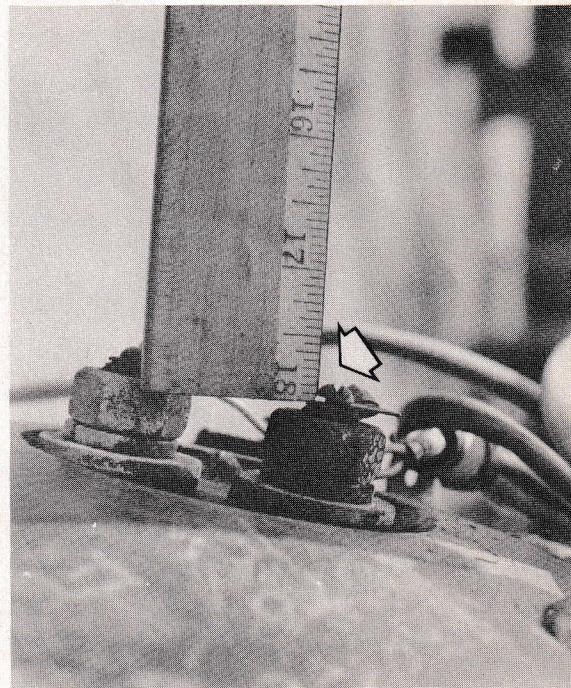
How much time would it have taken to replace this screw with a shorter one? Loose connections can cause duds!

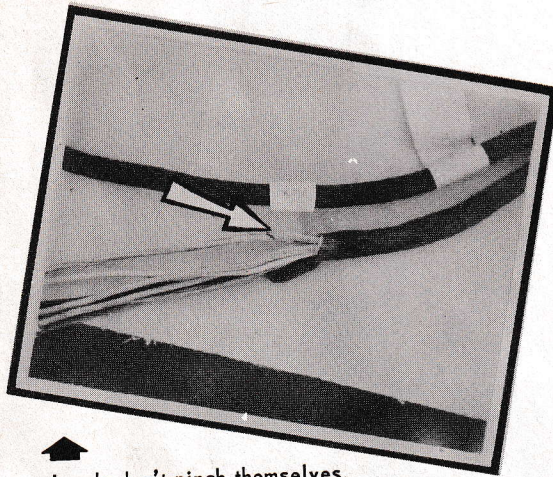
Leads don't pinch themselves.

"Make-do" is taboo! If you can't back out a broken terminal screw, replace the block. ➔

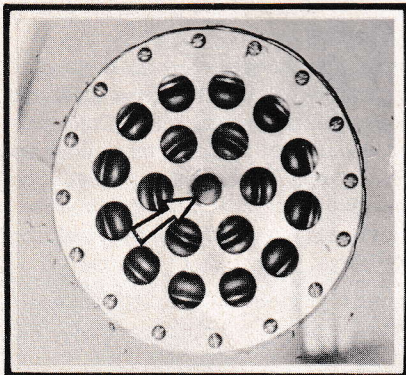
← This broken parapack-locating stud may have been due to defective material.

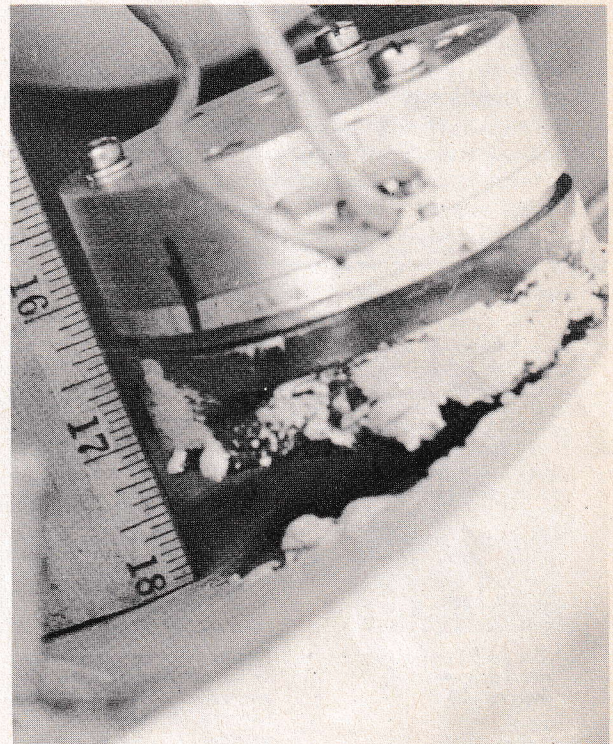
Suppose this had been an explosive-loaded mine? Proper torpedo-tube loading procedure would have prevented the tripping latch from doing this. →

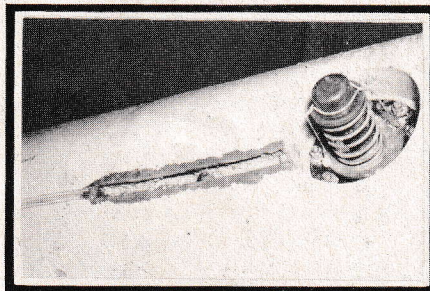
Whose weld was this? →
