mine and depth - charge

THE TROUBLESHOOTER

AN OFFICIAL BUWEPS PUBLICATION

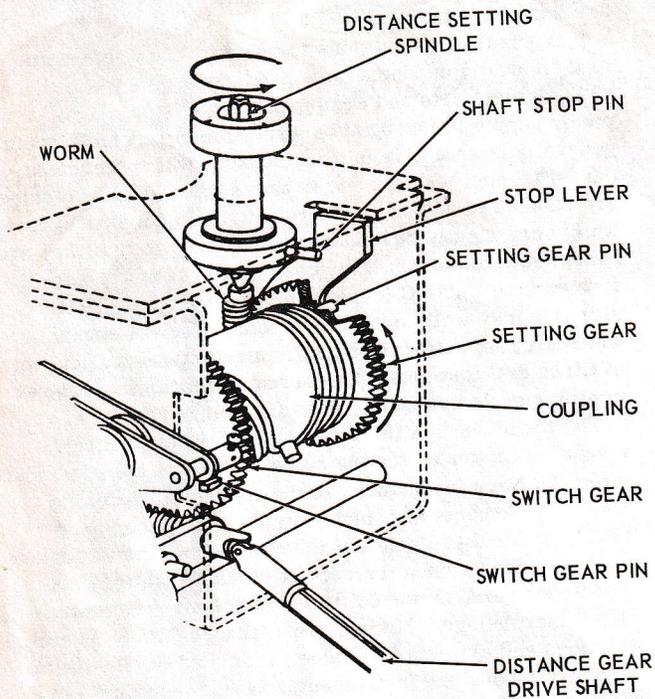
DISTANCE SETTING SPINDLE CAN'T STAND ONE TURN MORE

DISTANCE setting units in Mods 1 and 2 of Mine Vehicle Mark 1 are turning up inoperative after maximum distance settings are made, resulting in a number of Rudmines asking why. The reason lies in the number of turns given to the distance-setting spindle. This unit is designed for 20-7/8 turns maximum, but there are units in the field which at one time or another have been given 21-7/8 turns. The result: stop levers have been bent in the doing, and the mechanisms thereby rendered unfit for service use. How could this happen? It happens like this:

As the distance-setting spindle is turned, the worm gear on the shaft rotates the setting gear. And as the setting gear rotates, its pin pushes the stop lever into a slot. When the lever bottoms in the slot the mechanism is set for maximum distance. This occurs at 20-7/8 turns, which is also the point where the shaft's stop pin strikes the stop lever, to insure that no more turns are made. This is as it should be.

But . . . the Groov-pins used in some as yet unidentified manufacturing lots (they function as the shaft's stop pins) were, at the time of manufacture, pressed too deep into their holes, permitting them to clear the stop lever, after 20-7/8 turns of the shaft, thus allowing that extra turn. The stop lever, caught between the slot and the

pressure of the setting-gear pin, had nothing to do but bend when the distance-setting spindle was turned up to max.

The real cause goes back to the manufacturers' use of an improper Groov-pin: one designed for through-drilled holes, known as type 2. The proper pin is a reverse-taper groov-pin for use in blind holes, known as type 4. The reverse taper of the type 4 jams the pin and holds it firm.

So what should you do when you come across a unit that turns up to 21-7/8? First, do not try to reposition the stop pin. It won't help, since the lever of the mechanism is also bent. In this condition the unit is not acceptable for service use and your only recourse at present is to tag it Code B and order a replacement.

Soon, though (in response to recent NMEF action), those type 4 Groov-pins will become available via APL 23521.01002, which already lists the stop levers. When they do, you can overhaul, using the instructions in OPs 1935 Vol 1 and 2363 Vol 1, and install new stop levers and the type 4 pins.

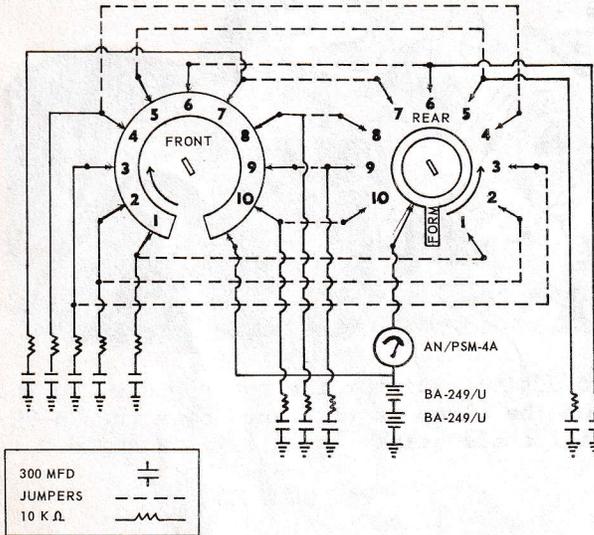
The switch called out in our parts lists for the test panel is a good one for the job but if you can't find that one 5930-248-6596 will get you a rotary switch that is an adequate substitute. This switch is in a single section with contacts front and rear of the wafer. To make

it work you have to jumper between contact 1 on the front and contact 1 on the rear, and continue through all 10 contacts. The schematic here shows how the connections are made.

You should also change our operating procedure in the first paragraph of the right-hand column, top of page 12, where 100 MA/2.5v should read: 100 micro-amps/2.5v.

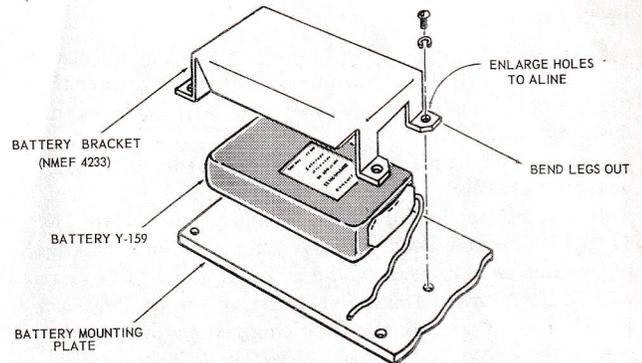
Battery bracket stretch

All of a sudden we get pinger batteries (Batteries Y-159) that do not fit their mounting brackets, NMEF DWG 4233. They were mixed in a group of batteries issued for FSMT Mines Mark 6. Some fit and some didn't. How come?

That bracket 4233 (specified for Mines Mks 6, 10, 25, 27 and 49) was designed to fit the first lot of Batteries Y-159 received from the manufacturer. Later the manufacturer shipped in some batteries that were longer by a fraction of an inch, and that's the cause of your trouble.

In future procurements, length will be controlled so those Y-159s will fit the brackets properly. Meanwhile, when you get a long one, bend the bracket legs slightly at the battery-connector-card end, and your battery will fit.

To install it, though, you'll also have to enlarge the two holes in the bracket legs with a round file, so they'll line up with the holes in the mounting plate. The same fix is needed for Brackets NMEF 4222 when an oversize battery has to be installed in a Mine Mk 18.

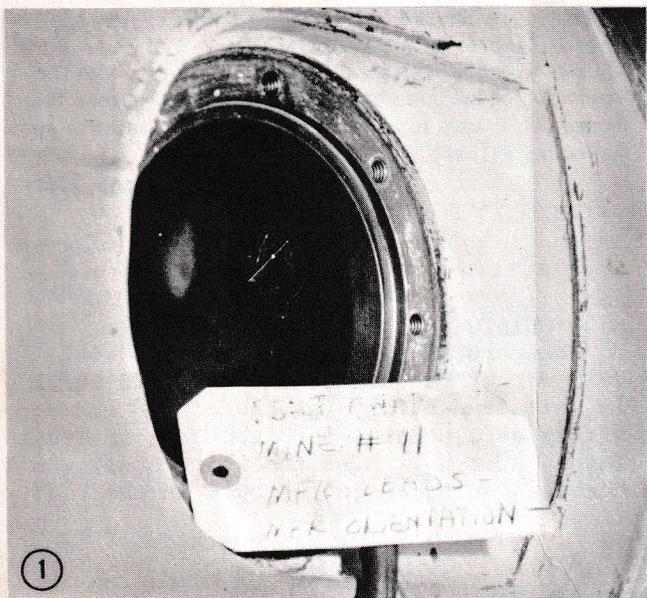
①

Not like this . . .

Photo number 1, for example, shows a Mk 52 resting in its normal position, suspension lugs up. Looking through the arming-device well, you can see that the fire recorder's dials are also "up".

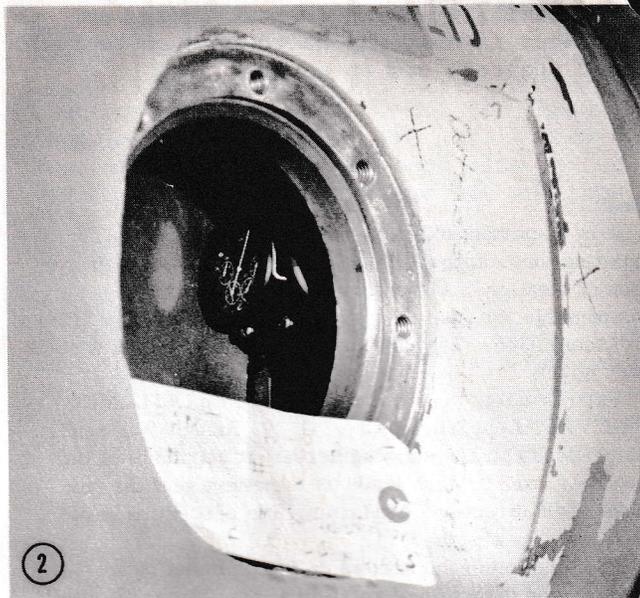
②

But like this

In photo No. 2 the mine is in the same lugs-up position, but the recorder's dials are upside down. By that we mean that the numbers on the dials are upside down.

So where does it tell you the right way to install those recorders? Job Sheets 10 and 11 in OP 3233. Make sure yours are labeled change 3, install those recorders exactly as they specify, and you'll not be misled.

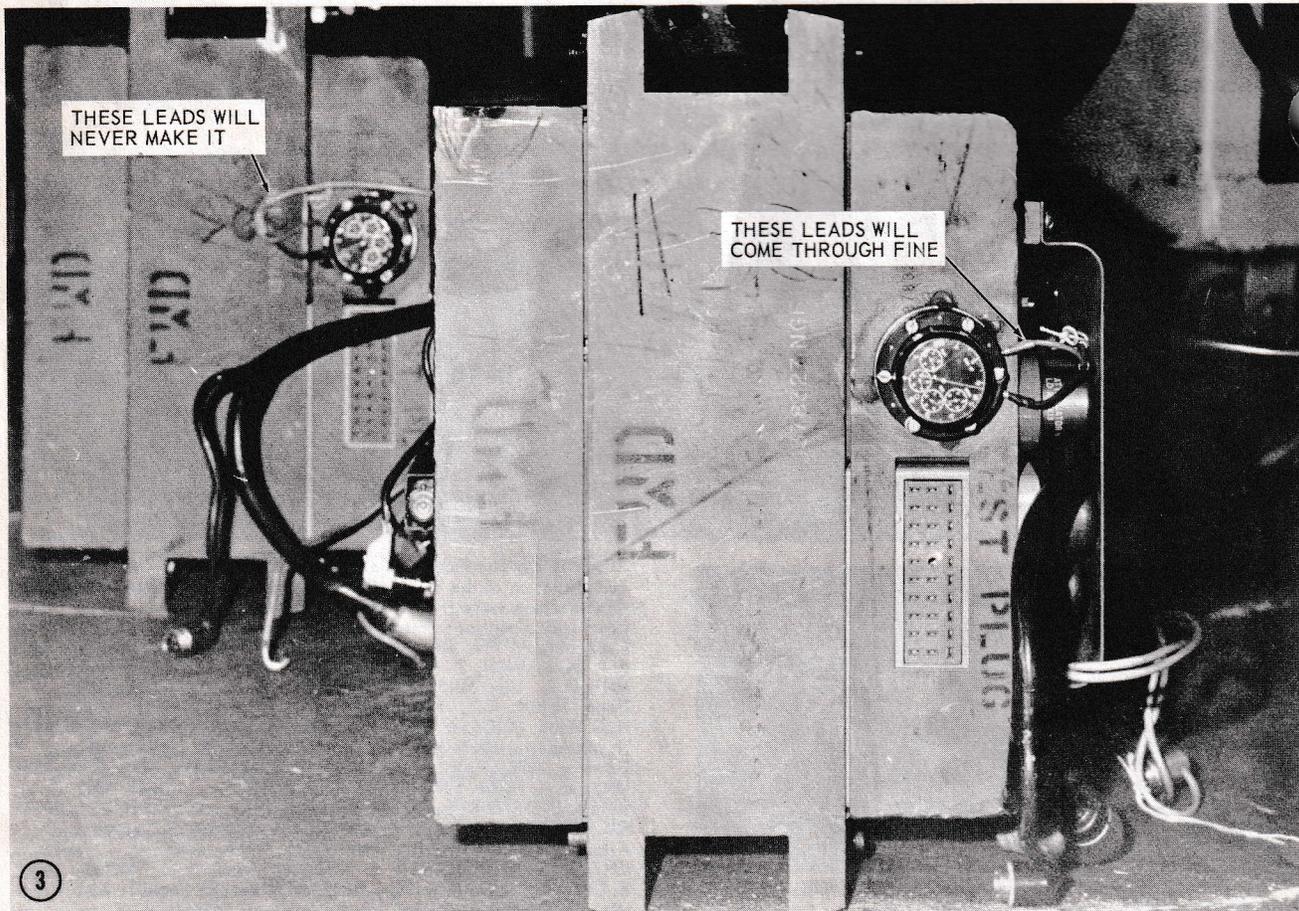
③

THESE LEADS WILL NEVER MAKE IT

THESE LEADS WILL COME THROUGH FINE

So which is right? Upside down! And a look at photo No. 3 shows why. Of the two instrument racks from Mk 52 mines, you can see that in the one on the right the orientation of the recorder's leads would be "up" when the dials are "upside down". As you can see, this allows a clear shot for the recorder's cable, through the rack's cable cover and aft to the terminal board.

The rack on the left, though, with the dials "up", shows the recorder's leads pointing to the lower left. In this position the leads are in a bad way indeed: they are forced to lay in a position where they'll be jammed between the instrument rack and the bulkhead of the explosive compartment when the rack is installed in the mine case.

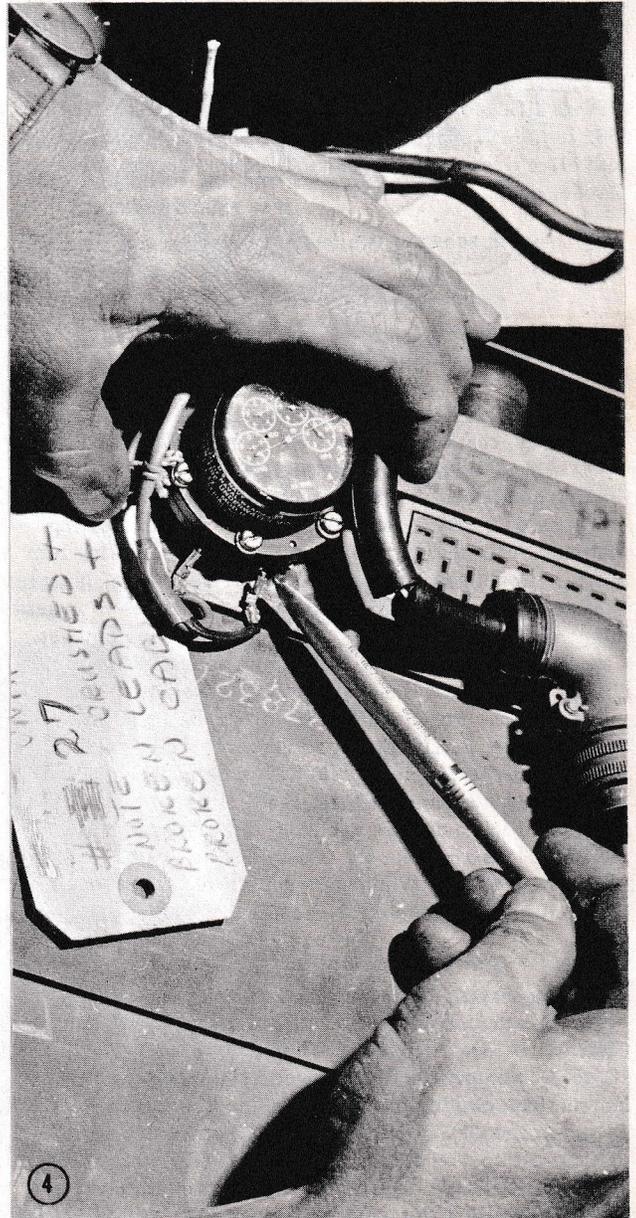
Jammed tight enough to break electrical contact? At time of rack installation, maybe yes and maybe no. But at time of water entry the answer is all too often affirmative. The leads are crushed and the connector pins are often broken off the recorder exactly as you see in photo

No. 4 . . . whereupon one more of those "actuated-upon-water-entry" reports shows up in the record!

That stops the clock

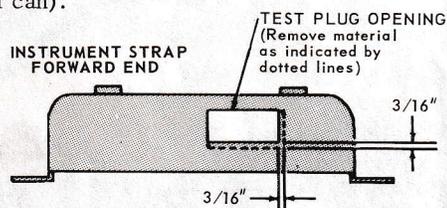
IT'S a rather close fit where the test receptacle in Junction Box Mark 35 Mod O meets the instrument strap's opening in the Instrument Rack Mark 3 Mod O, used in Mines Marks 52 and 55. By taking advantage of the tolerances provided, though, bolting the instrument rack together so they'll index has been fairly easy.

But now there's a problem. A slight offset in the manufacture of some junction boxes under a recent contract has made it close to impossible to plug the test plug of Cable Assembly CA-95 through the strap and into the receptacle.

To solve the problem fleet activities are authorized this temporary field fix:

- ▶ Disassemble the rack and remove the instrument strap.
- ▶ Enlarge opening as shown by grinding, filing, sawing or any suitable means available.
- ▶ Remove all ragged or sharp edges.
- ▶ Paint all exposed metal with one coat primer MIL-P-8585 (8010-297-0593 for 16-oz aerosol can) and finish with olive drab MIL-P-10687 (8010-848-9272 for 16-oz aerosol can).

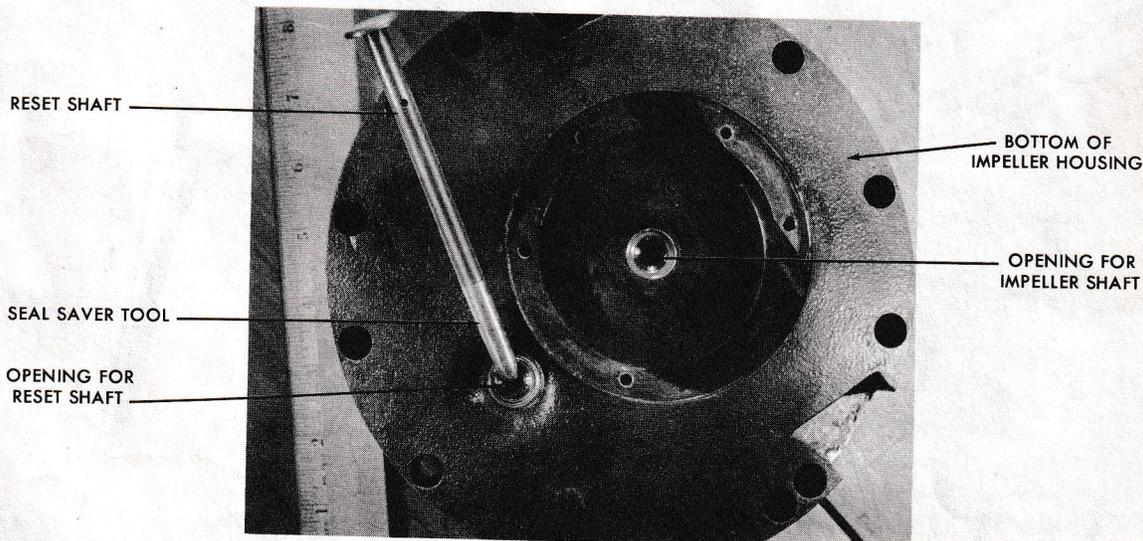
ASSEMBLED TOOL AND RESET SHAFT READY FOR USE

Rudmines tell us that a high percentage of impellers fail the hydrostatic leak tests required during overhaul of the nose sections of the Mk 27 mines' Vehicle Mark 1 Mods 1 and 2. This we attribute to two circumstances:

- ▶ The required water pressure (135 psig) is too high.
- ▶ The fluid seals are frequently damaged by the blunt ends and raised portions of reset and impeller-wheel shafts, when the shafts are passed through them.

To fix, the first volumes of OPs 2363 and 1935 will be changed to require only 75 psig. To insure that the fluid seals are not scarred by the ends and shoulders of the reset and impeller-wheel shafts when they are forced through them, here is a "Seal-Saver Tool" that should be used.

To use, place the seal saver on the reset or impeller-wheel shaft you are about to install. It should bottom on the shoulder of either shaft, whereupon the shaft can be pushed through the seal smoothly. On the impeller-wheel shaft, be sure to slip on the washer that bears against the impeller-wheel hub before placing the tool on the shaft (it may not fit over the tool).

With the shaft in position, remove the seal saver and finish assembling the impeller per figures 74 in OP 1935 Vol 1, or 82 in OP 2363 Vol 1.
