# THE TROUBLESHOOTER

*mine and depth - charge*  
**THE TROUBLESHOOTER**

Published by the Naval Mine Engineering Facility, Yorktown, Virginia

1 JULY 1966

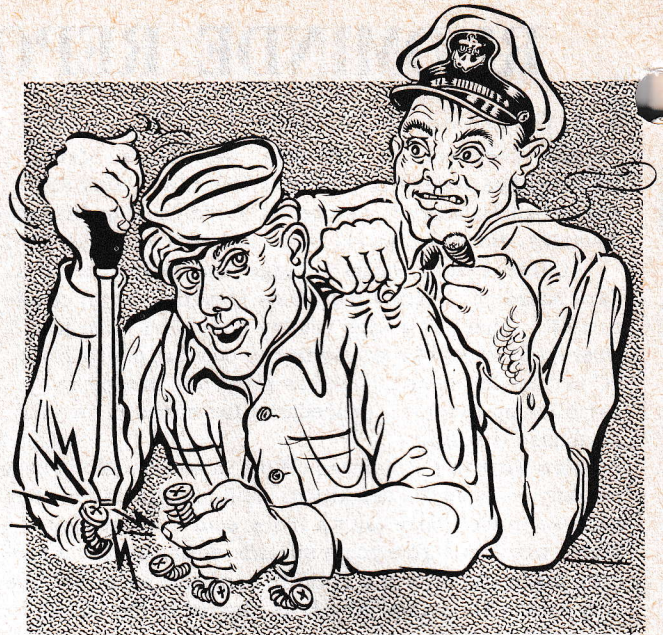
One of those dummy jumper plugs DWG 495722 in our basic tool set cost us two batteries BA-241/U while making operational tests with the Test Set Mk 97 Mod 2 on Mk 36-2 mines. A continuity

check showed that the plug's pins D & K had been shorted to pins J & F, which drained the 135-volt section of BA-241/U.

Now you can't inspect the plug's hook-up visually, since it is potted. To me this makes a continuity and insulation check necessary, to tell if these plugs are good or bad, yet DWG 495722 which shows the plug hook-up gives no test.

We agree that it would be more profitable to check out your dummy plugs some other way than by draining BA-241s, so here's a schematic which you can also find in OP 1860.

Using it, and a multimeter, one can quickly verify continuity between jumpered pins, C to H, N to M, L to E, K to D, F to J, at 0.5 ohms maximum. Also confirm insulation resistance of not less than 50 megohms at 500 VDC between non-jumpered pins: C to N, L, K, F, B, G, A; pin N to L, K, F, B, G, A; pin L to K, F, B, G, A; pin K to F, B, G, A; F to B, G, A; and all pins to shell.

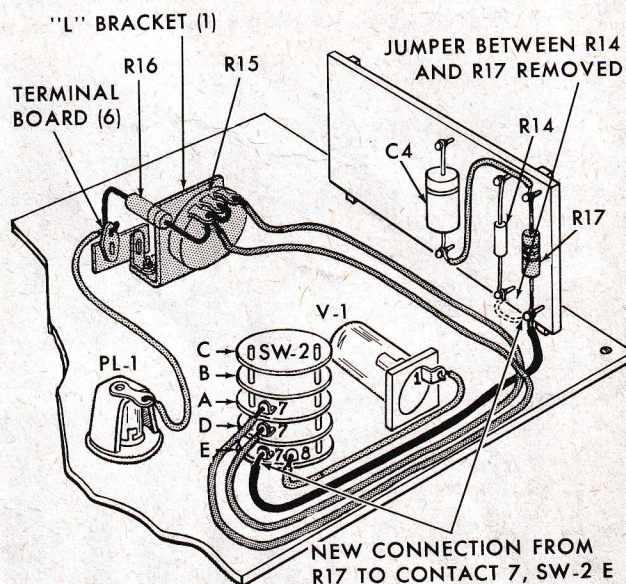
Figure 3 from Ordalt 4447D, Showing "Message" Alteration

RECENTLY WE LEARNED that, because of a peculiarity in the wiring of Test Set Mk 194 Mod 1, the act of changing that set's selector switch from one position to another could occasionally cause the Mk 19 firing mechanism's 125-microfarad firing capacitor to discharge during Mine Mk 50-0 operational tests, damaging tube filaments in both test set and mine circuits.

If you have or receive a 194-1 with no tape on the panel you'll know that's what has happened to you. To fix, open it up and check with the wiring pictorial here, which shows the circuit alteration of Message 222155Z and the forthcoming Revision E to Ordalt 4447, superimposed on the wiring provided by Ordalt 4447 Rev D.

We think this illustration will let you determine without hesitation whether this "Message/E" alteration has or has not been made. If it has been, put the set back together and put tape on the panel exactly as instructed earlier in this article. If it has not been altered proceed as follows:

1. Remove the connection between R14 and R17 (this connection was made by Ordalt 4447-D).
2. Solder a new connection between the now free end of R-17 and contact 7 in section E of selector switch S2. (Section E is wafer nearest panel; use stranded hook-up wire, No. 20 or 22 AWG (6145-295-2823), and rosin-core solder.)
3. Check and clean all newly-soldered joints.
4. Prove the fix as follows:
  - ▶ Turn selector OFF and read 2.7 ohms (with ohmmeter) between P and K of the CA-838 connector on test set's panel.
  - ▶ Turn selector to 2 and read 2.7 ohms between pins K and A.
5. If set checks out per step 4, affix that tape to the set's control panel exactly as described earlier and the alteration will be complete.

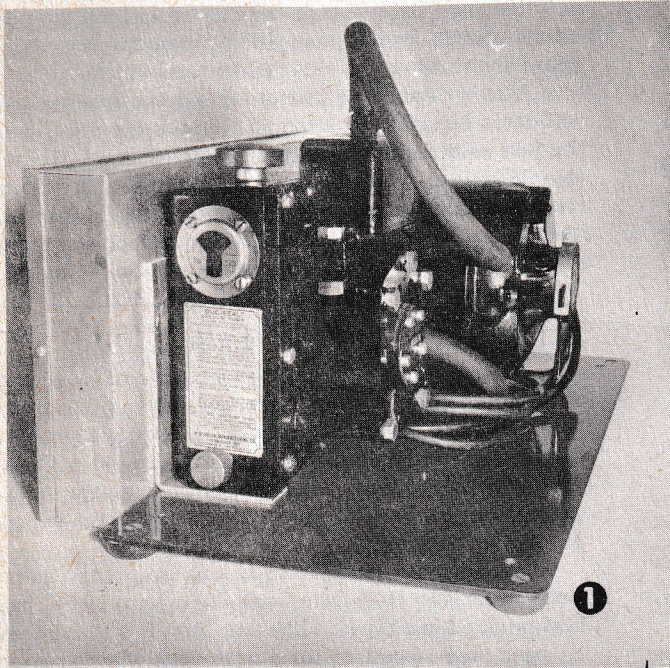
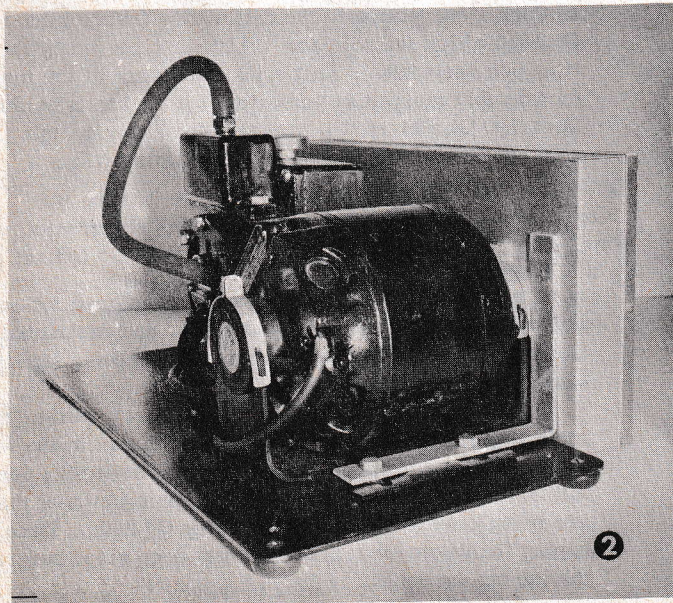
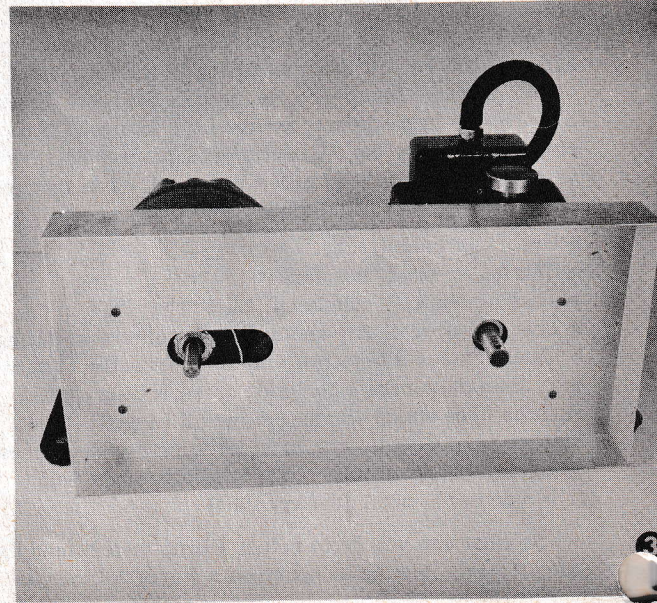
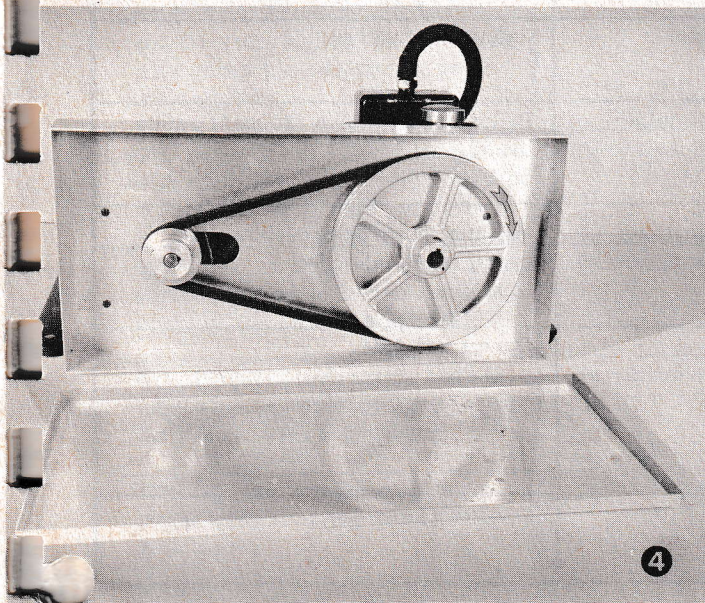
**T**EST SET MARK 157 MOD 0 is a mechanical test set that includes a 1725-rpm 1/4-horsepower motor that drives a vacuum pump by an exposed linkage of pulleys and belt. The rapidly rotating parts are a nasty safety hazard that can snatch a careless hand or an article of loose clothing.

To begin, make the two brackets that support the chassis, one for the motor-end and one for the pump-end. Use dimensions shown on sketch. Then, cut the large holes in the aluminum chassis using dimensions shown on sketch, but do not drill the four small mounting holes.

With that done, remove the four bolts that secure the pump to the base of the apparatus and place the bracket with the 3-inch foot under the pump support, the holes in the bracket centered on the two outside bolt holes in the

pump support. Place four 3/8-inch flat steel washers under the pump support centered on the two inside bolt holes (two washers for each bolt) to level the pump. Do not let the pump tilt, which it will do if not held upright; the pump is filled with a special oil and will not operate properly if this oil is spilled.

Next reinstall pulleys and belt, adjust until belt is tight. Run the motor and pump long enough to determine if there is any pulley interference with the guard, and if so adjust as necessary. ④

Now fit the cover over the chassis and secure with the two screws that were supplied with it and you'll have a job that's neat, safe, and should be troublefree for as long as the pump lasts.

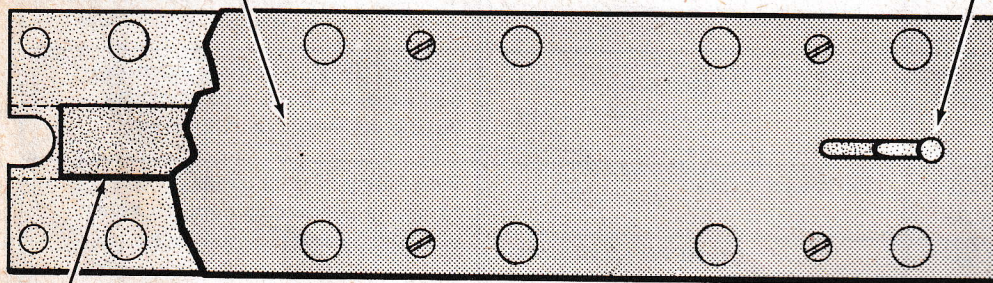
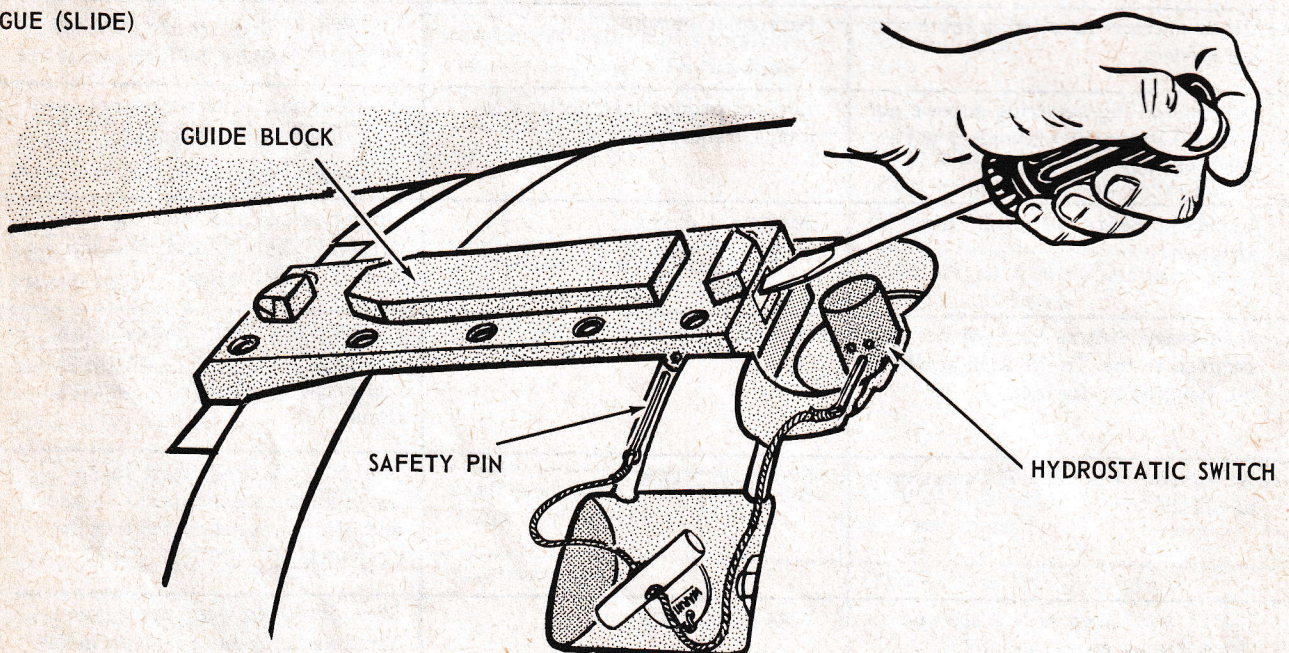
Cocking the Guide Block on Mine MK 57

Mod 0 contains a safety mechanism to prevent premature operation of the mud agitator. When the safety bar falls away after the mine leaves the torpedo tube it frees a spring-loaded cocking lever allowing a slide in the guide block to retract. When it does, the tongue of the slide uncovers a stop-release, which falls out freeing the explosive train to be lined up by hydrostatic pressure to a position where, when actuated, it operates the mud agitator. Thus if the guide-block mechanism fails to operate, so does the mud agitator.

A maladjustment in assembly that could cause such a failure (e.g., failure of the slide to retract) is a protruding of the drive pin that secures the cocking lever to the slide in the base of the guide block. If not driven home this pin can drag on the guide-block seat when the block is mounted on the anchor. Even when
