THE TROUBLESHOOTER

Published by the Naval Mine Engineering Facility, Yorktown, Virginia

1 JULY 1967

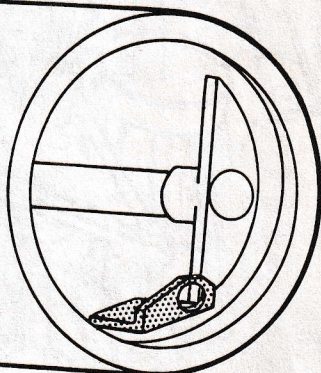
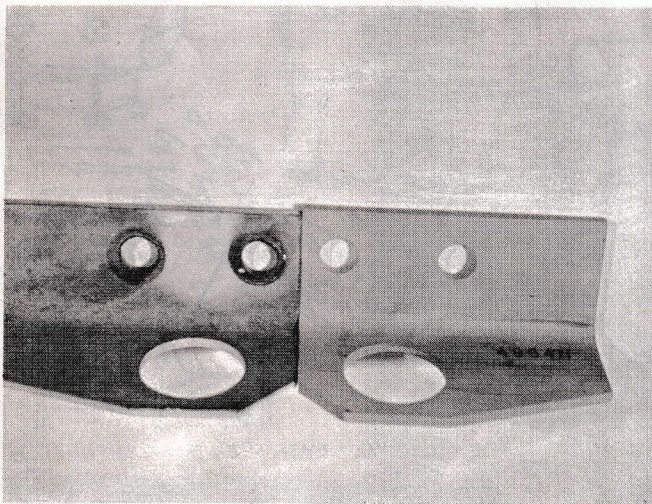
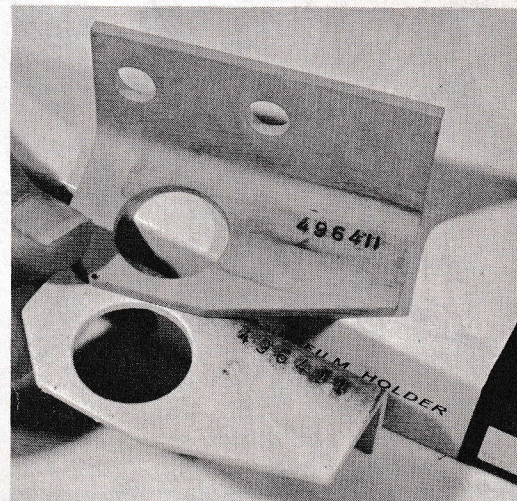
Installation of a reverse bent pin bracket

BRACKETS OB00092, used in Mine Mark 36 Mod 2 as receptacles for the tail-cover locating pins, are appearing in stocks bent the wrong way. We encountered this once before, back in 1960, at which time we found that only one manufacturer's idea of right had been wrong according to DWG 496411, and that total stock contamination was only 2 or 3 percent. By 1967, then, we thought the problem would surely be dead when along comes a report from MNI D. G. Duncan that some more "wrongies" had turned up in the stocks at Misawa.

No matter how you look at them . . .

. . . they're 180° out.
