THE TROUBLESHOOTER

Published by the Naval Mine Engineering Facility, Yorktown, Virginia

1 JULY 1968

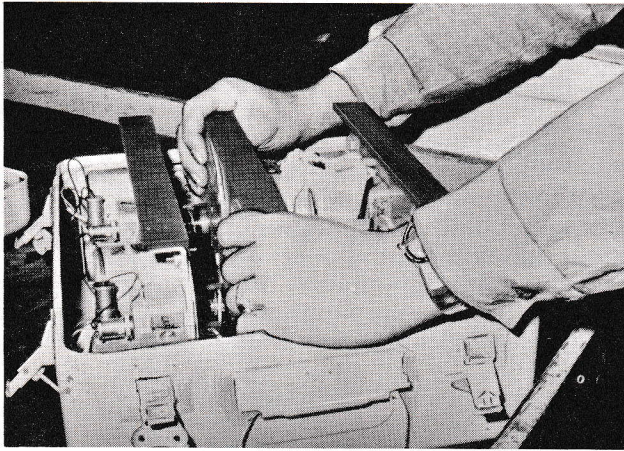
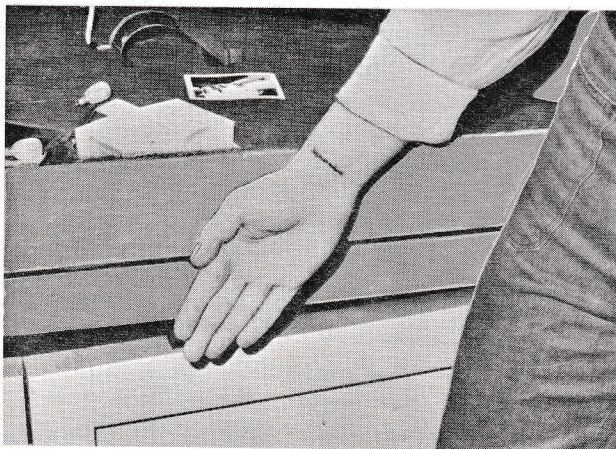
Just to prove that where safety is concerned you can't take anything for granted, one mineman has a wound that took six stitches to close. And all he was doing was trying to remove Mk 66 control units from their container!

The containers hold six control units in three metal partitions, in a split-type case. When the man tried to remove the middle partition he had to pull it loose because the cushioning material stuck to the floor of the lower half of the case. When it came free his wrist was slashed by the flange supporting the partition nearest him.

There was some justification in the accident report blaming the accident on the design of the container, but it is also true that it could have been avoided. If the man had removed the partition nearest him and then tackled the middle one there would have been no flange in the

way of his wrist, and thereby you can benefit from his experience: remove the partition nearest you and work from front to rear when removing these units from the containers.

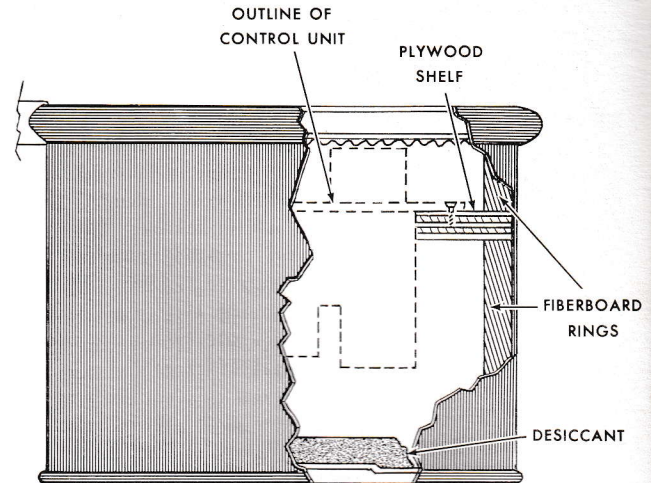
New Packaging Unit For Mk 66 Type Control Unit

Now the control unit container has been redesigned, primarily to eliminate a needlessly complicated and expensive multiple package for a simpler and less expensive unit package, but in such a way that the wrist hazard is eliminated too. The new package is a can 6-7/8-inches high and 9-7/8-inches in diameter with a plywood shelf into which the control unit is secured. Cushioning and a desiccant are included in the design. The units are packed eight to a fibre-board box in two tiers of

four each. A ring-type clamp with packing (O-ring) seals the lid on the container, which is reusable. The older containers are also reusable, though, so they'll be around for some time.

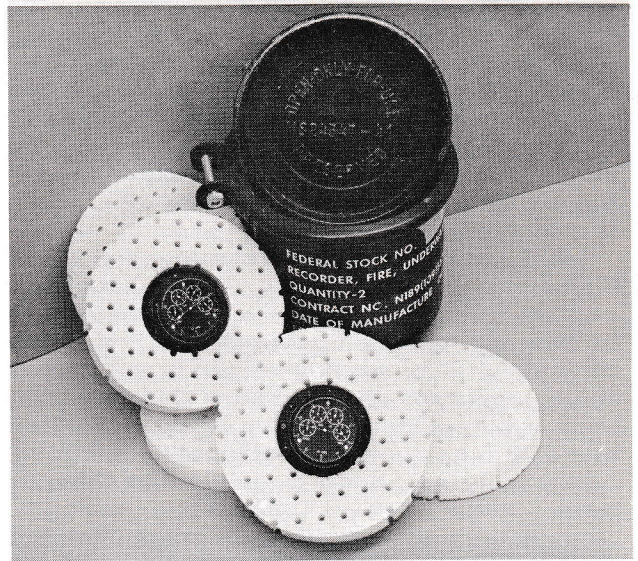
And that brings us to another mystery: what is causing the disappearance of the recorders' reusable shipping and storage containers. These drum-like metal containers, the original packaging of the fire recorder, were designed to hold two mechanisms protected by sponge-rubber cushioning material. Recorders should remain in these containers, except for inspections, whenever they are not installed in a mine. When the recorders have served their purpose in the mine, and post-recovery analyses are complete, they should be repackaged in these containers as soon as the necessary maintenance is accomplished. When the post-recovery analysis site is remote from the assembly site, assembly personnel should forward the containers to the analysis site promptly, for use when the recorders are later removed from

WANTED — missing containers like this one: one for every two mine fire recorders, complete with two "doughnut" cushions and three pads.

the mines. All this is spelled out in OP 3233, yet Long Beach recently received lots of 15, 5, and 2 recorders in three separate cardboard boxes with crumpled newspaper as the packing material. So what's to be done? Try these:

- ▶ Don't "drop" fire recorders.
- ▶ Store and ship recorders only in their authorized containers.
- ▶ Return all excess containers, with packing material, to issuing activities (DMPF, Long Beach, Calif., and MOMINASYULANT, S.C.).
- ▶ Re-read OP 3233.

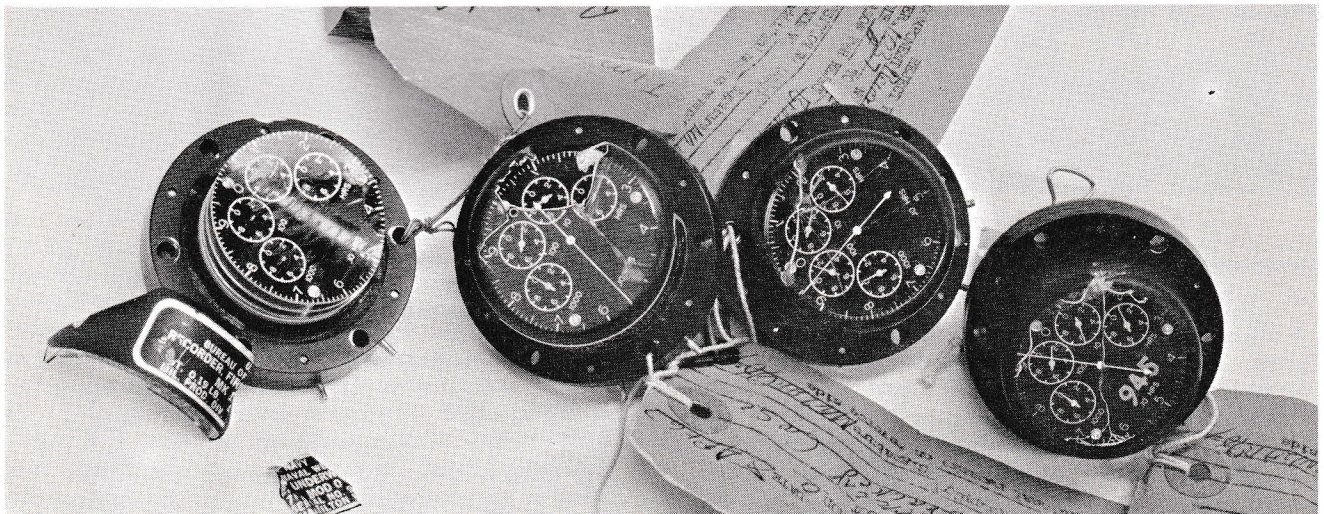
A recent FSMT yielded some results not expected as a part of the program: a remarkable record of destruction in the form of four Mine Fire Recorders Mk 17 Mod 0 damaged to an extent you wouldn't believe. The reject tags carried the simple notation "case broken," and broken they were. The tag on the fourth mechanism displayed a one-word explanation, "dropped". This wasn't so obvious, since it is hard to conceive what kind of drop would imprint the clock hands on the clock face, and dish the face in the process.

The photograph of the casualties was sent by DRILL-MINEPREPFAC, Long Beach, with this observation: "Due to the fact that an assembly or final prep activity would not install fire recorders in this condition, it is assumed that this destruction was accomplished during the post-analytic phase of the FSMT."

Casualties of an FSMT. Recorder on the left is the one that was "dropped!"

Be that as it may, we hope all responsible parties will be more careful with these fire recorders. They are expensive. Besides, what good is it to insure a timing accuracy of ± 30 seconds per day, put in fresh batteries, etc, if somebody is going to run over them with a 5-ton truck?

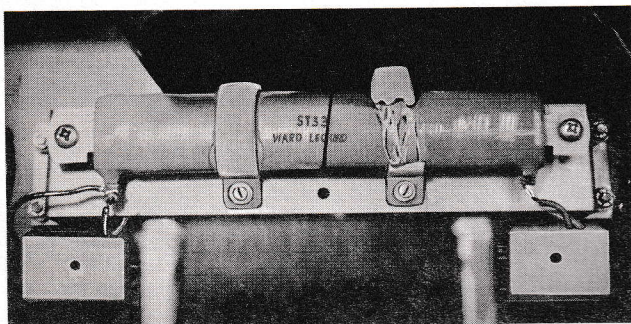
The absence of a spacer seems to coincide with damage to a resistor in a number of Power Supplies Mk 111 Mod 1. Two such broken resistors were discovered at NAD Hawthorne during inspections of Test Set 340, with which the power supply is used, both ST 3.3 Ward Leonard resistors, one of which was cracked and the other, shown here, actually broken. Neither resistor failed, however. There was no open circuit in either case.

Both power supplies were manufactured by Bristol Dynamics under contract N197-2365 and a sampling of other Mk 111 power supplies indicates that the spacer is apt to be missing in all mechanisms manufactured under this contract. The spacer is present in power supplies manufactured under other contracts. So if you have a power supply manufactured under contract N197-2365 examine it for a missing spacer, readily detected by a missing screw in the hole in the center of the supporting resistor bracket.

The tubing fits under the bracket at this point. Screw passes through and holds it in place.

The spacer is not in the supply system as a repair part but it is easy to make one by cutting a 7/8-inch length of 5/16-inch diameter aluminum tubing. To install, place the tubing between the bracket and the wall of the power-supply case, line up with holes in bracket and case, pass a flat-head machine screw 6-32 x 1-1/4 inches long through the hole in the bracket, through the tubing, and out the hole in the case, and secure with a 6-32 lock nut. If these items are not available in your shop here are stock numbers for items that work: Tubing, aluminum alloy, 4710-279-0422; machine screw, flat-head 6-32 x 1-1/4", 5305-984-6222; lock nut, 6-32, 5310-590-3194.

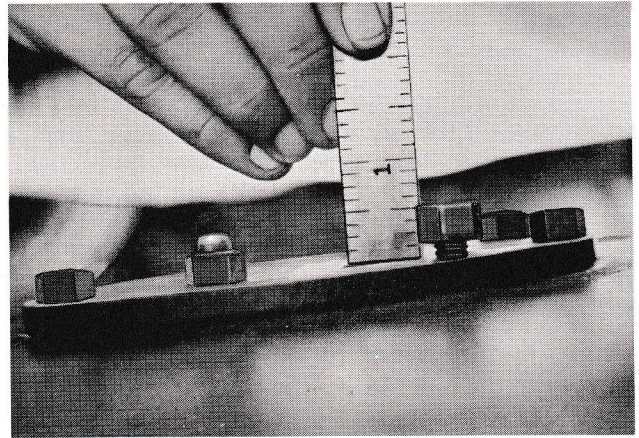
Regardless of all precautions to prevent it, on occasion an explosive-loaded mine case is going to come out of storage with a loose filling-hole cover. Retaining nuts on these covers are supposed to be placed under a final torque of 16 to 20 lb-ft by the loading activity, and should never be touched afterwards for any purpose by mine assembly activities, including the purpose of torque verification. A very loose one, however, warrants a Rudminde for sure, and consignment to Code E pending disposition instructions, even though it's true that some sea water will not interfere with the effectiveness of the main charge.

Shown here is an example of how loose a filling-hole cover can be. Thanks for the photograph go to MN1 J.R. Cottrell, Iwakuni, Japan, who sent it along with his Rudminde.

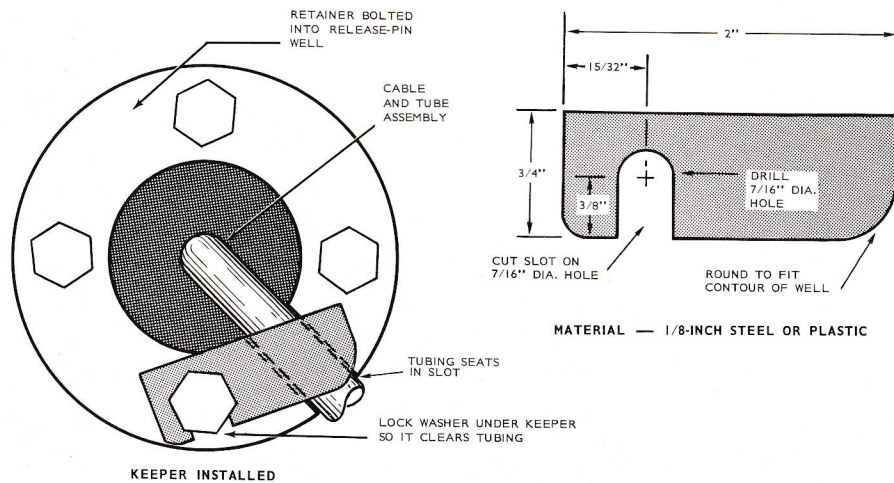
Cable and Tube Assembly Keeper, Anchor Mk 56 Mods 4 & 5

While assembling Anchors Mk 56 Mod 4 it's relatively easy to damage the copper tubing that carries the electric cable to the explosive driver, by getting it pinched between the anchor housing and the anchor sleeve. The copper tubing is led into the well by a series of bends which tend to make it act like a spring. And this, combined with the fact that the retainer that is supposed to retain it doesn't retain anything but the bushing sleeve in the release-pin well (unless the explosive driver is installed) is the situation that makes the trouble.

When fully assembled the retainer holds everything securely in place, but in Assembly Condition D the explosive driver is not installed and the tubing is free to escape its alignment slot and spring out of the well. Under these conditions two men would be required: one to keep the tubing fitted into its slot, and another to manipulate the anchor sleeve, except that W. L. Johnson, retired MNC and now an inspector in Quality Assurance, NWS Yorktown,

Johnson's keeper is made from a piece of 1/8-inch steel or plastic, 3/4" x 2", shaped as shown here. It doesn't have to be strong but it must be rigid. In use it is fastened by a retainer slot (hold the free end of the keeper against the wall of the retainer recess and tighten the bolt with the lockwasher under the keeper). The keeper should stay in place after the sleeve is secured to insure against damage to the tubing should it spring out during shipment and handling.

Eventually a keeper will be placed in the supply system as an assembly part, one which will serve both as keeper, and as a cover for the release-pin well.
