# THE TROUBLESHOOTER

**AN OFFICIAL NAVORD PUBLICATION**

Published by the Naval Mine Engineering Facility, Yorktown, Virginia 23491

1 JULY 1969

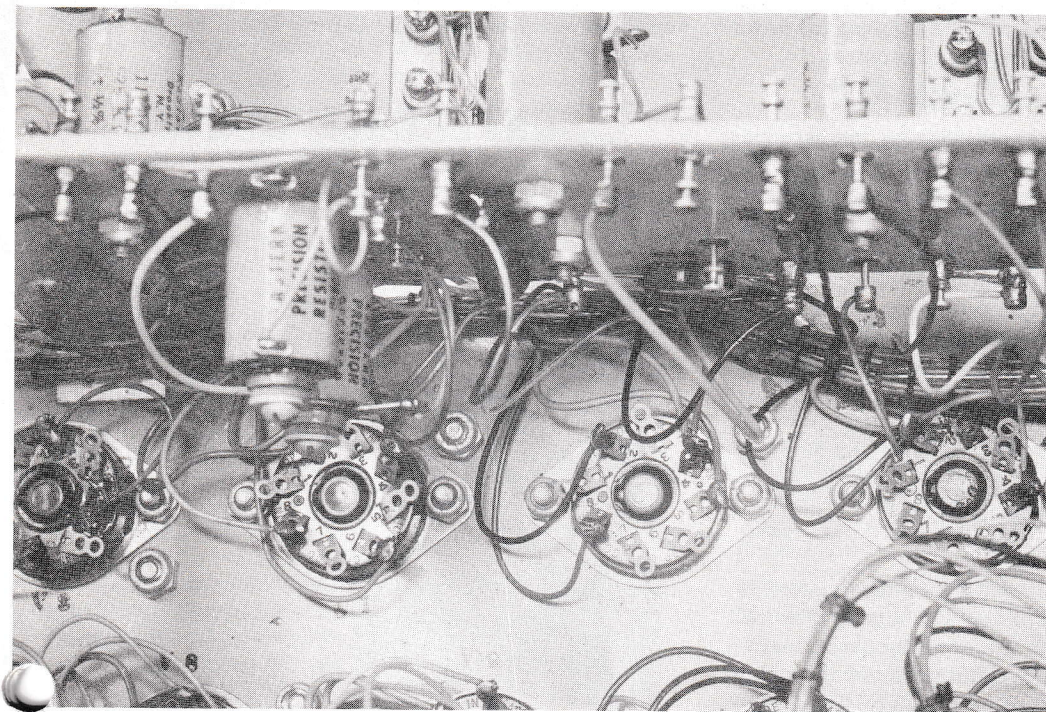
If 5Y3 tubes are present remove cabinet base and check socket wiring to determine that Pins 6, 4, 8, and 2 are connected for both the V1 and V2. If they are, replace base and connect power supply to 115 V, 60 Hz source. If tubes light the changeover is correct. This double check insures against mis-wiring as illustrated here.

This is what you see when the base of the power supply Mk 20 is removed and the underside of the chassis exposed. In this power supply the changeover of wiring to accommodate the 5Y3 tubes is three quarters complete. The changes have been completed on the V1 socket. The wiring has been changed from Pin 3 to 4 but not from Pin 5 to 6 on the V2 socket. To further assist in checking out your power supply for correct wiring to make it operative with 5Y3 tubes see the schematic for the power supply in chapter 9, OP 1860.

- ▶ Remove cabinet - bottom from chassis.
- ▶ Locate socket V1 under chassis and unsolder wire from Pin No. 7 and solder to Pin 2 (Pins may be located by counting clockwise from key-way).
- ▶ Unsolder wire from Pin 3 and solder to Pin 4.
- ▶ Unsolder wire from Pin 5 and solder to Pin 6.
- ▶ Locate socket V2 and repeat procedure as for socket V1 with the exception that two wires are connected to Pin 3 of the V2 and both wires should be moved to Pin 4 since this is a tie point for another circuit.
- ▶ Secure cabinet - bottom to chassis.
- ▶ Place strip of tape inscribed "Tubes 5Y3 installed" on face of test set.

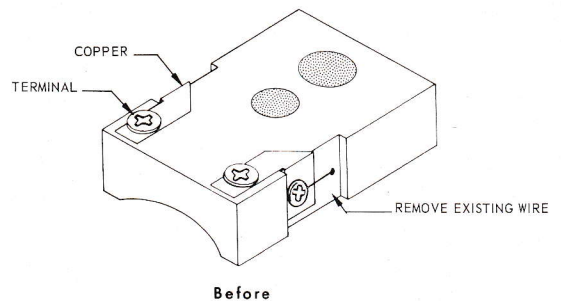
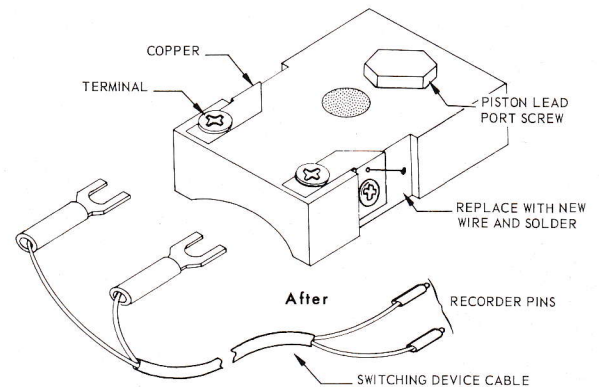
SWITCHING DEVICE, TYPE F, MODIFICATION

Because of a premature break in the circuit between terminal screws to which the Mine Fire Recorder cable is attached to the Switching Device, Type F, valuable mine actuation data was lost in FSMT CSP 1-69 when some recorders stopped at times that had no possible reference to actuation times. The probable cause was the loss of continuity due to the method of attaching the shorting wire under screws that also hold copper terminal busses. It is this wire that maintains the recorder circuit until blown by the explosive fitting when the mine actuates.

To connect with a fool proof connection, substitute soldering for the wrap-around binding post technique. Use the following wire replacement procedure for rehabilitating blown Type F Switching Devices as well as for replacing wire in operable ones using screws as binding posts. (For future procurement these switching devices will have soldered connections, and use bare AWG 34 copper wire.) You will need Solder 7S00254, Soldering Iron 7S00255, Enamelled Magnet Wire AWG 34, Long Nose Pliers 7P00090, fine abrasive cloth, enamel remover, and Phillips No. 2 Screwdriver 7S00120.

► Loosen side-mounting screws holding copper terminal strip. Remove and discard the shorting wire running through the hole in the insulating block but keep the insulating tubing that is in the hole. Retighten screws but don't overdo it so threads are stripped.

► Cut a working length of enamelled magnet wire, AWG 34, about 4 inches, and remove enameling where the wire comes out of the block at the ends to get a good soldering job. Use an enamel remover such as coat stripper 8010-160-5799. Be sure to read instructions before using enamel remover. Do not scrape the enamel off wire ends. (If you requisition replacement wire get AWG 34 wire, 9Z6145-236-9483.)

► Tin wire at points of soldering where it passes through insulating block. Replace insulating tubing

tinned area. Pull taut with long-nosed pliers, making snug bends where wire leaves the hole in the block and duplicate soldering job on the other terminal strip while holding wire tight with pliers. Only a very little solder is needed for a good job. Test with a slight tug on the wire. Cut off excess wire. ► Check with multimeter for continuity. You should have a trouble free Type F Switching Device.
