THE MINE AND DEPTH CHARGE TROUBLESHOOTER

THE MINE AND DEPTH CHARGE

TROUBLESHOOTER

ISSUE 2-70

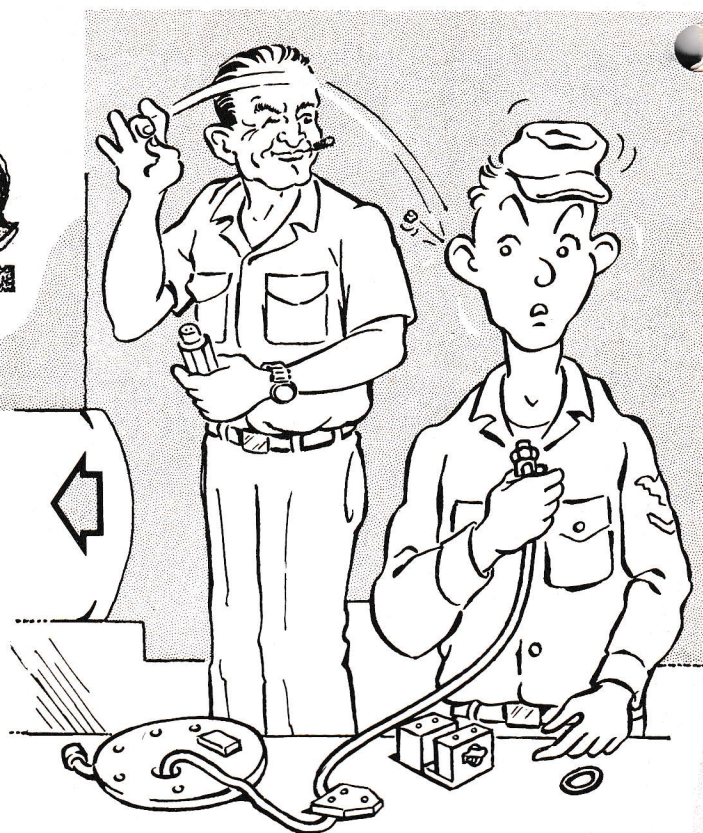
We are having problems with Radio Interference Filters Mk 4 that have cracked inserts. We surmise that the cable connector is being allowed to turn so that inserts are being put under undue strain. Eliminate the twist and you save a filter.

You are right, when an insert is cracked the filter must be rejected, and the trouble does in fact lie in the way the locking ring on the filter is handled when it is secured to the Cable CA-72. The solution is to prevent the cable from rotating when the ring is tightened. Since there is no keyway, the cable connector must be hand held while the locking ring is being secured, and the ring secured only finger tight. This also applies to the radio filter's flexible lead connected to Explosive Fitting Mk 18.

What complicates the whole thing is that the cable connector and an amphenol-type connector look alike when they are connected. Those not aware of this might confuse the two during disassembly. Use the procedure that would disconnect an amphenol and you are turning a cable connector counter clockwise compounding the error of overtightening and increasing the chance of breakage. If the next move is to reach for pliers break it you will! Therefore it is evident that proper care must be exer-

cised during assembly and disassembly of the locking rings on filter and explosive fitting connections.

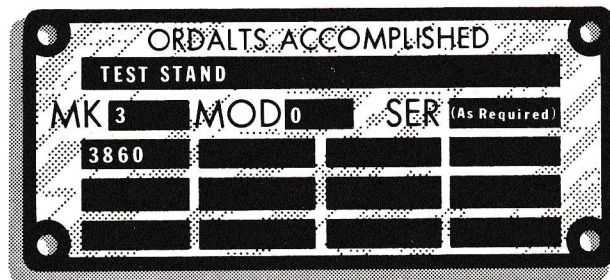
We have received Test Stands Mk 3 Mod 0 for repair with the accomplishment of Ordalt 3860 noted either by stenciling or written on tape. Tapes were torn and stenciling damaged so the information was all but obliterated and hard to decipher. The ordalt only specified that its accomplishment be "noted" but it appears more permanent methods should be used for noting such information. We found an "Ordalts Accomplished" plate that would serve the purpose and used it for a better job of identification.

The identification plate you describe, designed for ordalts accomplished, does serve the purpose very well and is okay to substitute for tapes and stenciling as a method of identification in this

case. With notations engraved, etched, or die-stamped, as shown here, the plate should be affixed with drive-on screws below or adjacent to the existing name plate on the panel of the test stand. The FSN of this plate is 909905-639-5856 and the cost 26 cents each.

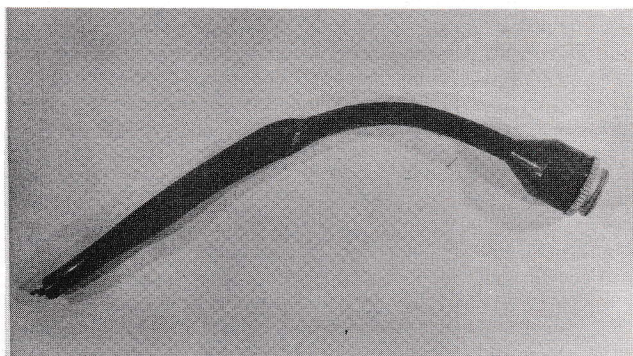
Cables are still being pinched when caught where they shouldn't be, when the instrument rack Mk 3 is installed, in spite of specific instructions in OP 2608 that should prevent it. If the conductor is not severed here it would be when the mine hit the water.

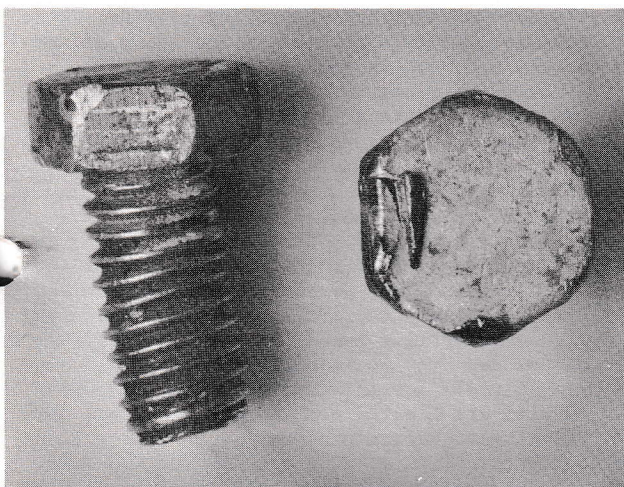
To find a cap screw in this shape is astonishing but the real mystery is how did someone find a tool to remove it? Perhaps the clue is in the scars on the hex head. With the evidence of cap screws like this anyone would wonder how the inside of the mine looks—and will it work?

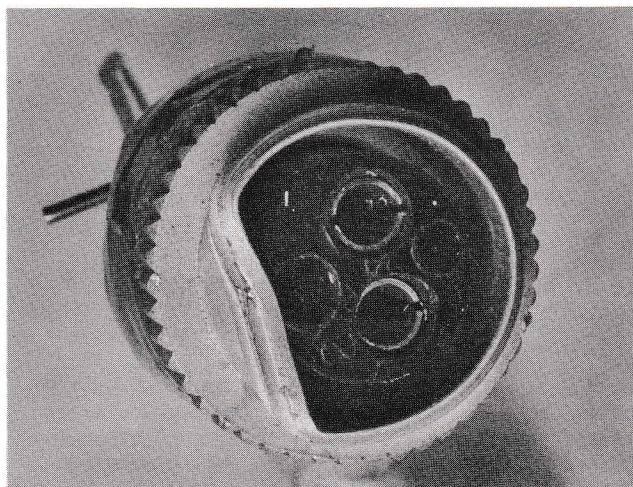
We can't tell you what happened to cause this P-3 connector to take this shape but we do know that it will never connect cable to explosive fitting on an arming device again. Besides that we have lost the price of an 1800 series instrument cable to the tune of some \$130.

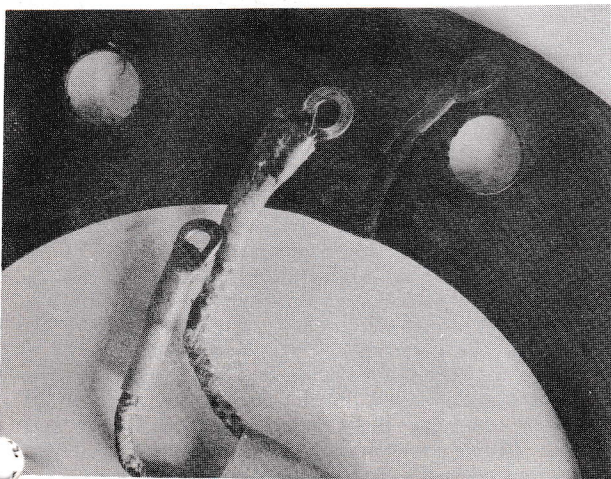
These patterns are interesting but they have no place on extender well gaskets, but they will appear every time cables are not tucked in the extender well with care. They make an impression that no mineman

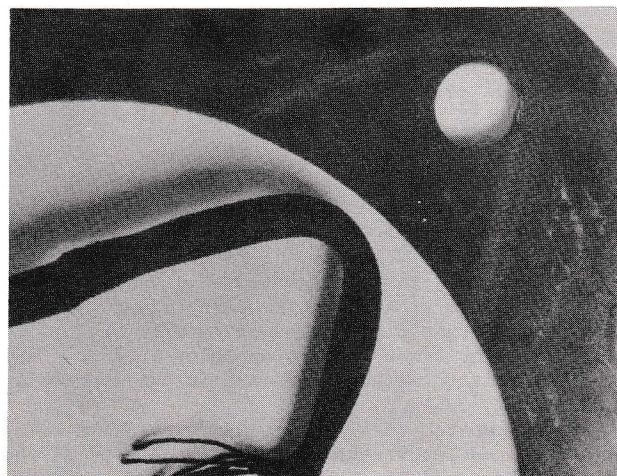
should let happen whether he is a supervisor or assemblyman. To coin a phrase—"a mine is only as good as it is leakproof"—so worry about those critical case openings.
