mine and depth - charge

THE TROUBLESHOOTER

1 OCTOBER 1964

Published by the Naval Mine Engineering Facility, Yorktown, Virginia.

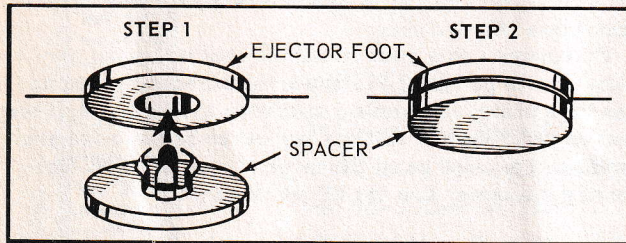
HOW TO INSTALL EJECTOR-FOOT SPACER

Position spacer so spring clips enter opening on underside of bomb rack's ejector foot, then push home. Spacer snaps into place, extends operable length of the ejector foot by 3/8-inch.

An ejector-foot spacer has been designed to prevent the Aero-7A bomb rack's ejector foot from extending beyond operable limits when planting Mark 55 mines equipped with Suspension Lugs Mark 3, or Mark 56 mines with Lugs Mark 17. The spacer is a 3-inch disc of hard plastic with a four-leaf spring clip. Easily installed without tools, as shown here, it serves as a semi-rigid spacer between the ejector foot and the mine's strongback. The

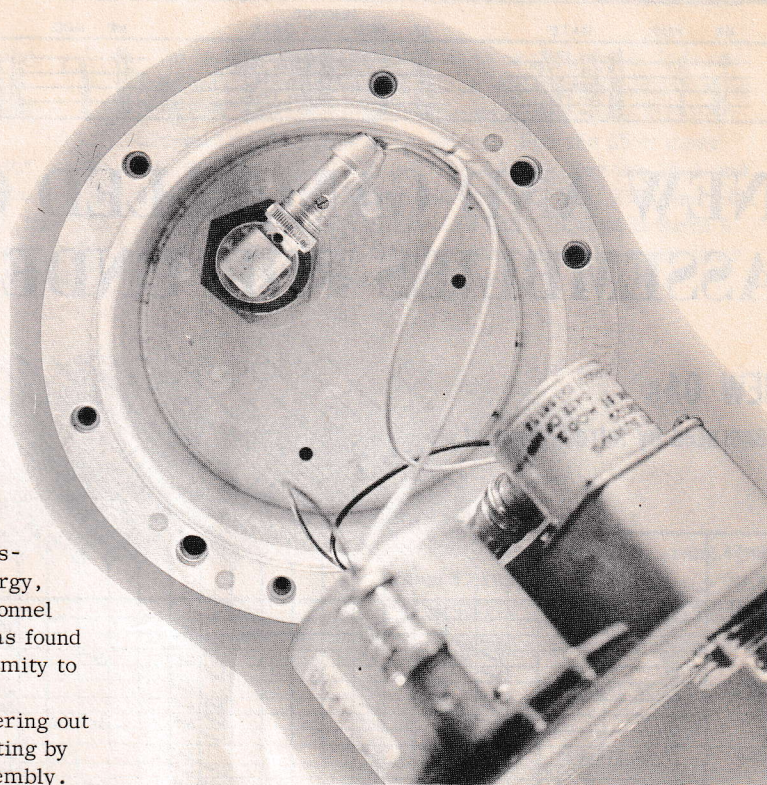
MK 66-2 CONTROL UNIT

The Mod 0 control units were altered by Ordalt 4377 of 1 October 1963 to the more reliable Mod 1. The forthcoming Ordalt 10108, in altering the Mod 1s to Mod 2s, will eliminate susceptibility to spurious actuation by stray rf energy, which could otherwise prove hazardous to personnel and aircraft. This became necessary when it was found that Mod 1s are susceptible to rf energy in proximity to communications and radar transmitters.

Corrective action will be accomplished by filtering out the rf energy before it reaches the explosive fitting by introducing a ferrite material into the cable assembly.

The ferrite bead is in the red-coded connector of the Mod 2s Cable Assembly CA-1261, which will replace the Mod 1's CA-943. This change in cables and the designation of the unit as Mod 2 are the only evident changes in appearance of the two mods. Their functions are identical. A few "prototype" Mod 2s are already in the system.

To test the 66-2 units the Test Set Mark 246 Mod 0 can be used following the instructions for Mod 1 units in OP 1452, with changes to specify use of a multimeter to check insulation resistance, instead of the 246 test set

(or a megger) both of whose impression of excessive DC voltage would break down the 66-2's ferrite bead. The necessary changes will be released when the Ordalt and stock Mod 2 units are made available.

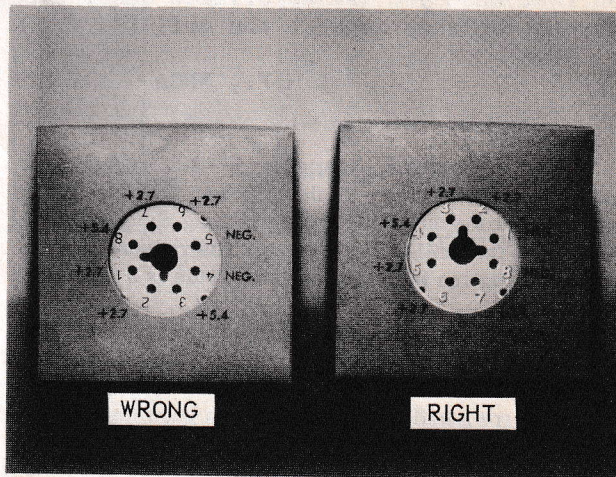
The jacket of the BA-1322/U on the left has been put on upside down. The plug-in markings are correct in both batteries.

During inspection of seven Mines Mark 52 one BA-1322/U battery was found with its jacket bearing polarity and voltage identification 180 degrees out of orientation (see photo). When assembled in the battery pack with "labels up" as directed by OP 2608, the two keyways stand at 6 and 9 o'clock when they should be at 12 and 3 o'clock.

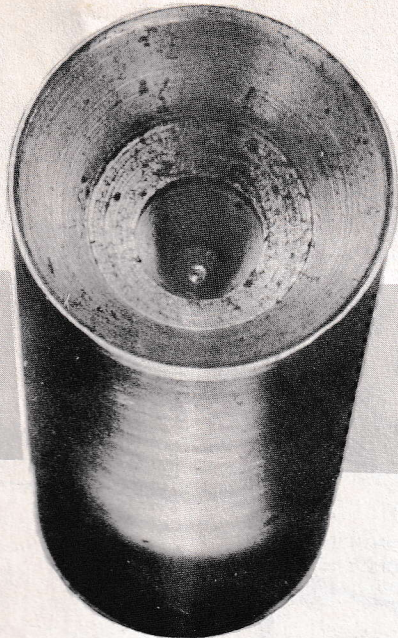
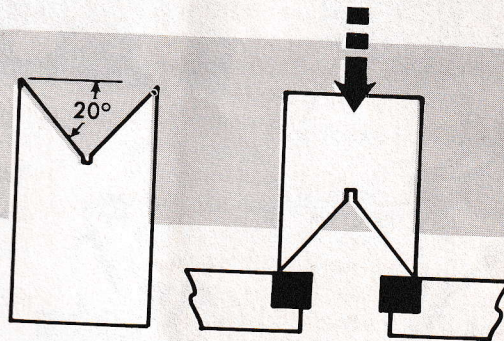
ONE of those nasty little jobs in the overhaul of Mine Vehicles Mark 1 is the removal of the fluid seals, nine per vehicle in diameters from 3/4-inch to 1-5/8-inch. The job is easier than it once was since it is no longer necessary to remove all seals and install new ones regardless of condition. Now you are only required to replace those showing signs of damage or leakage.

These metal-encased seals are a drive fit into machined seats, the seal designed to bear against a moving shaft. Once installed, though, they cannot be driven out and most men resort to screwdriver and hammer to distort the metal casing so they can be pried out. Besides being hard on screwdrivers a misplaced blow only too often results in a marred seating surface and a ruined part.

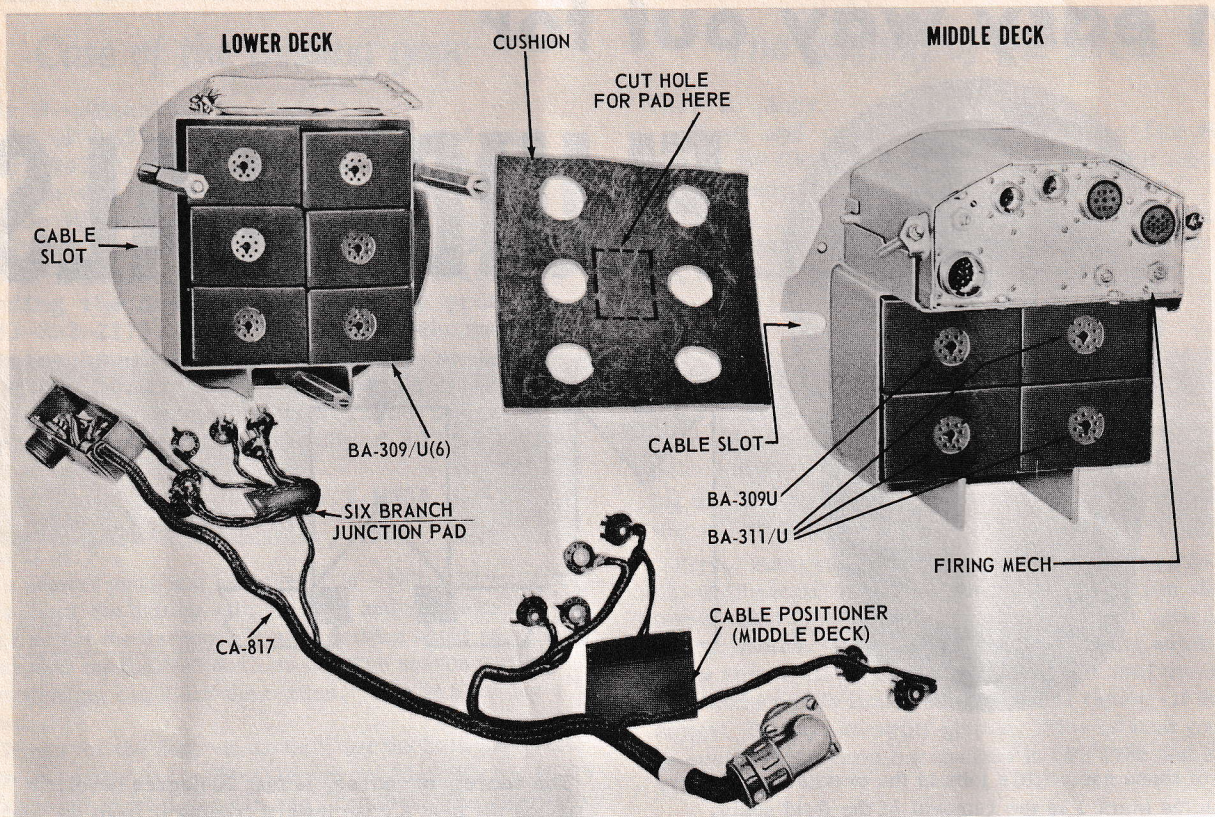
TAKING CRUSH OFF BATTERIES IN MK 50's INSTRUMENT RACK

IN assembling the Mk 50 mine's instrument rack tolerances are more critical than some minemen realize. . . with the result that the Batteries BA-309/U

become damaged when marrying the rack's lower and middle decks.

The mine assemblyman is cautioned to keep those six cable leads clear of the various plugs so the leads cannot become pinched between the plugs and the middle deck. It also appears that the bulk of the six-branch junction pad and the thickness of the cushion can be great enough, combined, to crush the batteries in the way of the junction pad and thereby cause shorts inside the batteries. This introduces a possible hazard. B. N. Johnson at Navy No. 3002 says the pad and cushion caused the edge of the battery case (electrical negative) in one of their Mk 50s to cut through lead's insulation, short the battery, and generate enough heat to melt the wax coating on the battery's cells.

Johnson's solution: Cut a hole in the lower-deck felt cushion like we show here, to accommodate the added thickness of the junction pad.
