# THE TROUBLESHOOTER

Published by the Naval Mine Engineering Facility, Yorktown, Virginia 23491

**1 OCTOBER 1968**

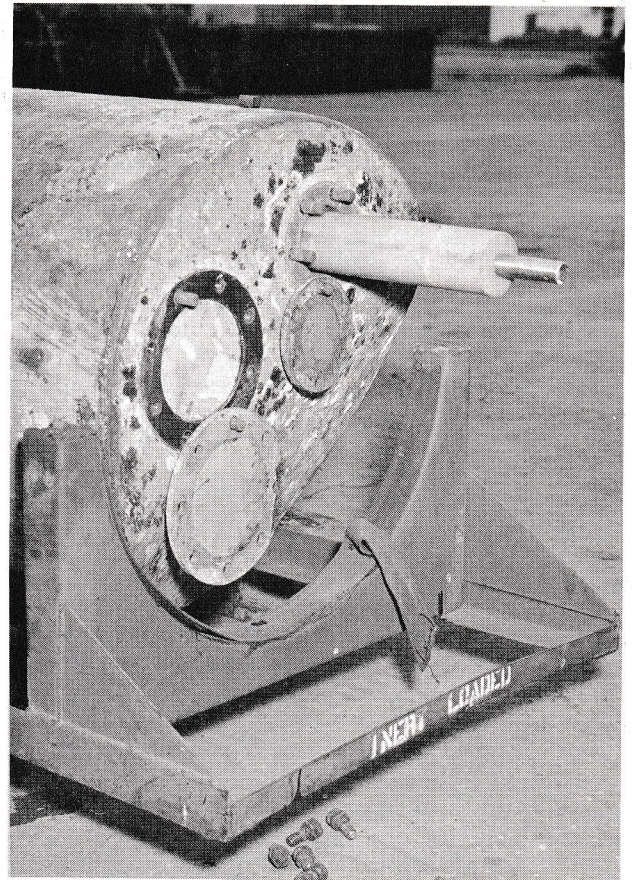
Preliminary inspection revealed the case to be in remarkable shape. The bottom must have been smooth and sandy as the exterior of the case was not fouled with sea growth. All abraded sections of the exterior were smooth and shiny with little evidence of rust. Electrolytic action between the mine case and the clock starters had eroded the clock starters. The clock starter for the recovery clock was the more advanced in deterioration, with approximately one to two months left before final failure by flooding of the case would have occurred.

Search coil slides easily in tube.

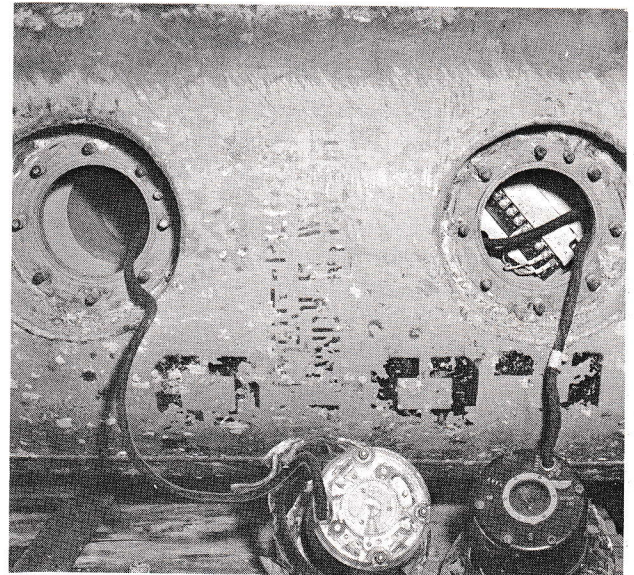
Clocks still operable but near the end of the line because of electrolysis.

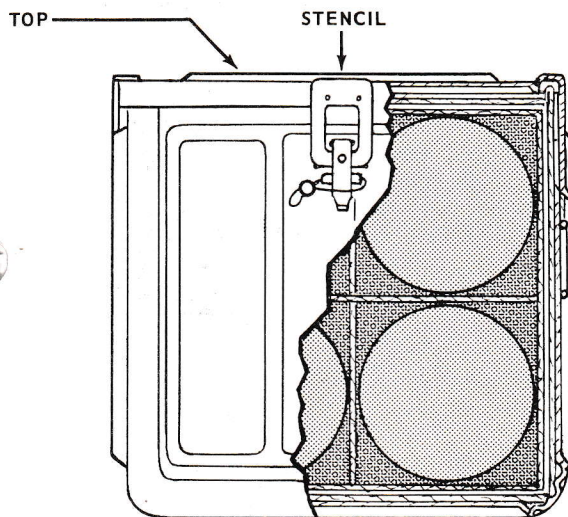
Unfortunately the way the charges are packaged makes horizontal the normal attitude (see cutaway top-up view). An immediate solution, then, is to turn all such containers on their sides. This will make the propellants vertical and arrest the tendency of the explosive to "slump." You should even go a step further. To keep some well-meaning soul from turning them back again stencil on the lid of the outer container, in black, the legend: STORE CONTAINER ON SIDE.

CONTAINER TOP-SIDE-UP: PROPELLANTS ON SIDES

age has been designed. Together, these measures should take care of the problem. In cases where they do not—where you find propellants which have "slumped"—place them in Code H and request disposition. Do not try to reshape or force-fit them.

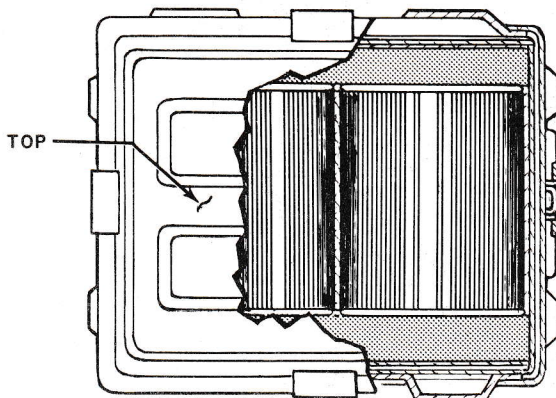
CONTAINER ON ITS SIDE: PROPELLANTS UPRIGHT

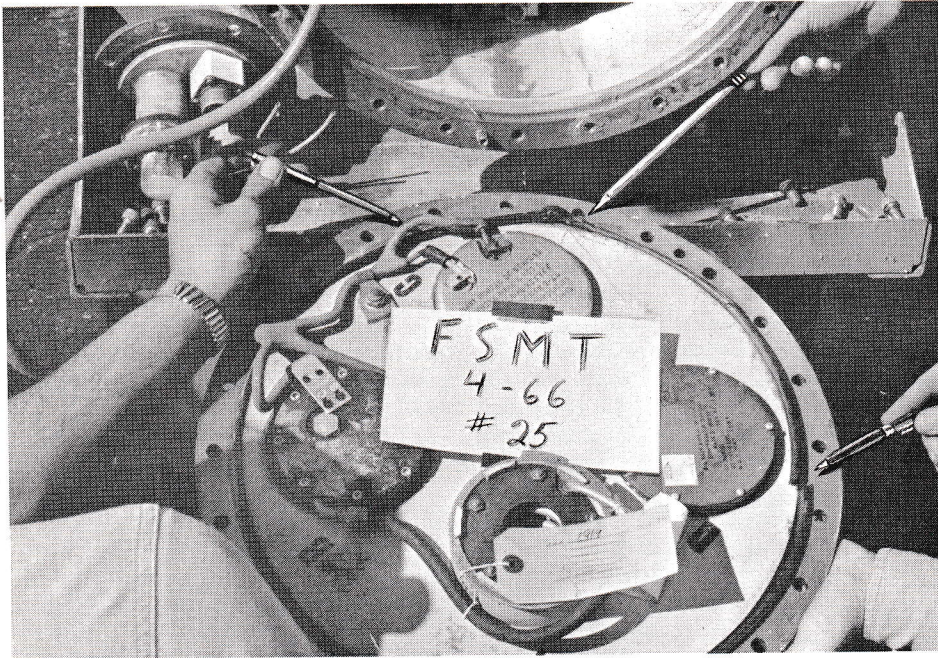
It's more than minor when the point is installation of the wrong-size packing (O-ring) on a mine-case watertight opening. Here three hands point out the breaks it produced.

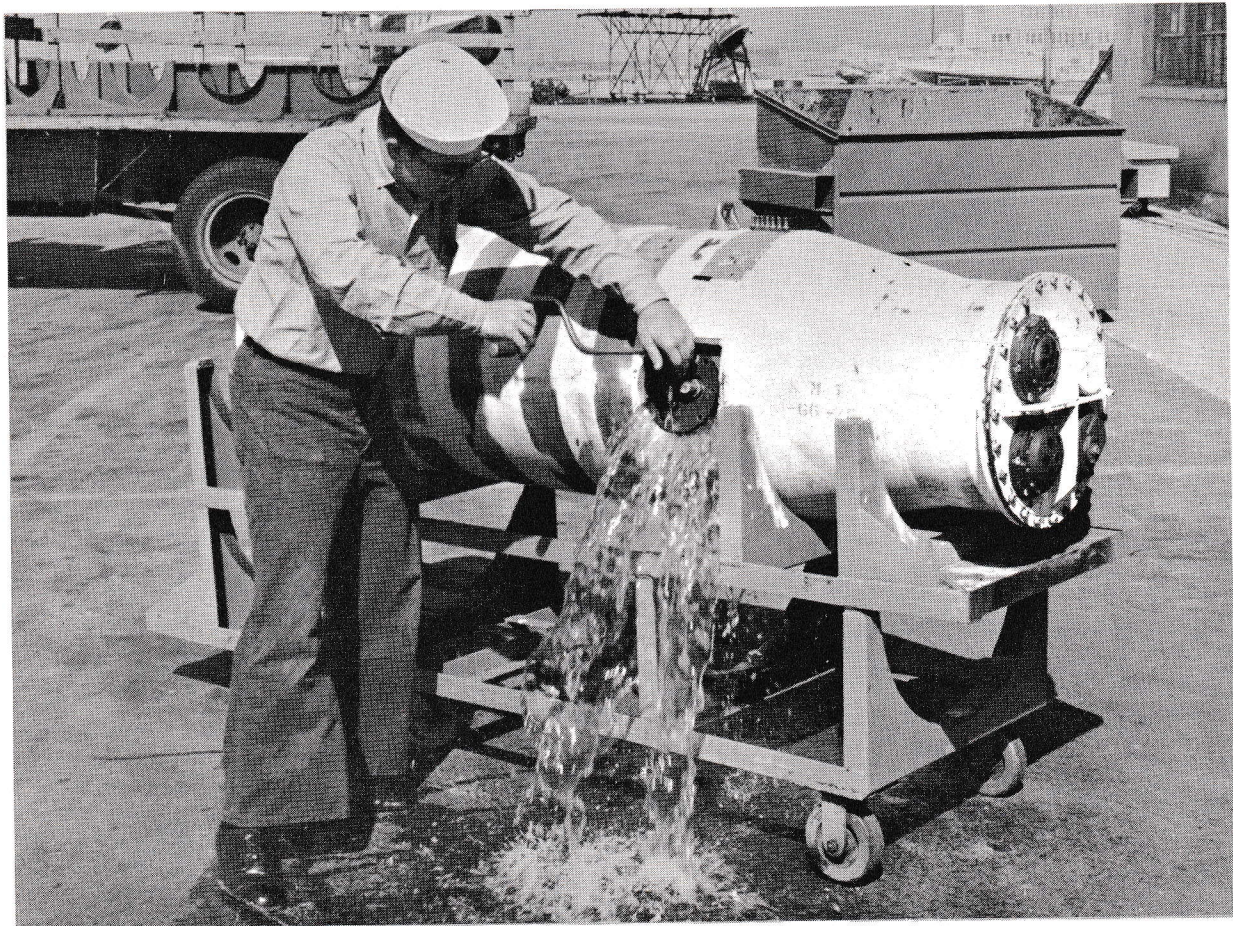
The result should be predictable to all hands: an FSMT Mk 55 flooder. This shouldn't even happen to a Mark 6!
