THE MINE AND DEPTH CHARGE

TROUBLESHOOTER

ISSUE 3-69

1 OCTOBER 1969

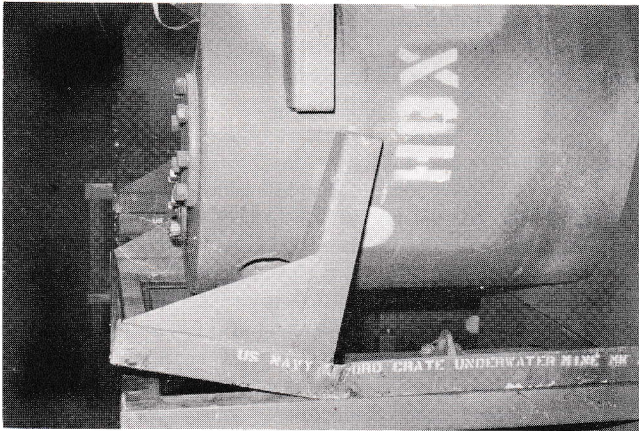
When all bolts are not used the crate no longer protects the mine and you have a problem straightening crates. Use all the crate bolts.

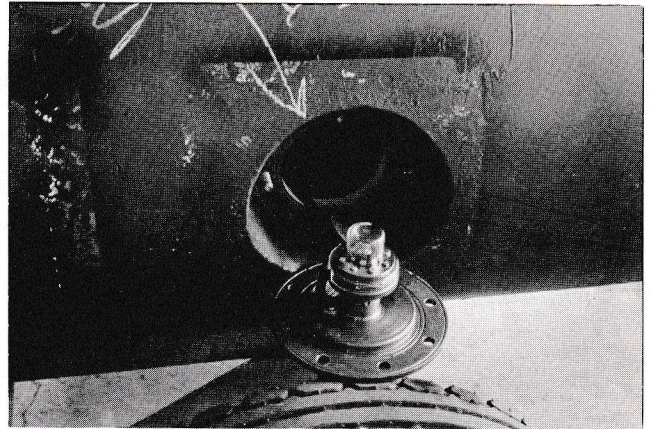
Of course if the gasket is omitted entirely, as in this Mine Mk 25 clock well, you can be sure of a leaker.

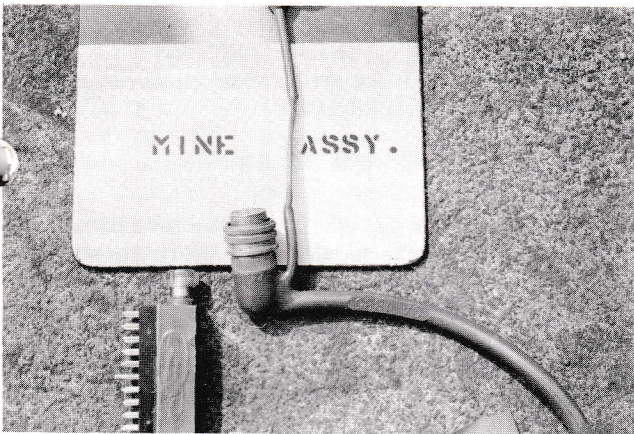
If P-3 leg of the instrument cable is not held clear while instrument rack is installed, the rack doesn't give, the cable does.

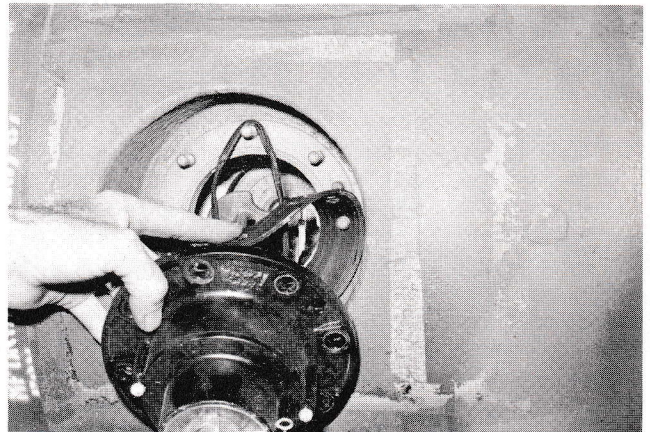
This Mine Mk 25 extender well gasket was not designed to go over a CA-410 - nor should the CA-410 be routed around the stud!

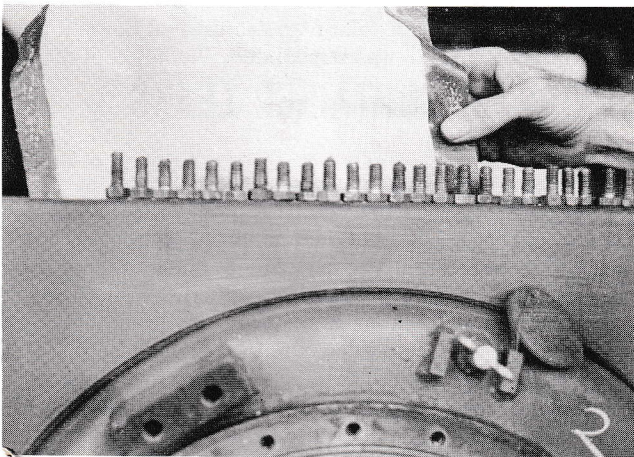
All the real Mine MK 49 tail cover screw step forward. You can't all be OC 24202.

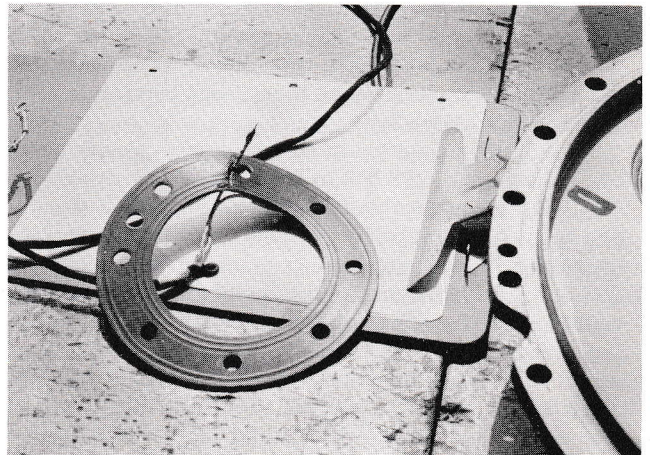
Nor does the mine wiring call for the CA-410 to go through the gasket.

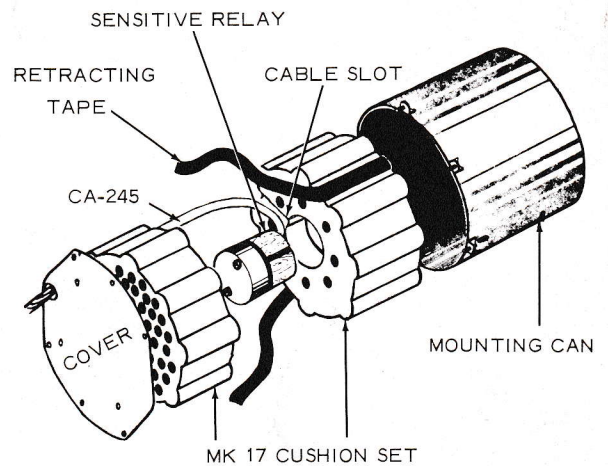
The Cushion Set Mk 17 that protects the Sensitive Relay SR-6 in the can that mounts on the M-9 mechanism compartment cover also can be a problem. In this case it is one of withdrawal of the two cushions of the set with the SR-6 sandwiched between them. This is because the cushions have a tendency to adhere to the sides of the mounting can during prolonged mine storage.

To avoid this trouble use cotton tape, 5T00503, FSN 9D8315-641-4375 to pull out reluctant cushions. The unit of issue is a roll of 36 yards. This is the same procedure used to extract Cushion Set Mk 29 and the SR-7 in Mine Mk 36 Mod 3. Do it this way.

Place a 36-inch length of cotton tape across the flat side of bottom (thicker) section of cushion set and lead equal lengths of the tape along the sides of the cushion being sure they do not obstruct the cable slot. Then insert the cushion and the SR-7 in its mounting can.

The top cushion is inserted so cable slot aligns with cable slot in lower cushion. The tape is pulled straight and taut up the sides of the upper cushion and tied across the top. The can's cover can now go on in the usual manner.
