THE MINE AND DEPTH CHARGE TROUBLESHOOTER

TROUBLESHOOTER

ISSUE 3-70

1 OCTOBER 1970

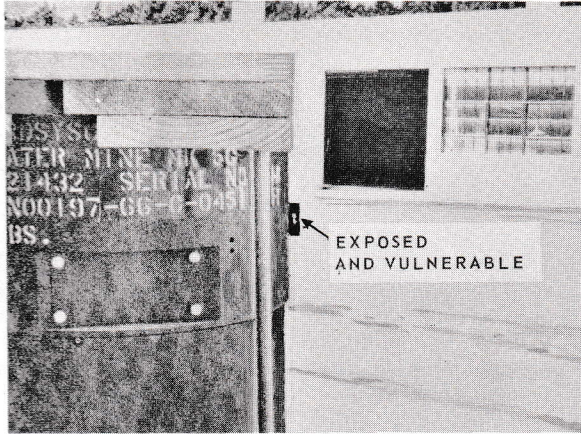
EXPOSED AND VULNERABLE

Shown above is an example of an inspection hole cover with boss broken off. The end of the helper spring retaining bar is exposed.

As mine anchors Mk 56 Mods 4 and 5 are now oriented on pallets for shipping and storage the inspection hole covers, there are two 180 degrees apart on the anchor shell, are exposed to damage. The reason is that the cover bosses, which also serve as anodes for the anchor marriage compartment, protrude from the periphery of the anchor and therefore, in most cases, beyond the edge of the pallet tangent to it. The result is bent and cracked covers that must be replaced. In some instances they are broken off as the photographs sent us by MN1 L.D. Moir at NAD Bangor show.

To correct, the anchor will be rotated 45 degrees or so that the protruding bosses of the covers are oriented on the diagonal between the rods (bolts) that tie the top and bottom halves of the pallet together as shown.

The Mk 56 anchors will be placed on the pallet in the new position by the manufacturer in the future to protect the covers. Meanwhile when maintenance requires removal of the anchor from its pallet return anchors to the pallet in the position shown in the sketch above. Action is being taken to get extra covers (anodes) to replace those that are broken.
