# THE TROUBLESHOOTER

*mine and depth charge*  
**THE TROUBLESHOOTER**  
Published by the Naval Mine Engineering Facility, Yorktown, Virginia.  
Frederick F. Jewett, CDR., USN... Officer-in-Charge  
Haines A. Miller..... Technical Director  
Thomas R. Nevitt..... Editor  
Roland R. Rollins..... Art Director

**1 JANUARY 1965**

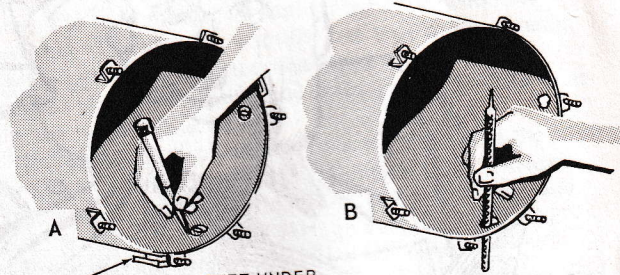
CRADLE BRACKET UNDER

In assembling Drill 36-1s the two holes in the side of the can for the SR-6 repeatedly (3 out of 5) fail to line up with the holes in the cradle bracket welded in the mine case. We enlarged the holes with a rat-tail rather than reject, but we thought you should know.

Glad you did. Your solution is OK as long as you don't ream so much that the attachment is weakened. If this

mis-match continues to happen with such regularity, though, it would probably be a good idea to trial-fit the cans by slipping their tabs over the six studs on the M-9's compartment cover for a look-see before securing. If the holes line up, go ahead like in par 27 on page 26 of

A - With SR-6 can fitted over studs of Firing Mech Compartment Cover mark offset to indicate where holes should be opened to match securing holes in cradle bracket. B - Remove from mine case and open holes with rat-tail file as marked.

OP 1684. If not, mark with scribe or crayon just where to file.

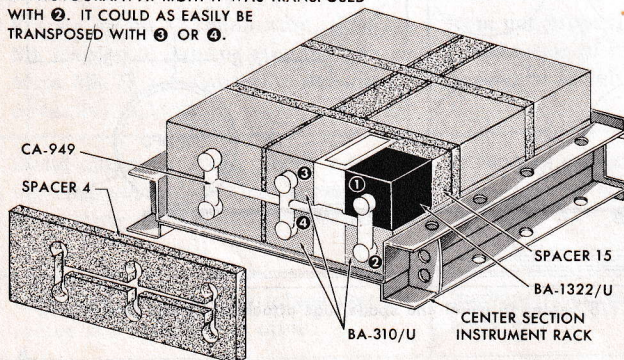
BATTERY ASSEMBLY, MK 52/55 MOD 2

① IS MERCURY CELL BA-1322/U IN ITS CORRECT POSITION. IN PHOTOGRAPH AT RIGHT IT WAS TRANSPOSED WITH ②. IT COULD AS EASILY BE TRANSPOSED WITH ③ OR ④.

Once more, then, it turns out that the best laid plans of mice and men can go awry. In all probability we'll shortly be introducing some sort of field fix into OPs 2608 and 2974. Meantime, men, better make it a habit to double check your placement of Batteries BA-1322/U against those exploded views in your OPs before you plug in your cables.

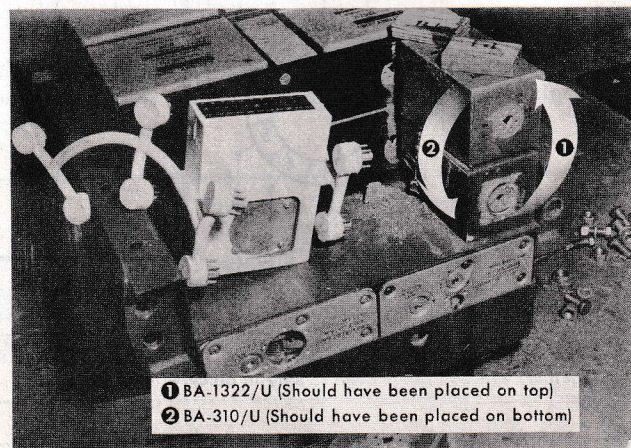
① BA-1322/U (Should have been placed on top)  
② BA-310/U (Should have been placed on bottom)
