THE TROUBLESHOOTER

mine and depth - charge

Published by the Naval Mine Engineering Facility, Yorktown, Virginia

1 JANUARY 1966

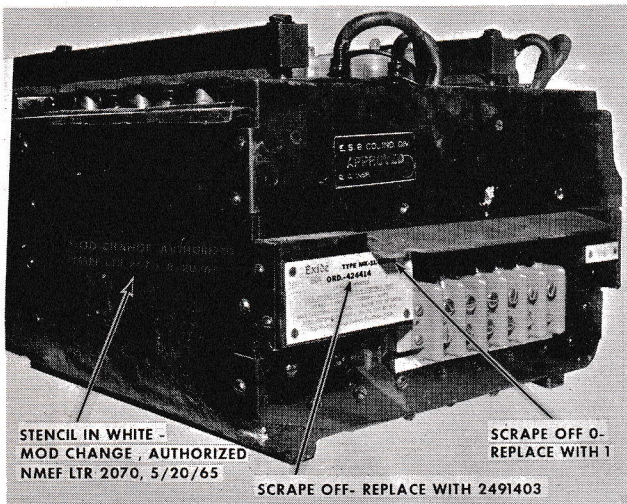
INTRODUCTION of new calcium-lead-type Mark 33 batteries to power Mk 27 mines marks a definite improvement. Like the older lead-acid batteries, though, these new Mk 33s were accepted into stock designated as Mod 0. Such a practice is fine for items that are interchangeable in every way, so can share the same stock number. But in the present instance it is important that the identities of the old and new batteries not become merged, if only to insure full benefit being derived from the much-prolonged period that the new types can be stored without maintenance: up to 90 days!

There is also a fit problem that 27 miners should know about, evidenced by the fact that, when you try to install it, the new battery will strike the forward brace and hold-down inside the war-battery section of Mine Vehicle Mk 1 Mod 2. (There is no fit problem when the battery is used with the Mk 1-1 vehicle.) To correct this, a field fix is authorized as follows:

- ▶ Position the battery in the battery section and push battery forward until it strikes the battery brace.
- ▶ Scribe the battery's wooden bumper along the line of interference, where it presses against the brace.
- ▶ Withdraw the battery, remove its wooden bumper, and saw along the scribed line. Then put the bumper back on the battery. It will now clear the brace.

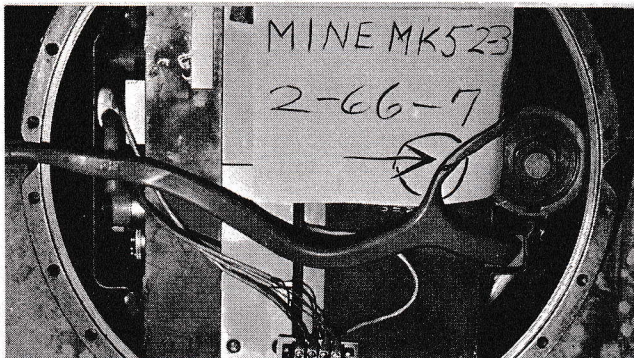
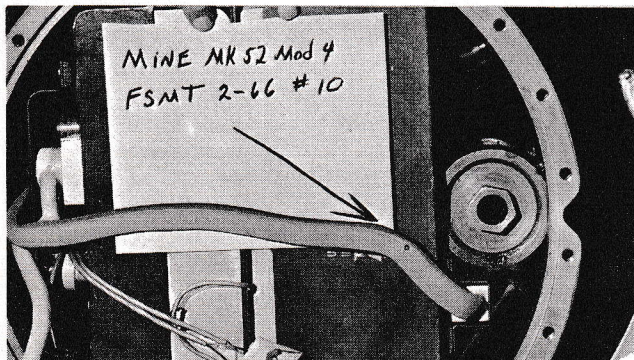
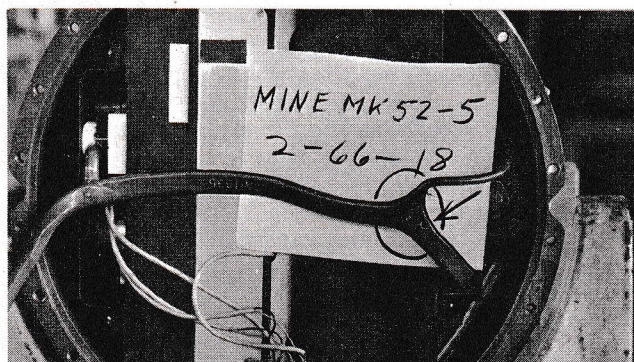
Instrument cable pinch

When they put the depth compensator in the tail cover of Mines Mk 52/55 Mods 1, 3, 4, 5, and 6 they didn't leave enough room between compensator cover and instrument rack for the instrument cable . . . at least

not when it gets under a screw head. Here are some examples of cables with impressions of the screw heads that show what we mean and, as you can see, it sure could cause trouble.

What we do now is tape the cables so they're held clear of the depth compensators. It works if done right.

Your tape method is OK as long as you map the route of the cable accurately enough. For new procurements, though, we've substituted truss-head screws for those fillister-head screws now used in the depth compensator cover. A better, though at times less convenient field fix can be had by replacing the two screws that interfere with the cable with 1/4-inch cadmium-plated steel truss-head machine screws No. 6-32-UNC, 5305-151-0691. Truss heads are thinner than fillister or round heads, yet are strong enough for this application, and at the same time will not pinch the cables.
