No. 3-61

Tail-Plate Rack For 52s, 55s

Drill-Mine Hazard

THE OFFICIAL JOURNAL OF THE RUDMINDE PROGRAM

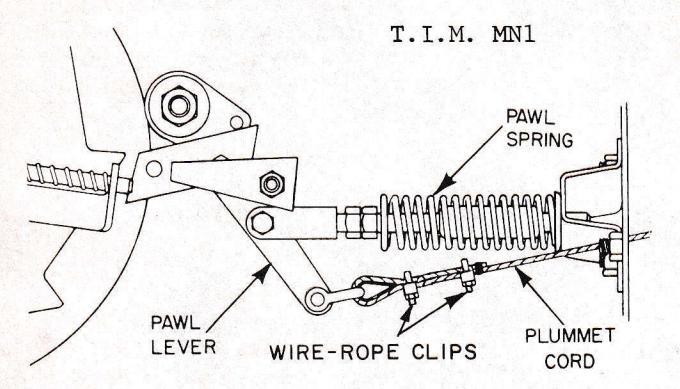
OP 1853 1st Rev Vol 1 says in step 4 on page 131 that when securing the thimble in the plummet cord, we should "Make certain the open ends of the wire-rope clips are down." I always work with the open ends of the clips up because I catch the "U"s in a vise and tighten the nuts real handy.

Shouldn't that "Make certain" business be in step 5 where we secure the shackle to the pawl lever?

It sure should. The reason for <u>installing</u> the shackle so that the clips' ends are down is to keep their ends from accidentally snagging the pawl spring.

Right now might also be a good time to tell you to be sure you set that hold-off nut like OP 1853 tells you to except when the assembly directive specifies drums locked. We've had plenty of mooring failures lately due to ignoring this part of the job.

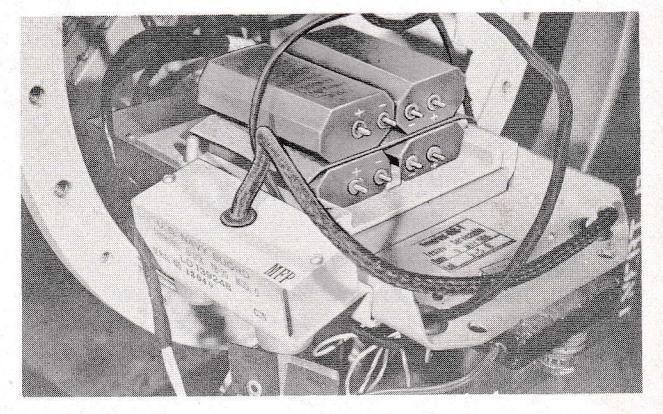
Here at the Mine Warfare School we've interpreted this to mean that the negative terminals should be adjacent to the TB-20 only to discover that the battery card on CA-579 won't fit correctly. Since there's no illustration in the OP to show wrong from right we have to clarify the business for each new class. Maybe we could get one of those proverbial pictures that're worth a thousand words?

Your suggestion that an illustration be put in the OP to clear up the adjacent confusion is good. Until this gets done here's a photo of legal togetherness BA-205/U-style in a Mk 25-0 mine.

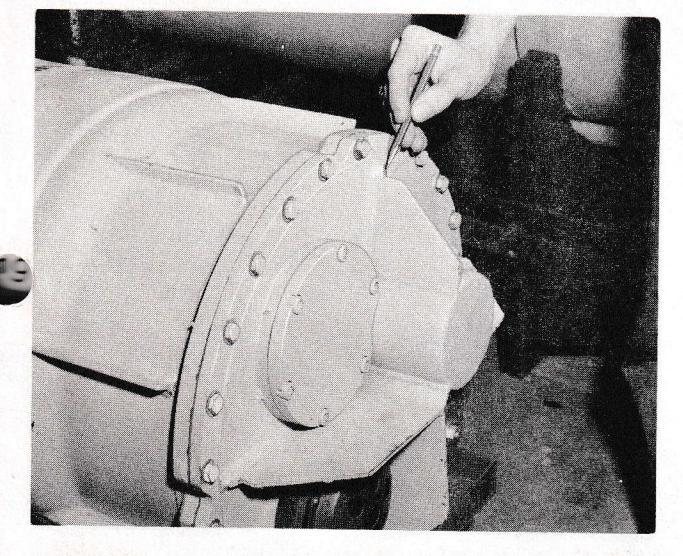
Your treatment looks good. Recently the drawing has been changed to reduce the ribs right where you filed and, for good measure, some metal has also been taken off the diagonal edge of each rib as well. But don't be half safe.

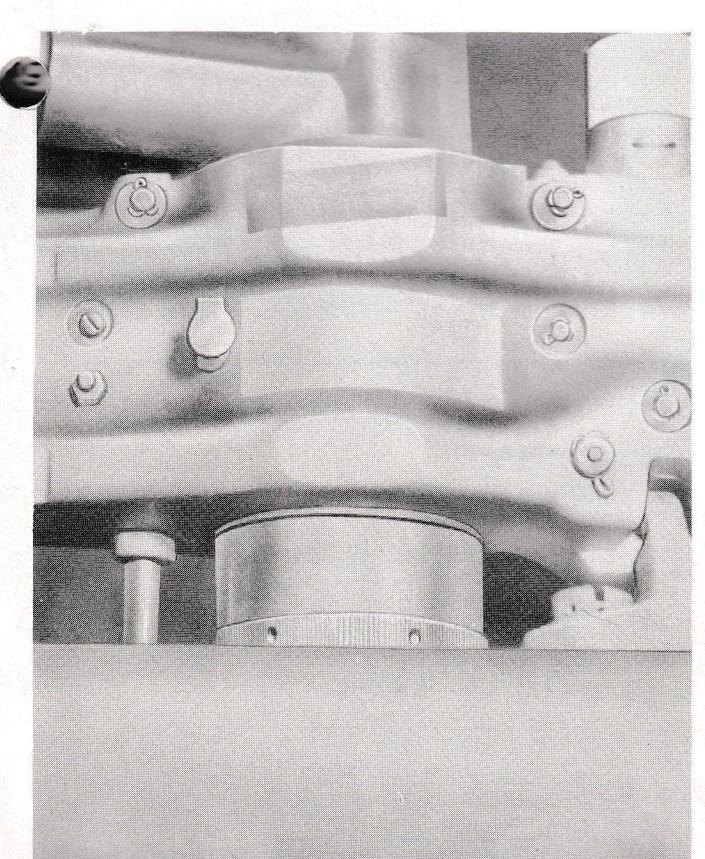
An improper connection may seem okay at first, then make you pass up perfectly good firing mechanisms later on. That's what <u>B. Busby</u> and <u>E. Conklin</u> of NAD/Hawthorne tell us.

Seems their Test Set Mk 110 Mod 1 passed the operational check and voltage adjustment (per MIL-T-18580) but consistently rejected Mk 15-0 firing mechanisms. After a run of "bad" mechs, the boys got suspicious and tallied the test set's connections against DWG 399014. What they found was that, during manufacture, pin A of the J6 plug (arming-relay circuit) had been connected to R42 instead of to R86, and C15A (reset-relay circuit) had been connected to R86 instead of to R42.

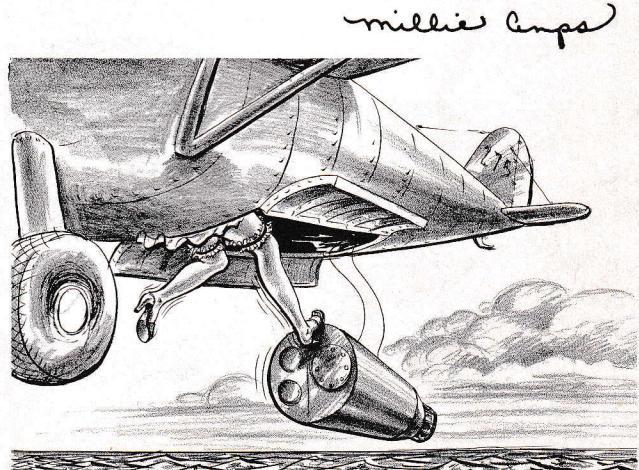
While installing Mk 39 mines in A3D aircraft for a Fleet Service Mine Test R. Turetz, MDAU 0323, noticed that the feet of the Aero 7A Ejector Racks were overextended because they were resting on the 14-inch suspension lugs' recessed pads. The black line on the foot—design extension limit—was visible when the feet were in contact with the mines.

Turetz suggests that a 1/4-inch metal pad be secured to the case between the 14-inch suspension lugs to prevent. A simpler solution—and one that works like a charm—is to put the 39's suspension lugs back in the 30-inch position where they're normally found and where they should stay when the 7A ejector is used.

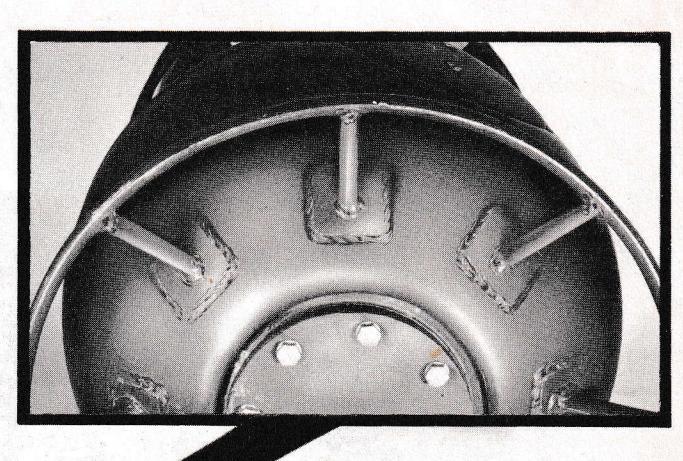
We still get reports about Mk 9 Mods 2 and 3 depth-charge cases leaking TNT exudate because cracks develop where the nose-ring support brackets join the case. This is dangerous, and a surprising number of T-Shooter readers seem to be in a quandry as to what they should do about it.

So much for that. Now let's consider what's to do when you find you're stuck with one or more leakers. First, make no mistake about that TNT exudate being dangerous. It's flammable, and it becomes explosive if mixed with wood chips, saw dust, cotton waste, or similar combustible material. First, then, get the leaker away from other loaded cases.

As for any mod 2 cases that do <u>not</u> have pads under those nose-ring support brackets they should be disposed of <u>right</u> now. Your authority and instructions are to be found in BUWEPS Message DTG P 152141Z of March '61.

Briefly, if afloat, the charges should be off-loaded at your nearest ammo depot and replaced with Mk 9 Mod 4s. If at sea (at least 10 miles offshore) you can deep-six 'em in 500 fathoms or more provided there'll be no great reduction in your state of readiness as a result. If there will, report it to your Operation Commander, CNO, and BUWEPS first, then wait for instructions. In any case you shouldn't lift the cases by those weak-in-the-knee nose rings, and it follows that you should not henceforth accept any more mod 2 or mod 3 cases from an ammo issuing activity.

But never—repeat, <u>never</u>—use soap or other alkaline preparations. They usually contain hydroxide, caustic soda, or potash, very small amounts of which can make the TNT extra sensitive. And do not, under any circumstance, scrape the paint off non-leaking mod 2 cases to find out if the welds look okay.
