THE MINE AND DEPTH CHARGE TROUBLESHOOTER

THE MINE AND DEPTH CHARGE

ISSUE 4-69

1 JANUARY 1970

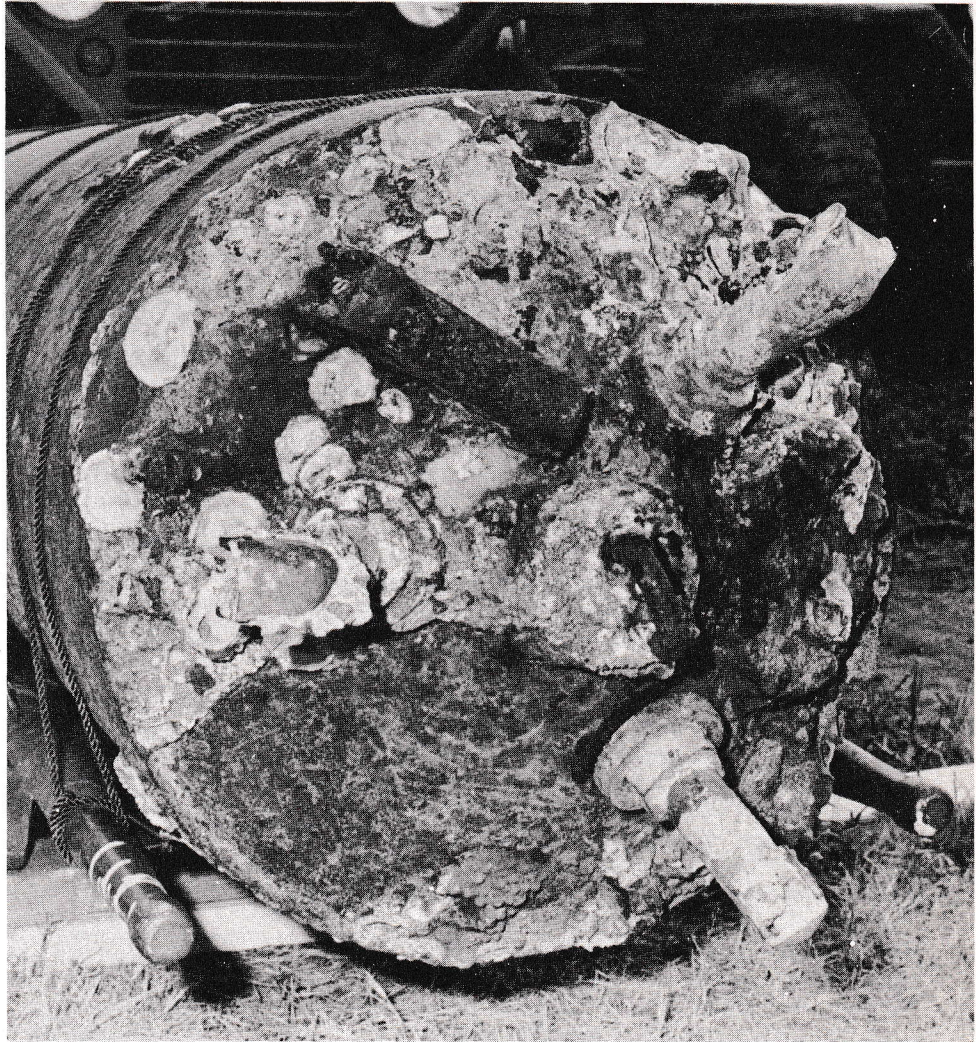
COVER

You are looking at a real ancient mariner on the cover of this issue of The Troubleshooter. What you see is what has been identified as the nose of a Mk 10 Mod 1 mine encrusted by coral and shell growth. Its three chemical horns are still identifiable. The mine was sand loaded. For story see page 3.

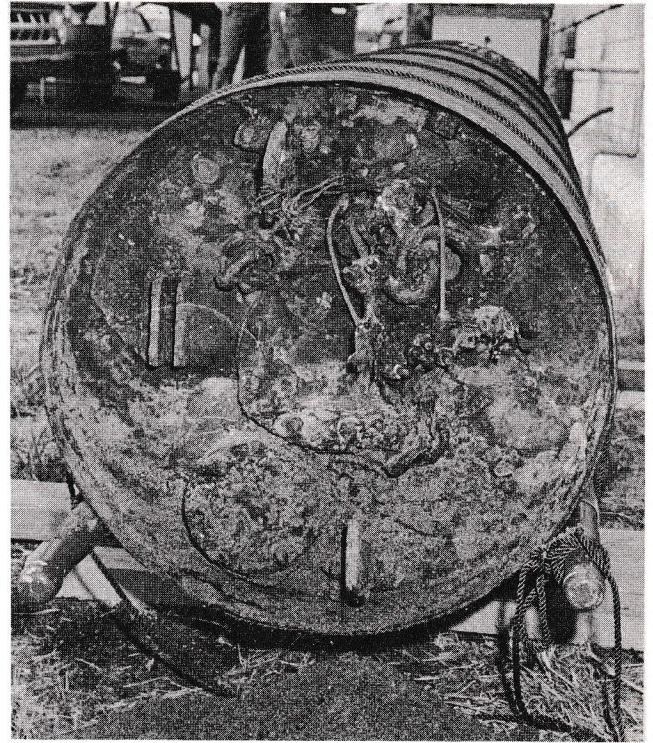
The aft end of the old man of the sea whose nose with the horns is pictured on the cover. Remnants of the mooring line can be identified still clinging to a shackle on the badly encrusted Mk 10-1 case.

Upon disassembly of the mine, EOD personnel found the extender and booster-well empty; there was no wiring harness to the horns, and no glass vials of acid in the chemical horns. The explosive section was filled with damp sand. Gasket surfaces were clean and dry, the gaskets were in good shape and the bouyancy cavity was merely damp, apparently due to condensation. Despite being badly corroded the mine case was water tight.

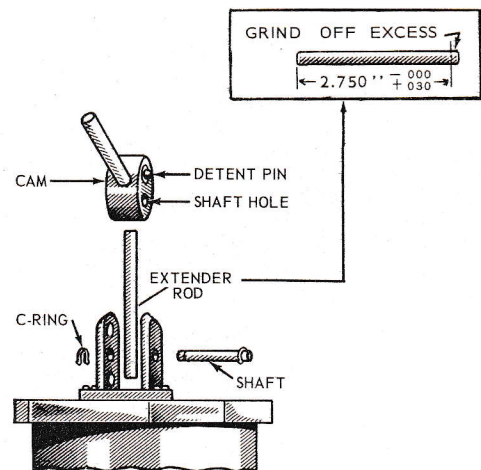
Disassembled Test Pot Mk 6-0

To disassemble remove C-ring from gauge end of shaft and withdraw shaft. Lift out cam, making sure you don't lose spring-loaded detent pin which falls out easily. Shake out bellows-extender rod. Reverse procedure to reassemble.

The length of the rod that operates the bellows in the Test Pot Mk 6 Mod 0 is causing trouble again. Originally, by Troubleshooter 3-65 Job Right, it was shortened to 3.125 inches to avoid interference with the diaphragm covers of the Pressure Detectors Mk 1 Mod 0 during Class C testing of Mines Mk 52/55 Mods 3, 4, and 6. This corrected the interference problem but now the design limits of the test pot's bellows enter the picture.

It has been determined that either the original length or the 3.125 length rod forces the bellows to operate outside its design limits to the detriment of the bellows. The answer is to dismantle the pressure pots (four of them come with Test Set 263 in Accessory Set Mk 10) and cut the rod to a length of $2.750 \pm_{0.030}^{0.000}$ inches. The length is critical so grind off the excess on the square end of the rod. Check with calipers for accuracy. No minus tolerance is allowed because bellows is operating to within .003 inch of maximum compressed length when the rod is cut to 2.750 inch. Further reduction in rod length may exceed bellows design tolerance.

Upon completion of the rod-shortening job, stencil, rubberstamp, or otherwise mark the side of the test pot 2.750-INCH ROD INSTALLED.

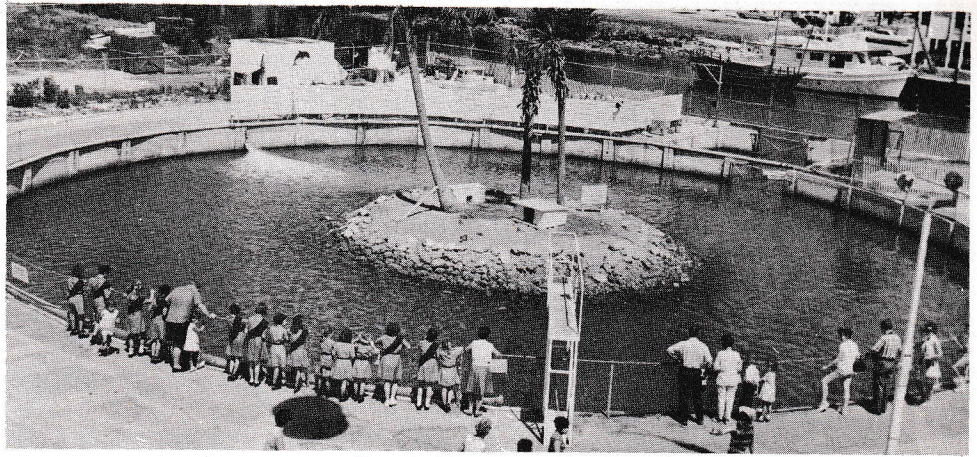
The shark moat at Ocean World in which samples of fiber glass mooring lines are placed in an effort to identify the marine creatures that have been biting them.

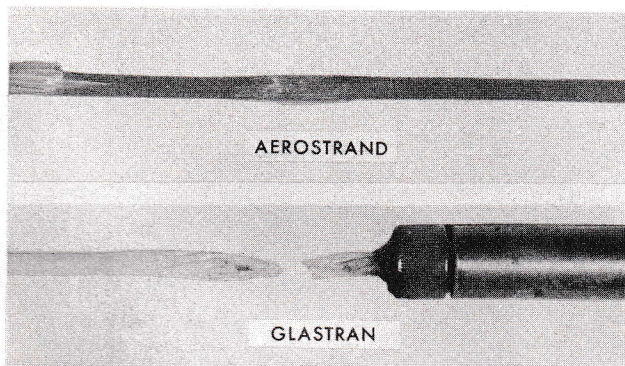
Samples of fiber glass mooring lines taken from Ocean World Shark moat. Aerostrand fiber strand (top) was chafed by unidentified inmates of the moat. A turtle probably cut through the Glastran sample (bottom).

One sample was bent to retain a fish strung on it as bait, then placed in front of a turtle. The turtle ate the fish, then took several bites at the line, making deep cuts in it. Another sample was suspended in the shark moat for several days. When recovered it was broken at its lower end and had a deep slice at the top end next to the metal fitting by which it was lowered into the moat . . . a cut that parted during retrieval.

The evidence isn't conclusive, although Hirschman is sure the cuts are turtle bites. The sharks remained indifferent to all sample lines. Only the turtles consistently attacked them, and left marks like those on the samples that had parted in NOL's field tests. Although tests continue at Ocean World, NOL is now all but certain that sea turtles are the villains.

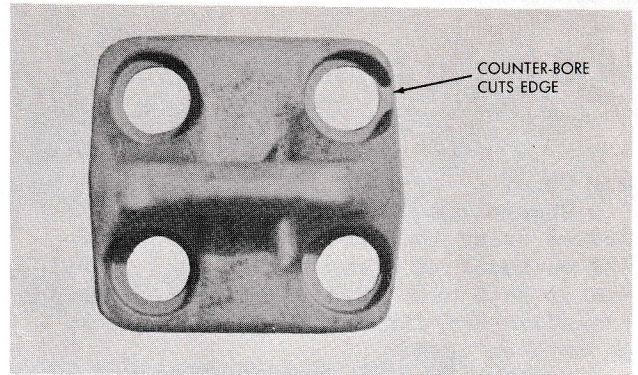
These are interim methods to be used while a proposal for the design of a gauging tool to do the job is being studied.

You did right to discard the lug with an oversized cross bar. Any cross bar thicker, fore and aft, than .490 inches just will not mate with all Mk 8 bomb shackles. When you use the gauging method described in the article on page 7 of the 1-67 Troubleshooter, keep in mind that the shackle you use should be on the minus side of the .010 tolerance allowed, otherwise the shackle could "pass" a .510-inch-thick lug in extreme cases. If screening unmounted lugs use a caliper, micrometer, 0 to 1 inch, 7C00006 set at .490 inches. The tool should not bind at any spot as it is moved across the lug.

Discard any lug with a missing counterbore; but those lugs that have counterbores that touch the edge of the Mk 12 lug base can be used with safety and are serviceable. An example of this condition is pictured here thanks to MNI J. J. Sbei, Iwakuni, who had the same problem and sent us the photograph.

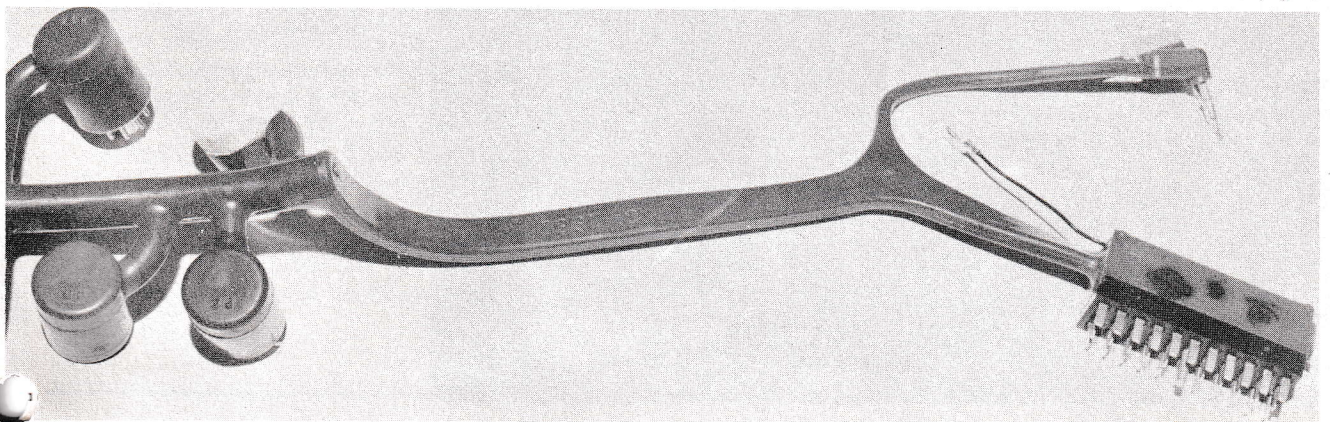
If the reversed-plug cable can make it in the Mine Mk 55 Mod 2 it should work as well with the twist as without it. It would be a good idea to examine your Mine Mk 52 stock of spares for odd-ball CA-1832s. These should either be swapped with cables for Mines Mk 55-2 and so designated, or replaced. If the plug doesn't lay-out like the one pictured here, it is reversed.

My guess as to how all this happened is that the manufacturer got a faulty mold in his production line. Since manufacturers work with five or six molds for any one cable, probably one in every five or six cables will show this defect.

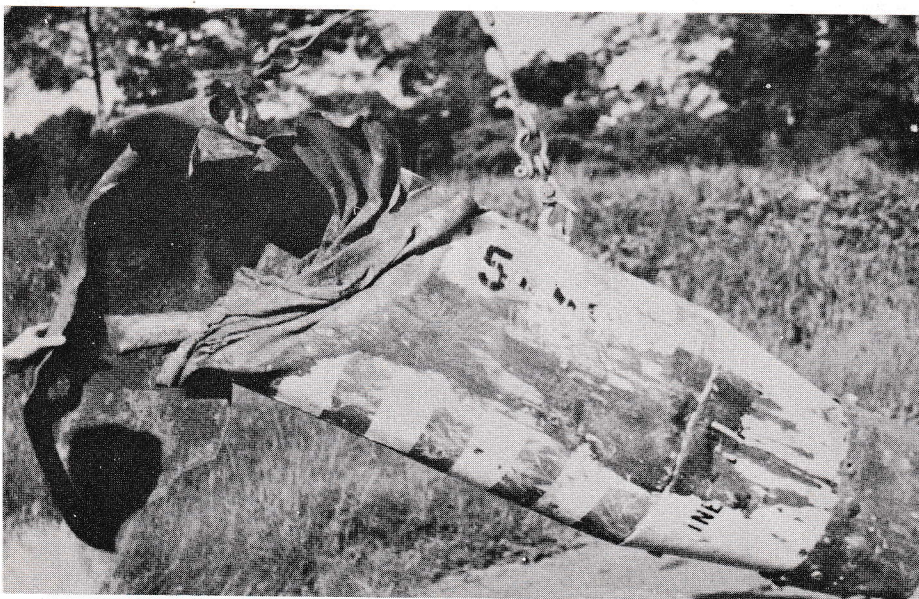
Here is a horrible example of what can happen to a Mk 25 drill mine when it is "planted" twenty feet up on the beach. MNC Robert N. Hart of Subic Bay, where it all started, reports the parapacks operated according to the book but parachute or no parachute it sure hit hard. Write off one mine every time.

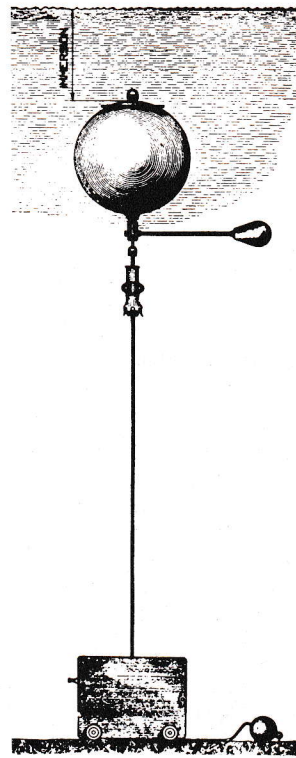
NAVAL DEFENSE MINE MK 3
The mine, shown here moored, is described in a 1916 Bureau of Ordnance pamphlet. The mine carried a long lever with a cork float at its end. Upon contact with a ship it was expected that relative rotation between case and lever would cause the case to rise an inch or two. This would compress the firing spring and then release it against the detonator.
