No. 3-61

Tail-Plate Rack For 52s, 55s

Drill-Mine Hazard

THE OFFICIAL JOURNAL OF THE RUDMINDE PROGRAM

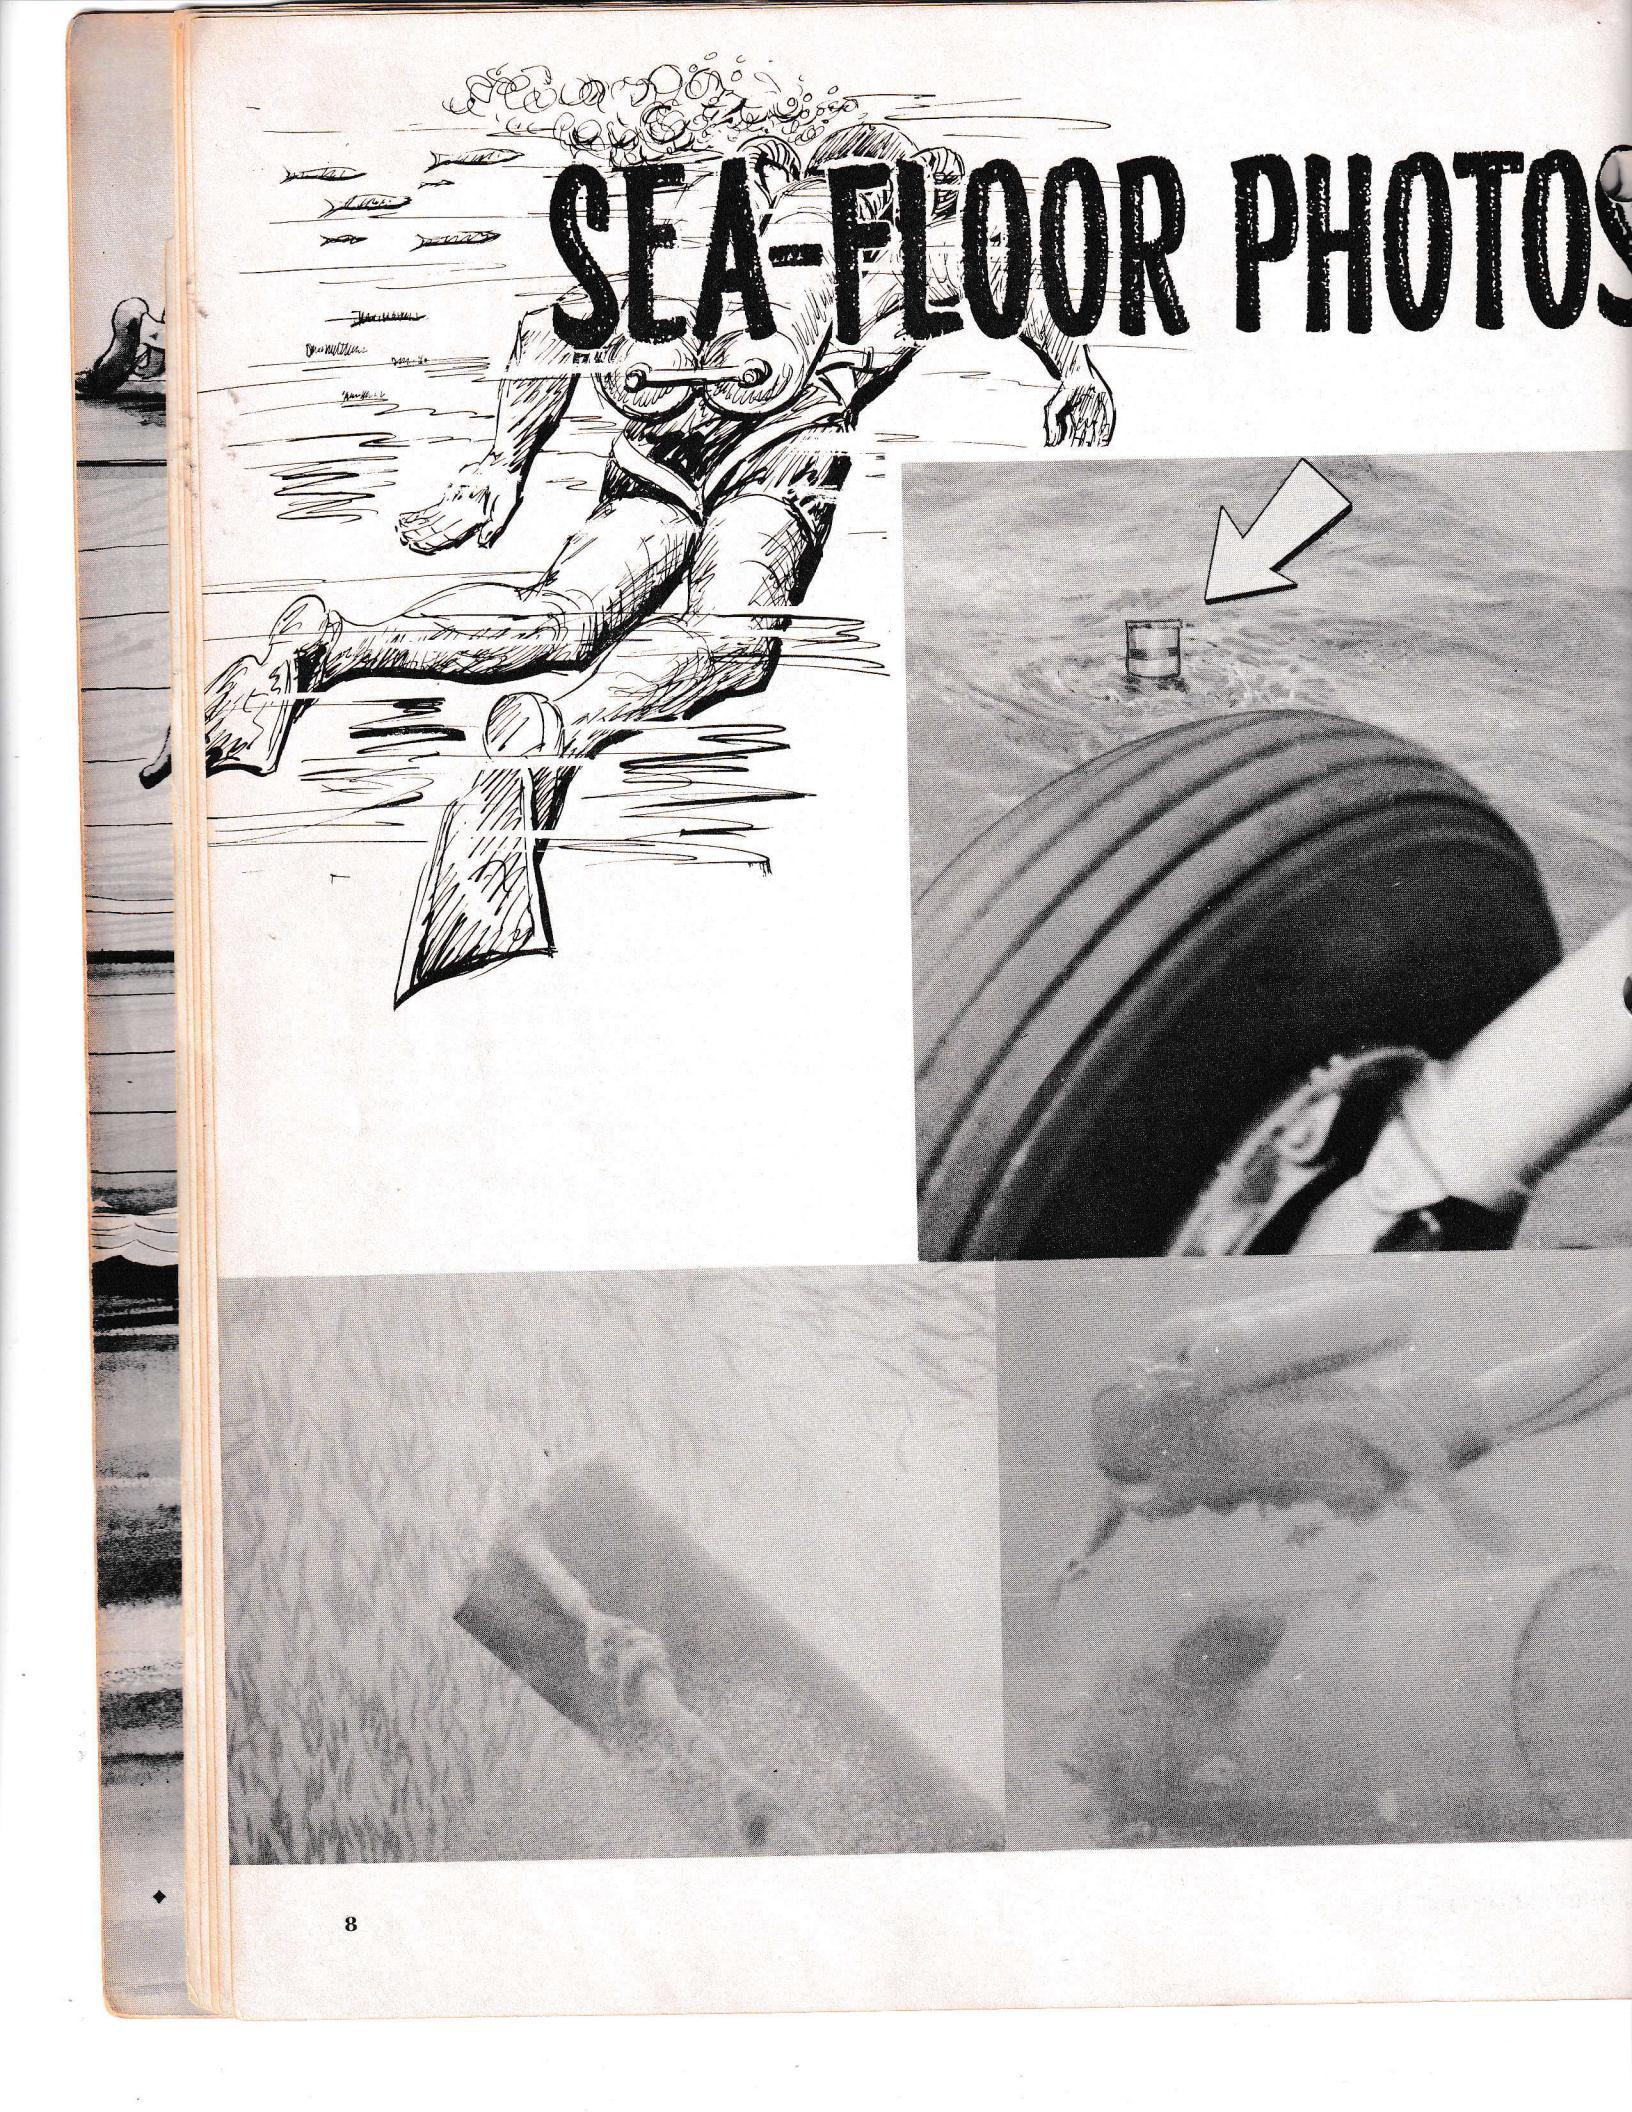
In a mine field some 30 miles from the floaters they found two Mark 10 anchors whose mooring cables had chafed through. In checking the remaining Mk 10s in the field they discovered two more with fouled (but still intact) mooring cables, and righted them. Another Mk 10 was found to be in trouble, having failed to separate from its anchor. The divers rigged this mine for recovery and photo at the lower right shows it coming aboard. The to lower left shows a properly moored Mk 10 about 30 days after planting.

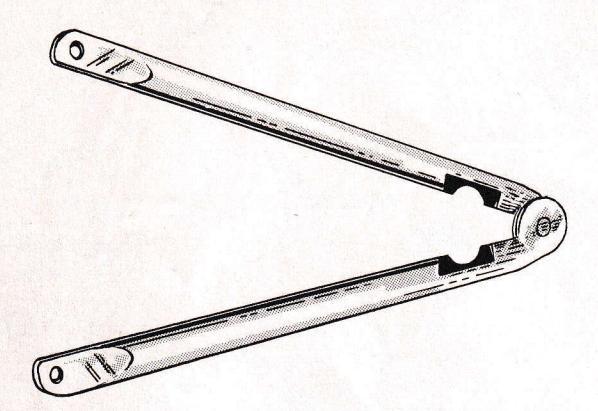
E.L. McMILLEN of QEL Keyport sent us a helpful Rudminde concerning the problem of removing tight acorn nuts from the potentiometers of A-8-0 firing mechanisms. The easy-to-make clamping tool he designed for holding the pot shaft while the nut is removed is also useful for installing the nut without having to remove the electrical component and cover from the mechanism.

The tool is made from $7/16'' \ge 5/32''$ steel stock. Any semi-hard material such as fibrous phenolic resin can be used for the inserts. When the tool is closed, the hole through the inserts should be 5/32''.

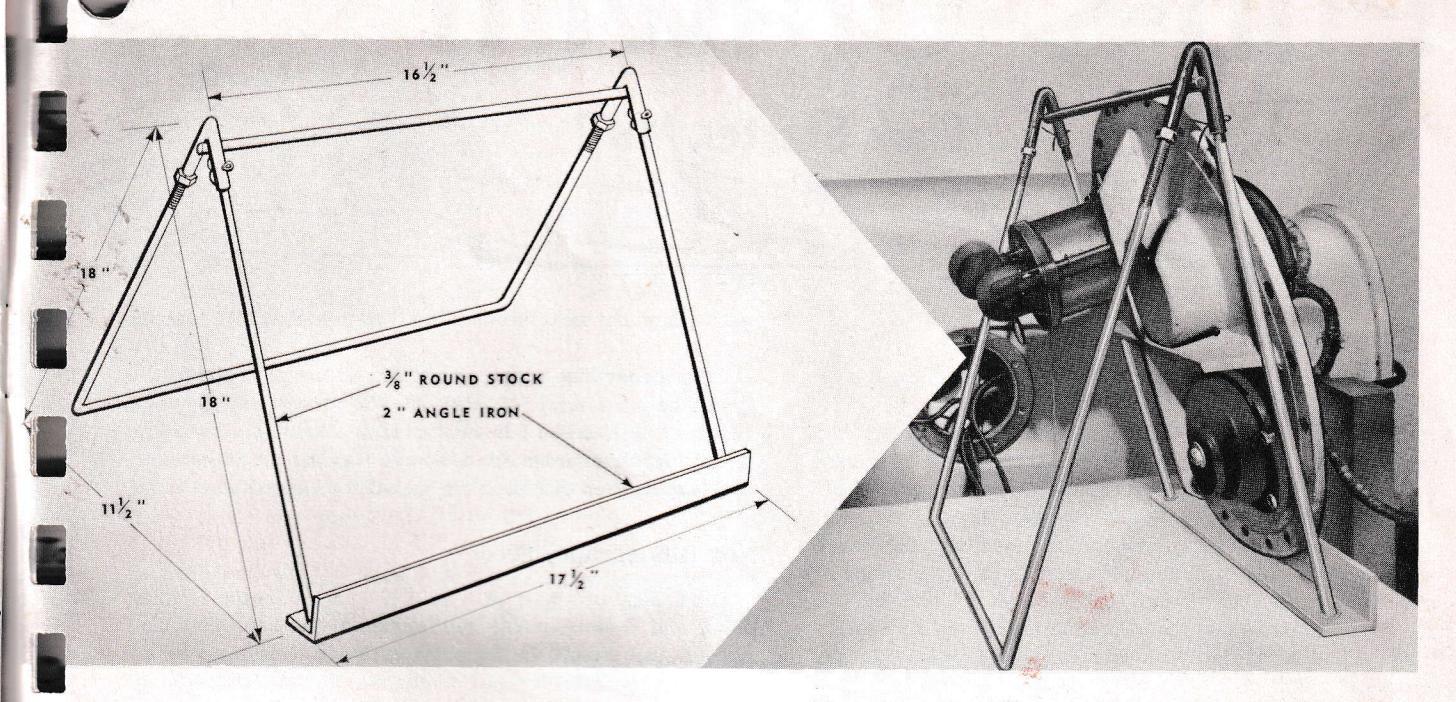
N EW WEAPONS are sure to mean new problems to be solved, and Mines Mk 52 and 55 are apparently not exceptions. Last issue we gave you Mine Project 4's smart art for handling those hefty instrument racks. Now we have a crackerjack rack for parking those bulky tail-plate assemblies, courtesy of <u>Harry F. Bright</u>, MN2 down at KWESTEVDET.

Not only does Harry's portable easy-to-build rack keep the tail-cover components from getting banged up, it also prevents strain on the instrument cable and makes testing a somewhat easier task. For instance, using this rack you can install the test pot over the pressure detector in Mod 6s for your operational tests without having to hang the tail-cover assembly on the tail of the mine.

Another very fine feature: Bright's crackerjack rack can be disassembled for convenient stowage simply by slipping the legs out of the headers. Just right!
