No. 1-64
I-0618-268-1640

THE TROUBLESHOOTER

Published by the Naval Mine Engineering Facility, Yorktown, Virginia.

1 JANUARY 1964

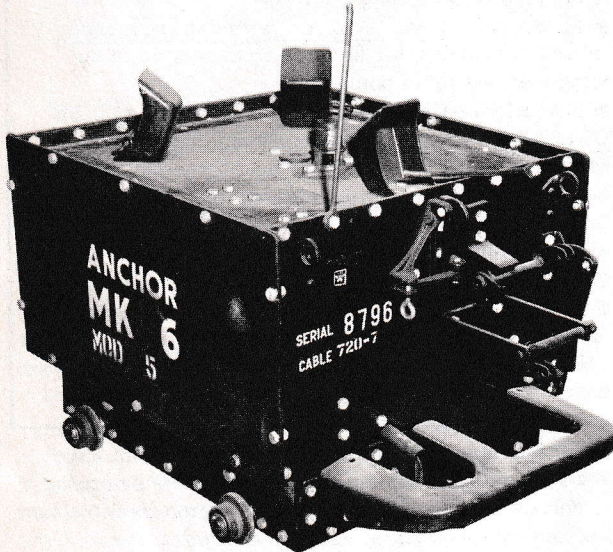
NEW ANCHOR MARK 6 MOD 5

The new Anchor Mark 6 differs from the old Anchor Mark 6 in two areas of quick identification. The case release hooks are different and the front bumper of the old Anchor Mark 6 is steel strap while the new one has a pressed steel front bumper. The old and new Anchors Mk 6 Mod 5 are shown here but these identification differences serve for all mods. The Anchor Mark 16 Mod 1 is shown here stripped to form the basis of the new Mk 6 anchors. Easily recognizable changes include removal of the backing-up anchor and associated hardware, and removal of the back bumper.
