# THE TROUBLESHOOTER

**AN OFFICIAL NAVORD PUBLICATION**

Published by the Naval Mine Engineering Facility, Yorktown, Virginia

1 APRIL 1967

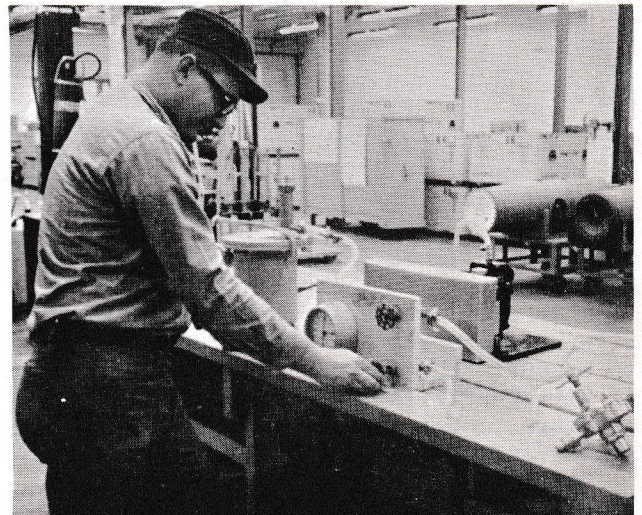
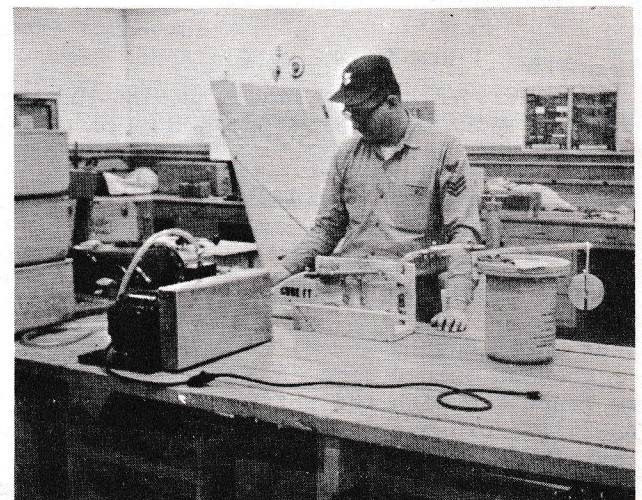
MN1 R. F. Stancik checks a MOMAT 0321 panel arrangement of the pressure-vacuum gage and valves for control of steps in the filling procedure for the Mk 23 container. The mounting provides convenient control center and a firm platform for operation of the gate valves.
