mine and depth - charge

THE TROUBLESHOOTER

AN OFFICIAL BUWEPS PUBLICATION

1 APRIL 1963

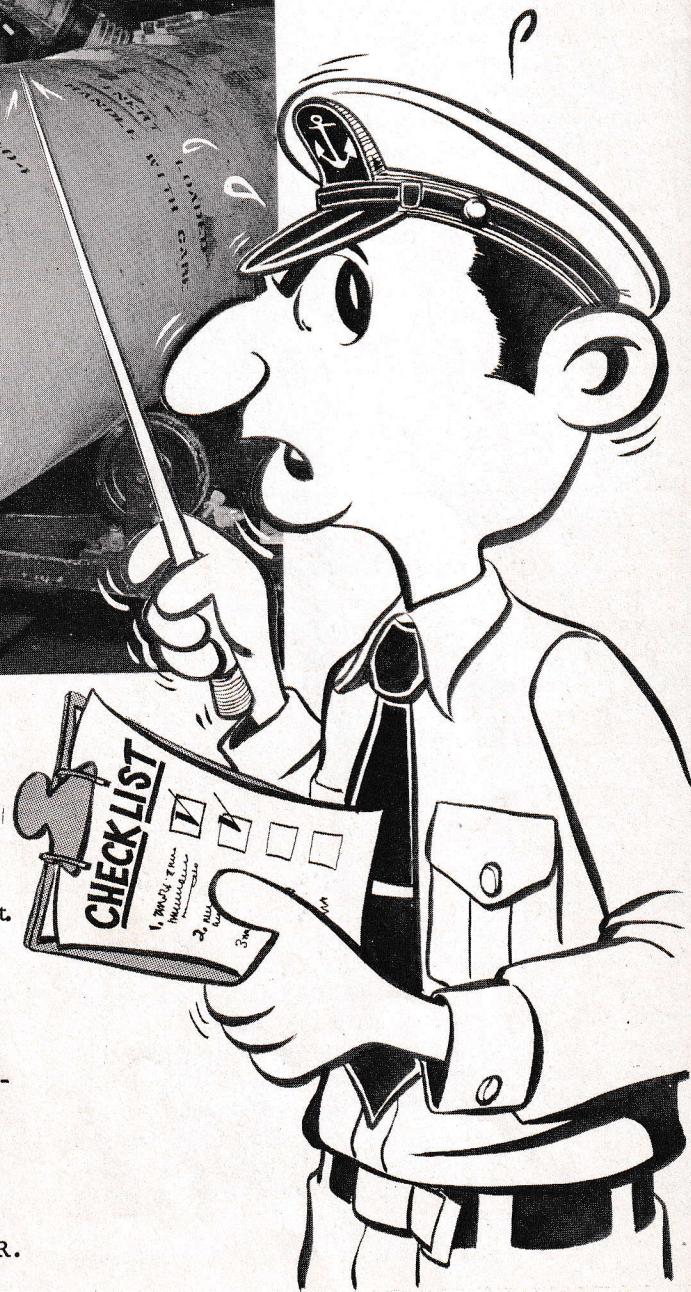
Water leaked into this mine because prescribed diaphragm replacement and test procedures were not followed.

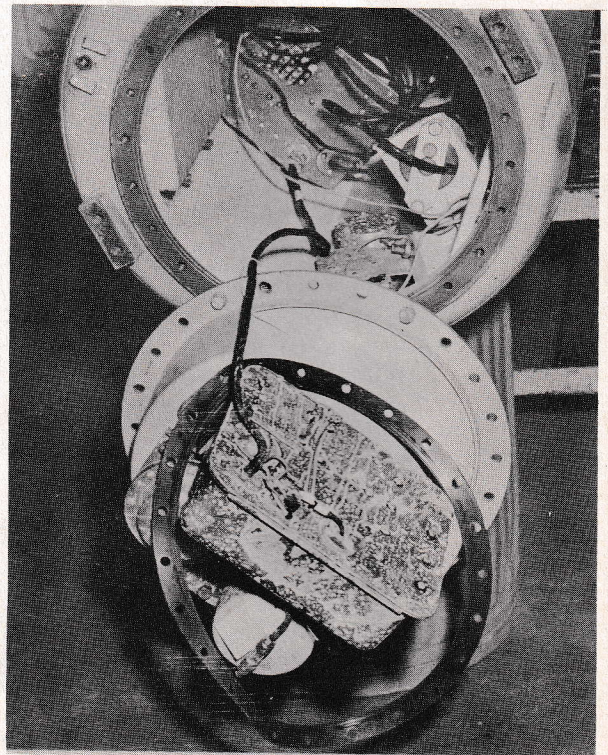
Bakelite terminal separators on terminal blocks broken.	Rough handling and/or inadequate packaging. Visual inspection not properly made.	Chances of short circuits between terminal connections increased.
Sterilizer Device SD 4-1 resistor carriage loose.	Carelessness and lack of attention to assembly details.	Possible loss of mine sterilization feature which increases the risk of casualties during subsequent check sweeping or mine clearance operations.

Forcing oversized lugs onto terminal blocks can also cause this barrier (separator) breakage. (See "TB patience" in HOT STUFF, in this issue.

Following proper procedures could have prevented this.

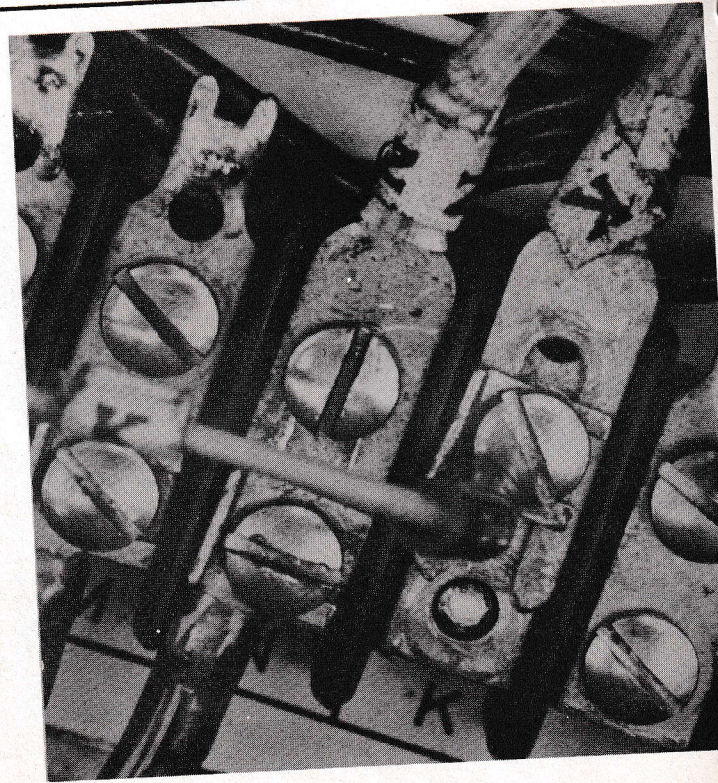
How much time would it have taken to replace this screw with a shorter one? Loose connections can cause duds!

Leads don't pinch themselves.

"Make-do" is taboo! If you can't back out a broken terminal screw, replace the block. ➔
