# THE TROUBLESHOOTER

*mine and depth - charge*  
**THE TROUBLESHOOTER**

Published by the Naval Mine Engineering Facility, Yorktown, Virginia

1 JULY 1966

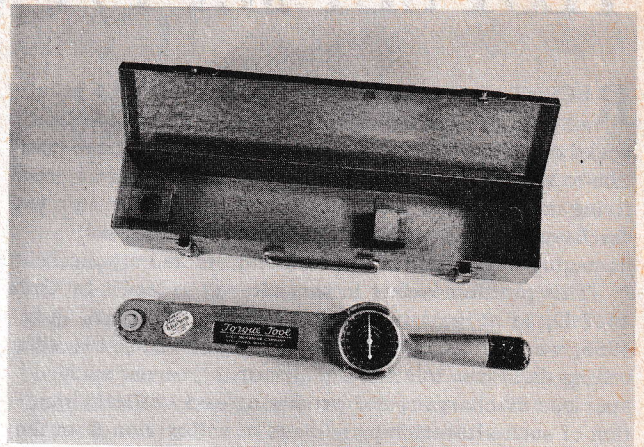
Torque wrenches are calibrated instruments and should be treated as such. To keep them honest when they're in hard use even good ones should be calibrated every three months. The lab that calibrates your test sets should have FED SPEC GGG-W-686b and all the gear necessary to calibrate your wrenches, including stickers to show the results, including "reject" stickers which notify you your

wrench should be discarded for a new one.

Adjustable-type wrenches are not authorized. When ordering torque wrench replacements for your basic tool set specify 5120-242-3264 for 50-0-50 ft-lbs, or 5120-230-6380 for 150-0-150 in-lbs. These are the same Type-II Style-A wrenches that are to be found in newer basic tool sets. Their actuating elements are enclosed in a rigid frame which affords some protection against accidental damage.

Even so a torque wrench should not be kept loose among other tools in a tool box but instead should be returned to the metal case issued with it for added protection. With this sort of care these wrenches should be good for a long time.

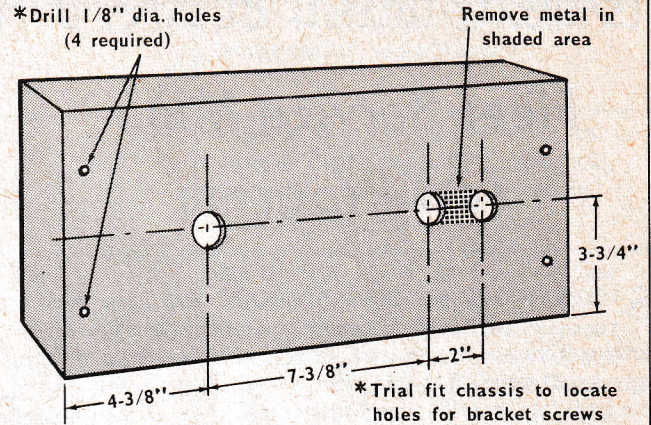
CHASSIS, MODIFIED, REAR VIEW

**T**EST SET MARK 157 MOD 0 is a mechanical test set that includes a 1725-rpm 1/4-horsepower motor that drives a vacuum pump by an exposed linkage of pulleys and belt. The rapidly rotating parts are a nasty safety hazard that can snatch a careless hand or an article of loose clothing.

Next reinstall pulleys and belt, adjust until belt is tight. Run the motor and pump long enough to determine if there is any pulley interference with the guard, and if so adjust as necessary. ④

Now fit the cover over the chassis and secure with the two screws that were supplied with it and you'll have a job that's neat, safe, and should be troublefree for as long as the pump lasts.
