THE TROUBLESHOOTER

Published by the Naval Mine Engineering Facility, Yorktown, Virginia

1 JULY 1967

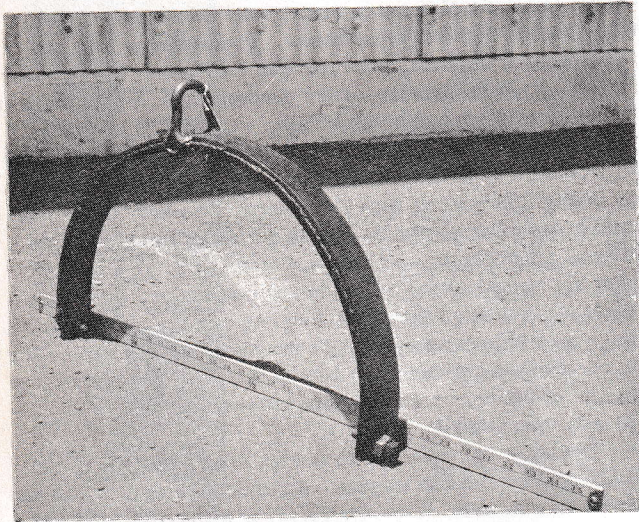
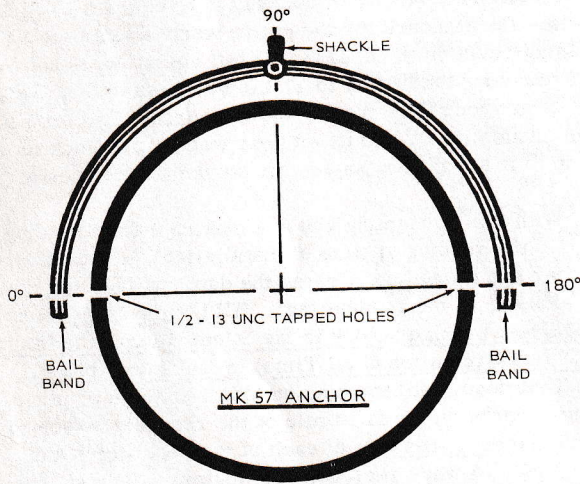
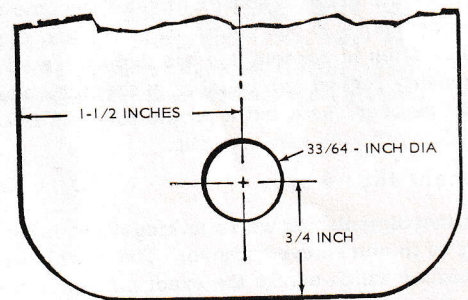
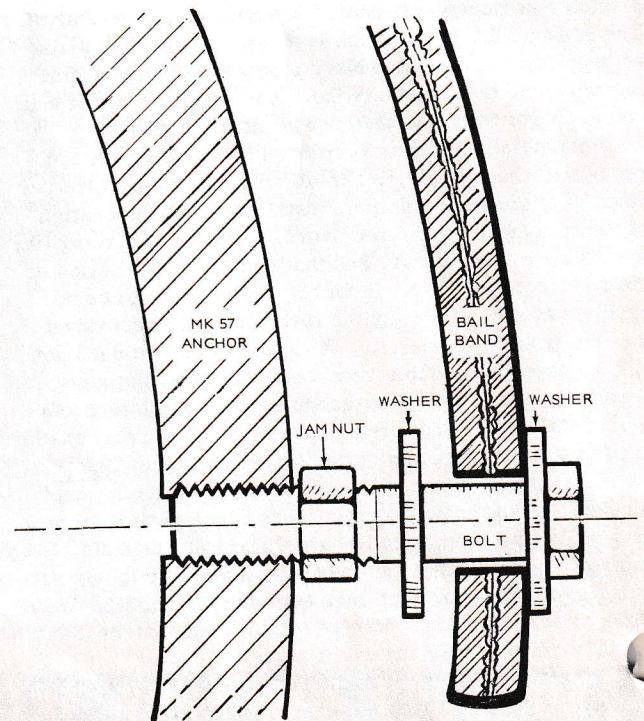
TO UPSET A MARK 57 ANCHOR

Christian's quarrel with the standard eye bolt and lifting plate method is that the final step (upending while the hoist is being slacked off) requires two men with three men's muscle. This, he observes, is being done at the same time the anchor is resting on its chine, and that gives the anchor a tendency to roll, making it even harder to control.

So Christian uses the eye bolt from the outside of the anchor shell, instead of the one inside, to make his first lift. And instead of the prescribed lifting plate he uses a bail band of his own design, pictured here, for the final lift. He constructed the bail by cold bending a strip of quarter-inch mild steel about 3 inches wide and 40 inches long into a semi-circle . . . specifically, a bending radius of 11-1/2 inches, and an arc of 180 degrees. To stiffen

Next step was to drill 33/64-inch holes near the two ends (0 and 180-degree centers) as shown, trimming any excess length and rounding off the sharp corners to save the skin and tempers when the rig is used. At this stage it would also be a good idea to trial fit the bend to the curve of the anchor shell: the object, of course, is to have the two 33/64-inch holes line up with the half-inch tapped holes near the rim of the anchor at its cover-plate end.

Midway between the two drilled holes, at the 90-degree point on the band, a half-inch steel shackle is welded to the band. This can take some blacksmithing, to spread the shackle so it fits snugly over the band. This weld is critical; it must be a good one.

WARNING Before using the device shown here it must be load-tested and certified for 1200-lb lift per Safety Handbook OP 2165.

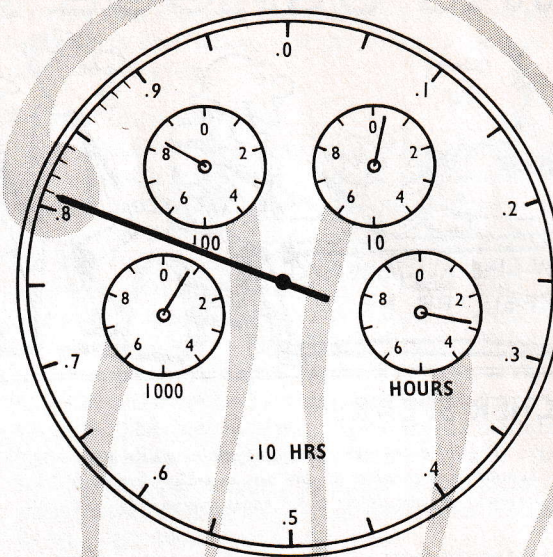
And that's it. Mark only in lead pencil, use only confirmed Greenwich Civil Time, copy the dials first and interpret them later, read all dials to the lowest whole number, and we think all will be fine. We think that present 20 percent data loss will become a thing of the past.

Thousands	Hundreds	Tens	Hours	Tenths
0	8	0	2	8
