THE MINE AND DEPTH CHARGE TROUBLESHOOTER

THE MINE AND DEPTH CHARGE

TROUBLESHOOTER

ISSUE 2-70

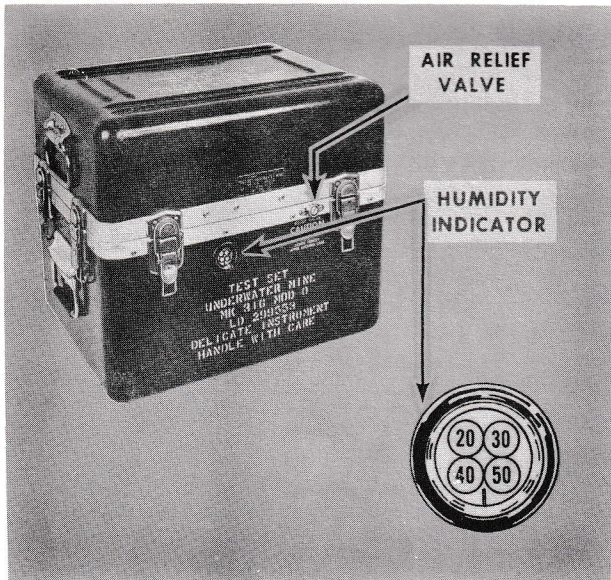
Air dryers will last longer when the newer test-set cases are kept airtight, but eventually will become exhausted and must be replaced. To tell you when, humidity indicators are built in: one on the

exterior of the case and another on the instrument panel. They are a 4-spot plug type, the spots showing the figures 20, 30, 40, and 50. All spots are blue when the desiccant is fresh. When the 30-spot turns pink it means 30% relative humidity has been reached within the test set case and the air dryer(s) should be renewed. If the 40-spot show pink the set should be examined for humidity damage. The sets should never be let go until the 50-spot turns pink!

The panel indicators show condition of the air-dryers in the containers on the dust cover of the chassis. Case indicators show condition of air-dryer bags stowed in the accessory compartments, or other free space where they will not contact

the equipment. Indicators do not have to be replaced. They should turn back to blue with fresh desiccant.

Instructions for desiccant-bag replacement will eventually appear in revisions to maintenance requirement cards for fiberglass-cased test sets. Meanwhile here is a list of current vacuum-sealed sets, with location of humidity indicators and unit size of desiccant bags. MMC for 2-unit bag is 5D00001, 4-unit bag 5D00005, 8-unit bag

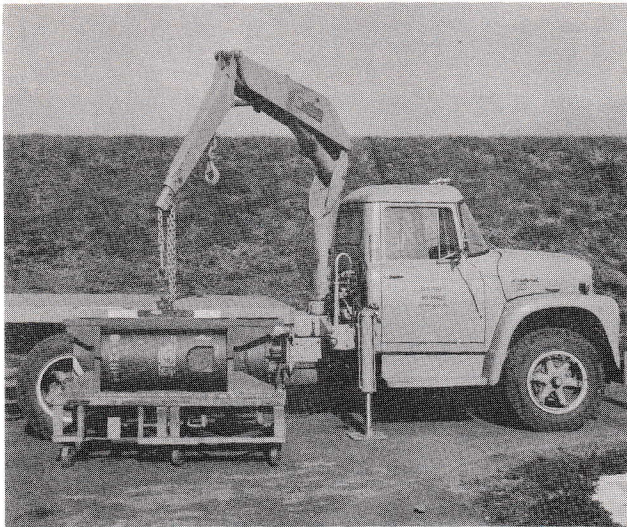
View of HIAB Speedloader mounted on platform truck showing location of hydraulic controls and with outrigger in down position.

Mine activities that have replaced their MJ-2 bomb service trucks with the new HIAB hydraulic crane mounted on a 1600 CVW and 2400 CVW stake or platform truck should be aware that stability and crane loading test procedures must be accomplished before the equipment is used for handling explosive ordnance. This is a requirement by the Naval Facilities Engineering Command. What agency will perform the tests depends on local conditions. Generally speaking it will be a public works function. You, the user, cannot test or certify your own equipment.

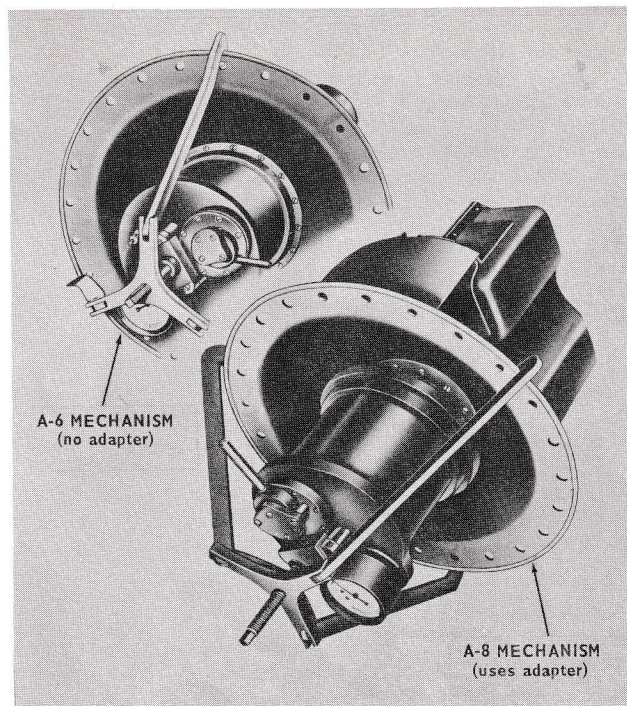
TEST SET MK 66 INSTALLED

The answer to all this is to ease up on the torque, which is to say don't take too many turns with the clamp assembly wrench when preparing to test the A-6 or A-8 firing mechanism. If you get a leak after following instructions in OP 2567 PART 1 VOL 1 Change 2 the fault no doubt lies in the gasket(s) not the lack of pressure exerted on them by the clamps.

To elaborate and augment instructions now in OP 2567 follow these steps in preparation for A-6/A-8 testing:

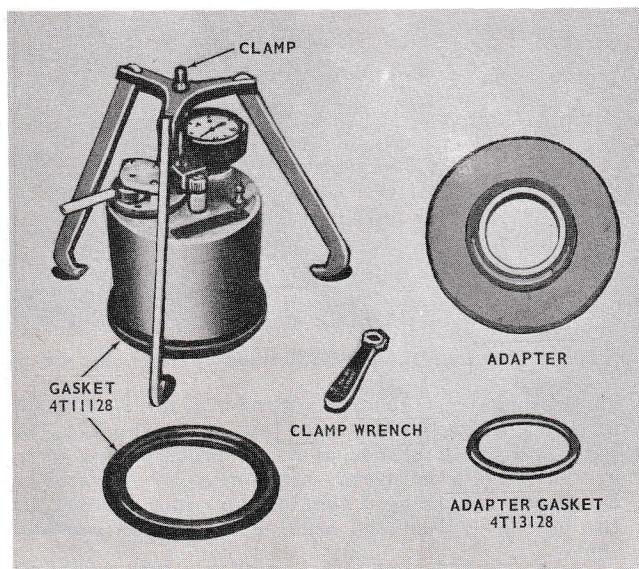
TEST SET MK 66 MOD 1
with clamp wrench, replacement gaskets

► Examine gaskets that come with the test set to be sure they are clean. Stretch slightly and look for cuts, cracks or gouges. (If you can't find good ones among the spares, replacements are the test pot gasket 4T11128, and the adapter gasket 4T13128.
