THE MINE AND DEPTH CHARGE TROUBLESHOOTER

TROUBLESHOOTER

ISSUE 3-70

1 OCTOBER 1970

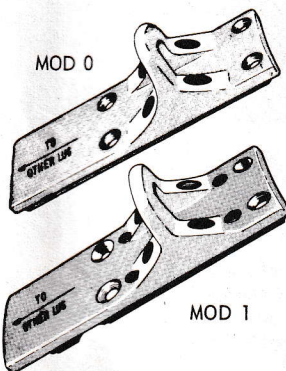
Mk 13, Suspension Lug

Suspension Lugs Mk 13 Mods 0 and 1. These lugs are specified for use on Mk 36 Mod 2 mine cases, replacing the original World War II type identified by Drawing No. 495999, which is now obsolete. Both Mods 0 and 1 are designed for use on high-performance aircraft. The purpose of the Mod 1 is to accommodate mine cases that have three-piece vs one-piece flush strongbacks, and they should be reserved for that purpose as long as Mod 0s are available. Mod 0s cannot be used on three-piece strongback cases with any degree of success. The mod designation is clearly die-stamped on the underside of the lugs. The two mods are easily identified by inspection: the Mod 0 has

eight holes and the Mod 1 twelve holes. The four extra holes are to take care of the set screws used to align the lugs when the sections of strongback under the lugs are not in the same plane.
