# THE TROUBLESHOOTER

*mine and depth charge*  
**THE TROUBLESHOOTER**  
Published by the Naval Mine Engineering Facility, Yorktown, Virginia.  
Frederick F. Jewett, CDR., USN... Officer-in-Charge  
Haines A. Miller..... Technical Director  
Thomas R. Nevitt..... Editor  
Roland R. Rollins..... Art Director

**1 JANUARY 1965**

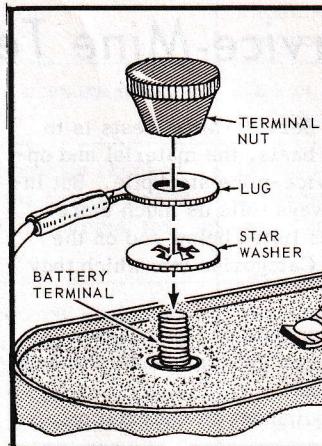
Believe you should call attention to the habit of placing star washers on top of a battery-cable lug when hooking up. With this setup any shock, vibration, or other movement tends to loosen the terminal nuts, whereas with the star washers under the cable's lugs the entire assembly is locked together and stays that way.

Brother Gotshall of MOMAT 0302 also called this slip to our attention, noting that instructions in mine pubs vary on the placement of starwashers, or else neglect to mention it altogether. Until they do, accept the location of the starwasher between lug and battery terminal shown here as the one right way to connect cables to batteries.
