THE TROUBLESHOOTER

mine and depth - charge

Published by the Naval Mine Engineering Facility, Yorktown, Virginia

1 JANUARY 1966

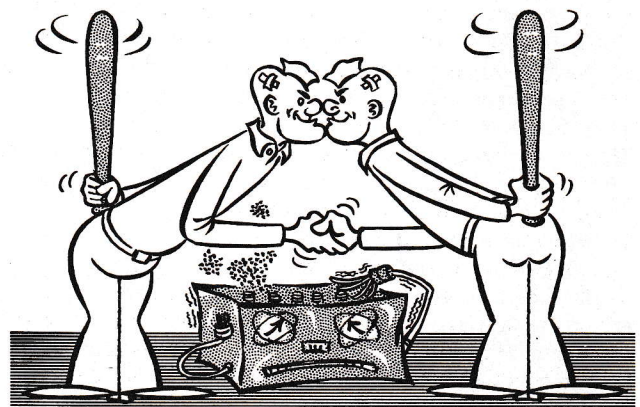
NEW FILLING KITS FOR OLD

A THORN IN THE side of holders of equipment for replenishing the nitrogen gas in the Mark 23 containers for Pressure Detectors Mk 1 Mod 0 has been the refill kit which, with a vacuum pump and nitrogen cylinder, make up a complete assembly. Surveys of samples from depot stocks, in response to some excellent Rudmines, have shown that the kits currently in stock, like those in use, just don't work. Among the reasons:

- ▶ Threads of regulator and gas cylinder frequently are incompatible.
- ▶ Magnets in the wrenches on the kits' evacuating-and-filling fixtures are too weak to hold the screw away from the Mk 23 container's filling hole.
- ▶ The laboratory type pressure-vacuum gage is not rugged enough for the job.
- ▶ Batteries BA-205/U, packed with the kits for use in positive-pressure test equipment, are mostly deteriorated from the effects of poor storage conditions.

- ▶ A new regulator with left-hand threads, to take the place of the present oxygen-type pressure regulator with right-hand threads (nitrogen cylinders require left-hand).
- ▶ An evacuation-and-filling fixture designed to accommodate a stronger magnet, one that can be brought in positive contact with the filling-hole screw heads, which an offset in the present wrench-socket types does not permit.
- ▶ A bourdon-type pressure-vacuum gage, replacing the present Stokes-McLeod types.
- ▶ Hose clamps, to insure leakless assembly of tubing and connectors.

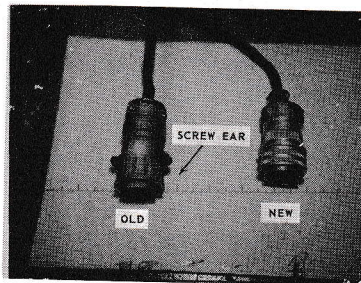
Anytime I got one of those amphenols on a CA-524 I sure would do exactly what you suggest. It appears, though, that not too many 524s still have those older type amphenols, and the new one-piece jobs pose no problems at all, as all hands can see from PEM's pix below. Therefore we do not plan to change the OP, feeling that this item in itself will be enough to alert assemblers of Mines Mk 36 Mod 3 (in 36-2 case) to watch out for split-type amphenols on CA-524s, and to install them first when they encounter one.
